#### ABANDONED MINE LAND INSPECTION

PROJECT NAME		PROJECT NO.	GRANT YEAR	REPORT NUMBER		
Golden Pond Gob Removal		18302	2018	HNM0008664		
CONTRACT INFORMATION						
CONTRACT NUMBER	EXPIRATION DATE		PERCENT OF CONTRACT COMPLETED			
C196013	0;	03/31/21		2

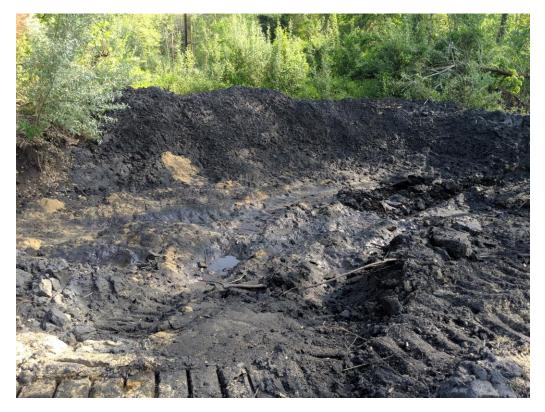
An area located near the building site that had been excavated to solid prior to backfill placement.

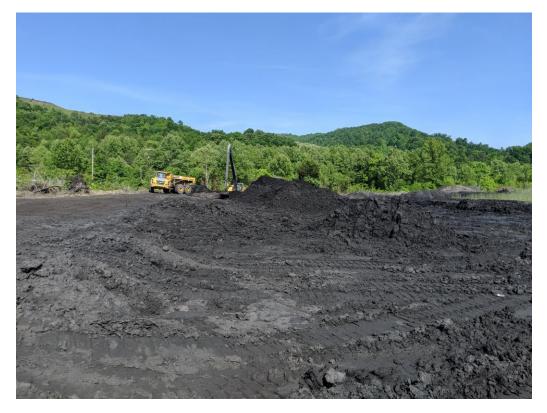
Material Excavation and Removal in Zone 1

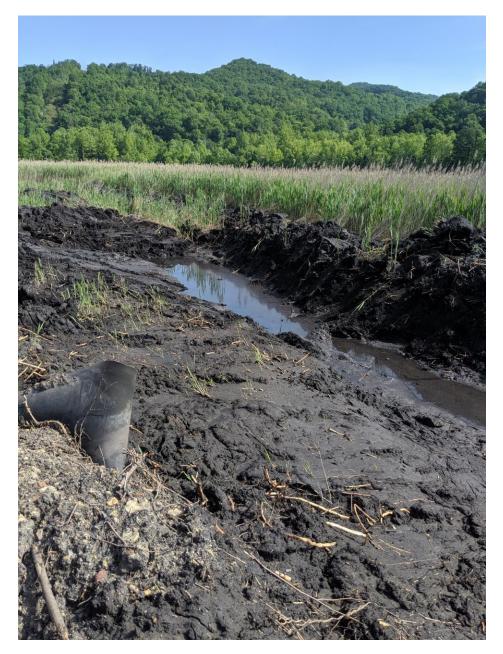
Unstable material located in Zone 2.
