### ABANDONED MINE LAND INSPECTION

PROJECT NAME	PROJECT NO.	GRANT YEAR	REPORT NUMBER
Golden Pond Gob Removal	18302	2018	HNM0008582

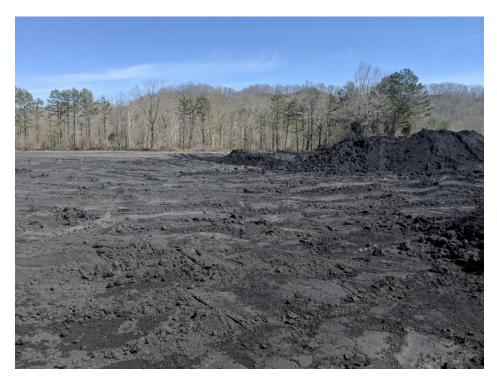
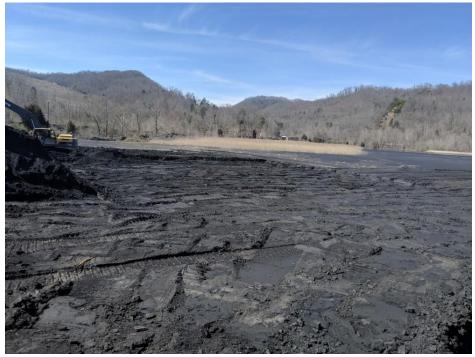
3/28/19-Excavation of material continues, with the company still excavating the upper 18 inches. The water discharging from Golden Pond was much less than in previous weeks. The discharge was estimated to be less than 1 gallon per minute and was clear. Photos of the site are shown below.
