Cumberland Plateau Planning District Commission

Hazard Mitigation Plan Update

September 2018

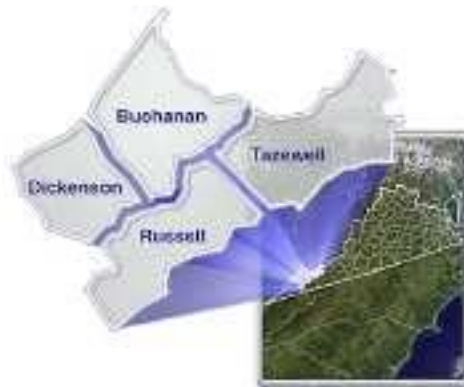
Figure IV-1 — Cumberland Plateau Planning District Commission

The Cumberland Plateau Planning District is 67 miles long and 40 miles wide and covers approximately 1,848 square miles as shown in Figure IV-1. It borders West Virginia on the north and Kentucky on the northeast. Wise, Scott, Washington, Smyth and Bland Counties in Virginia form the boundaries on the west, south and east. The District is divided into two physiographically distinct regions, both lying in the Appalachian Highlands. The counties of Buchanan and Dickenson, along with the northern portions of Russell and Tazewell Counties, lie in the Cumberland Plateau which is, in turn, a part of the Appalachian Plateau. This area has a uniformly mountainous surface characterized by many small streams separated by sharply rising ridges, steep slopes, and narrow valleys. The remaining region of the District, comprising the greater portion of Russell and Tazewell Counties, lies in the Valley and Ridge Province of the Appalachian Highlands. This belt, consisting of alternate valleys and ridges is bordered on the south by the Clinch Mountains and on the north by the Cumberland Plateau. Elevations vary from 845 feet above sea level to 4,705 feet above sea level.
