**Determining the Ecotoxicological Recovery of Black Creek (Wise County) and
Ely Creek
(Lee County) after Watershed Restoration of Abandoned Mine Lands and
Acid Mine Drainage: Final Report**

This report is submitted to Virginia Department of Mines, Minerals and Energy to fulfill the requirements of Applied Science Grant Funding.

Submitted March 26, 2008

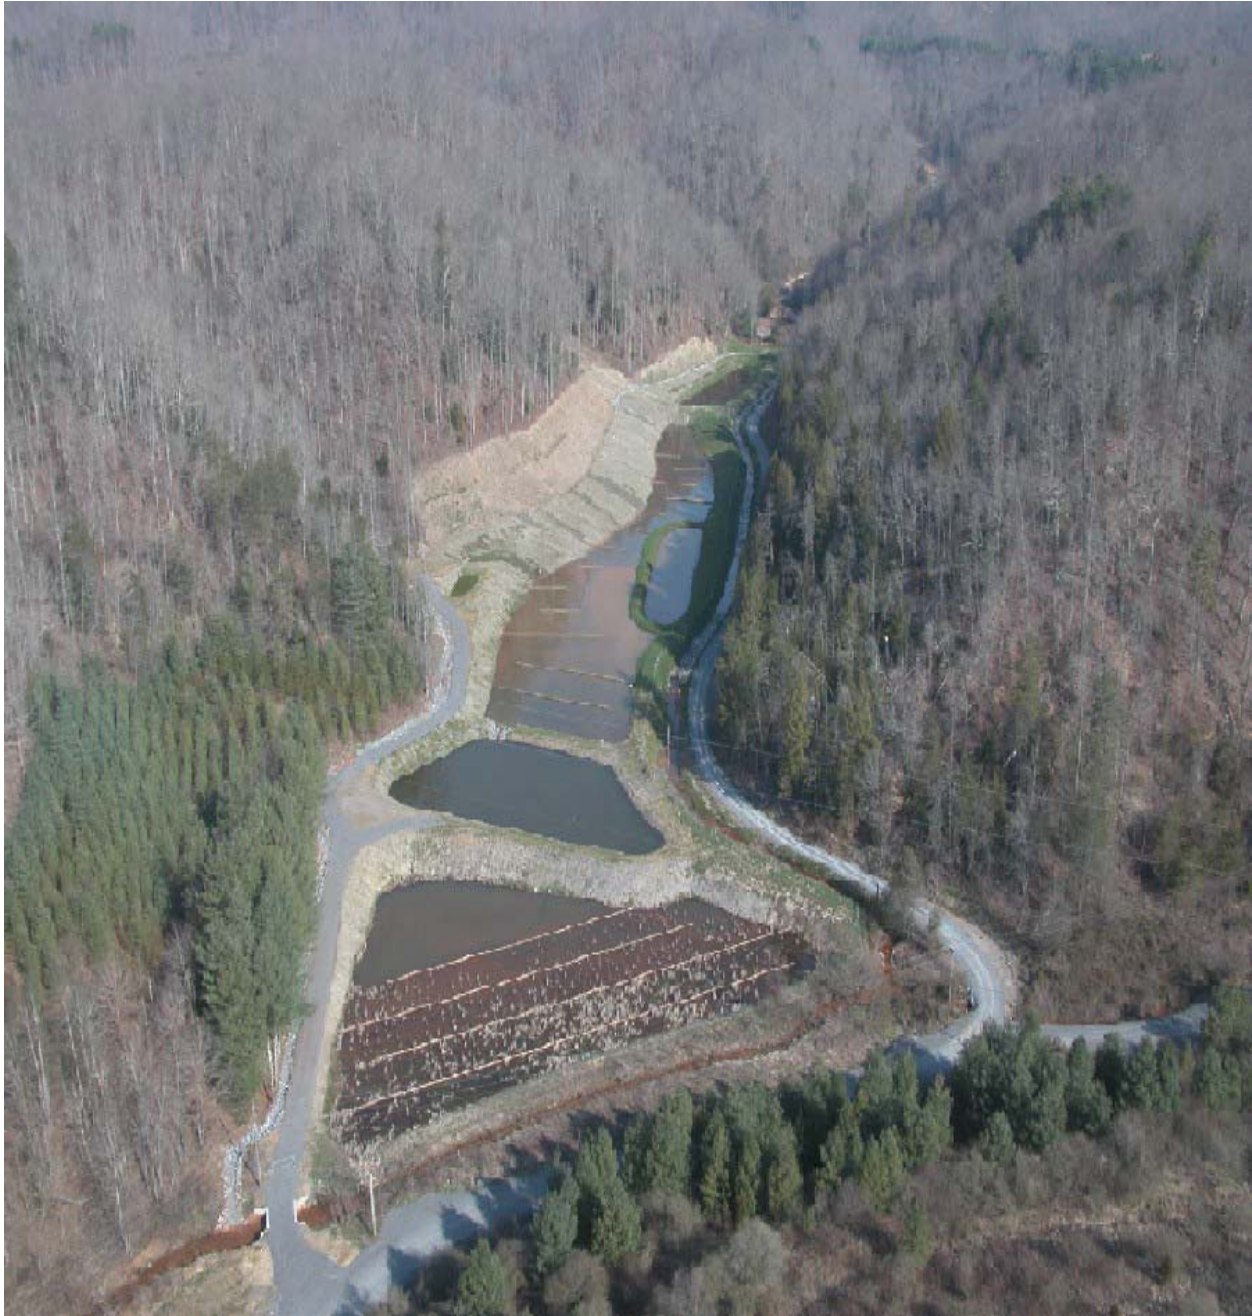
Fig. 2. Aerial photograph of SAPS implemented in Ely Creek at SW-8.

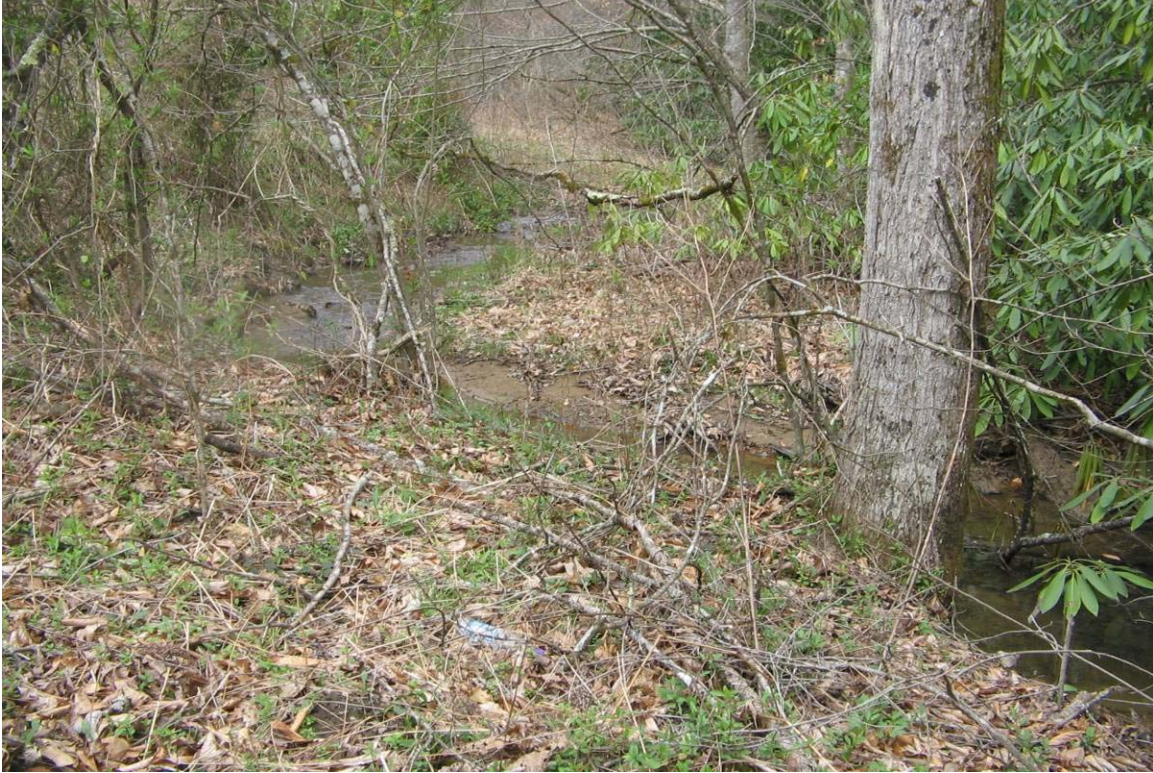
Fig. 3. Upstream view of SW-15 the most upstream site in the Ely Creek mainstem.

In the upper-most area of Ely Ck is the reference site, SW-15, that has a number of features for a pristine area except that the drought inhibited the quality of benthic macroinvertebrates found when it became intermittent during sampling this Spring 2007 (Fig. 3). Proceeding down Ely Ck is SW-13 which is now a pond like, backed-up area from the new beaver dams below it (Fig. 4). The beaver pond area just below has three AMD seeps that enter it from the outer perimeter of the area close to the county road (Fig. 5 A, B). Further downstream is the new SW-11 Seep discharge into Ely Ck and as the mainstem proceeds downstream toward Goose Ck (Fig. 6 A,B). The orange iron precipitate is quite apparent in this part of the upper mainstem of Ely Ck.

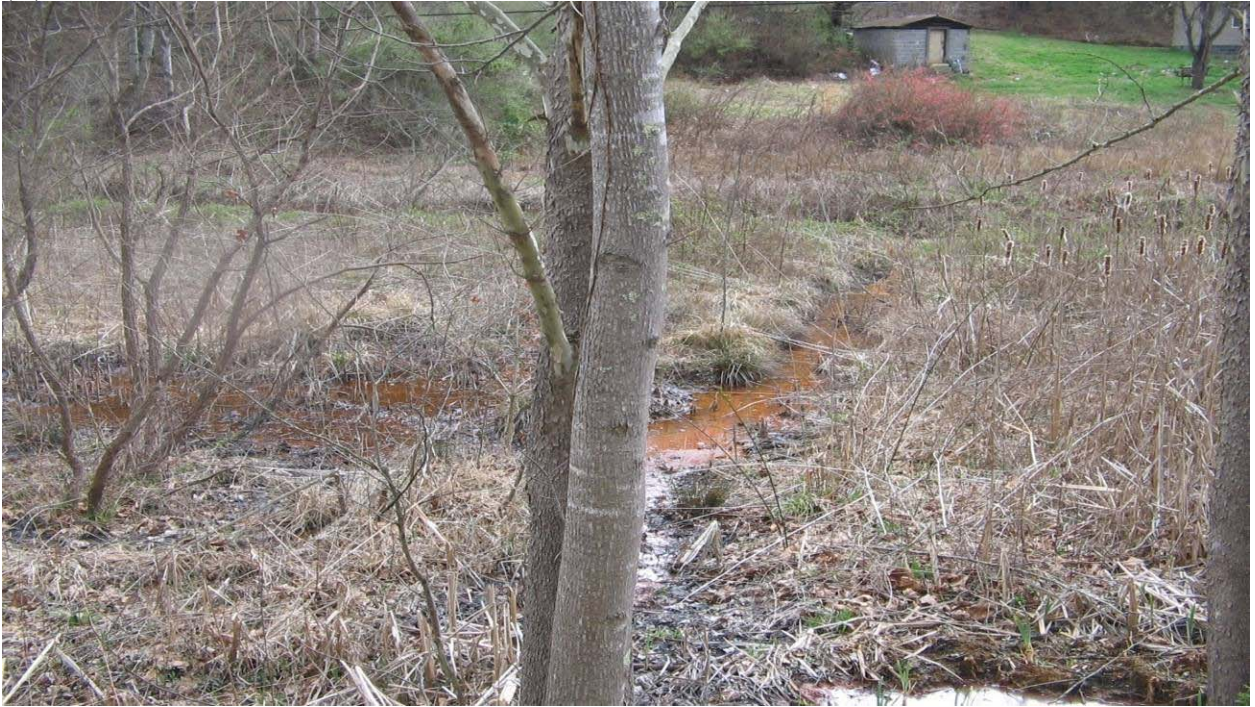
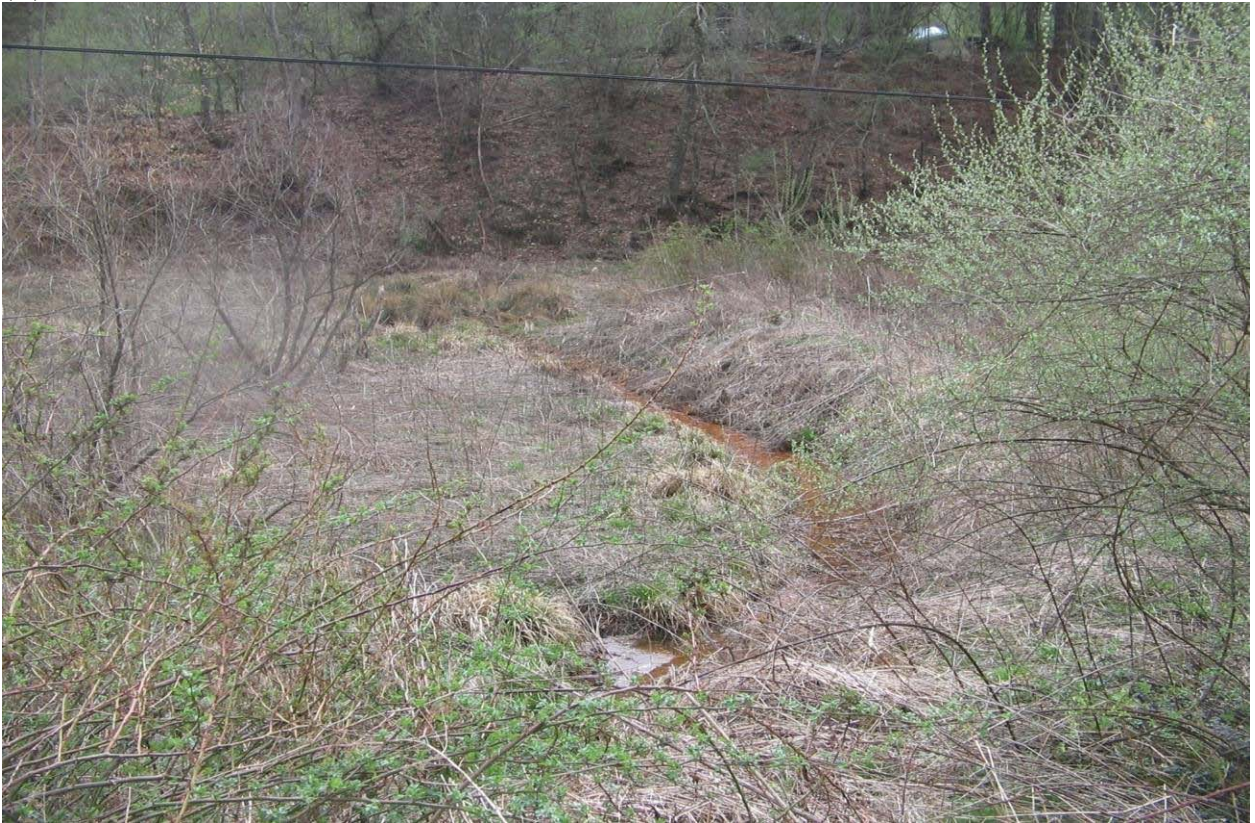
Fig. 5. Upper (A) and lower (B) beaver dam seeps in the new beaver pond.

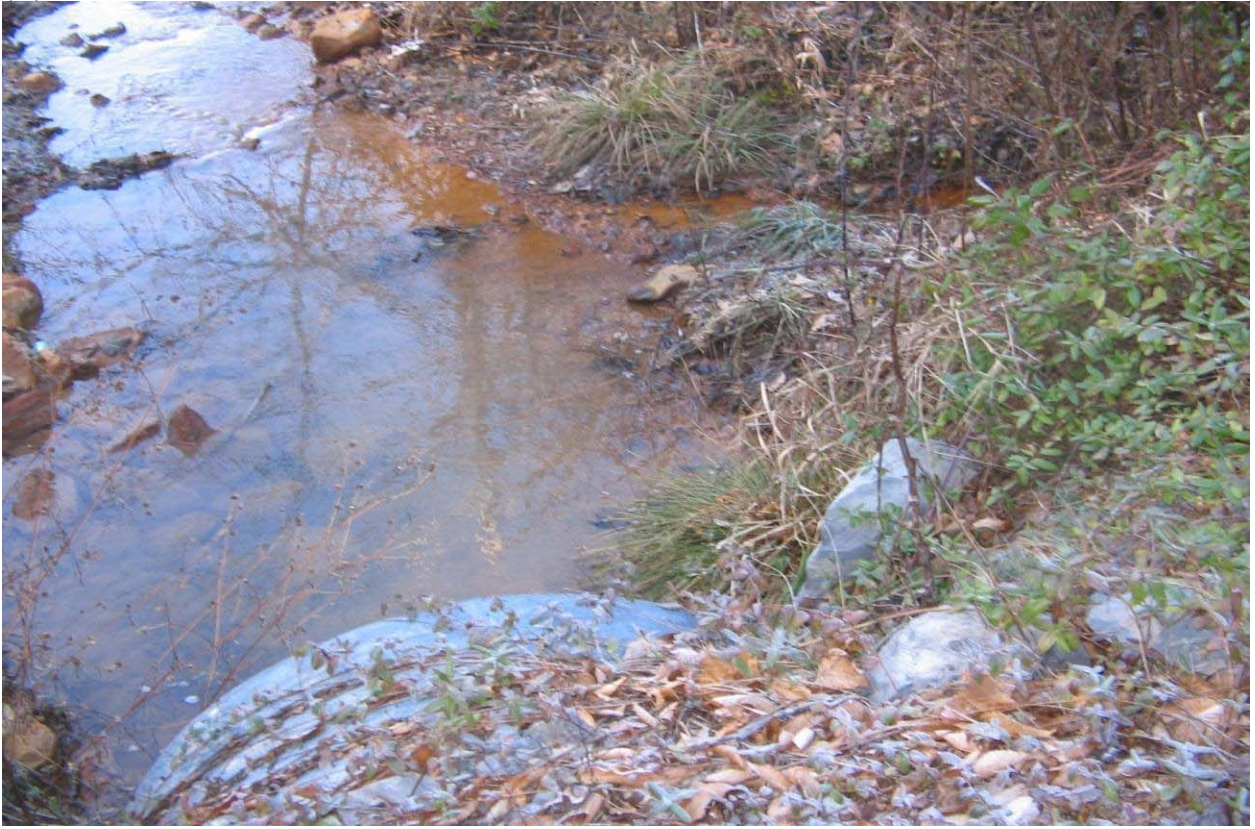
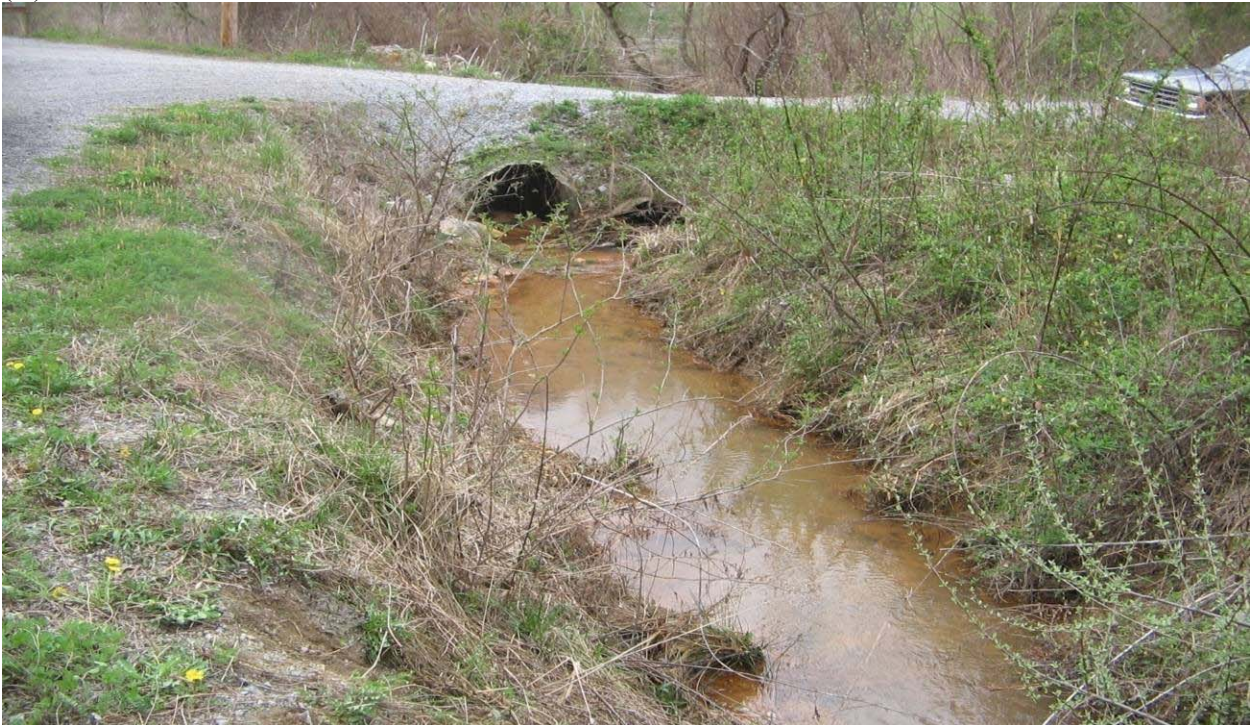
Fig. 6. (A) SW-11 Seep discharge into Ely Creek and (B) SW-11 Seep downstream view.

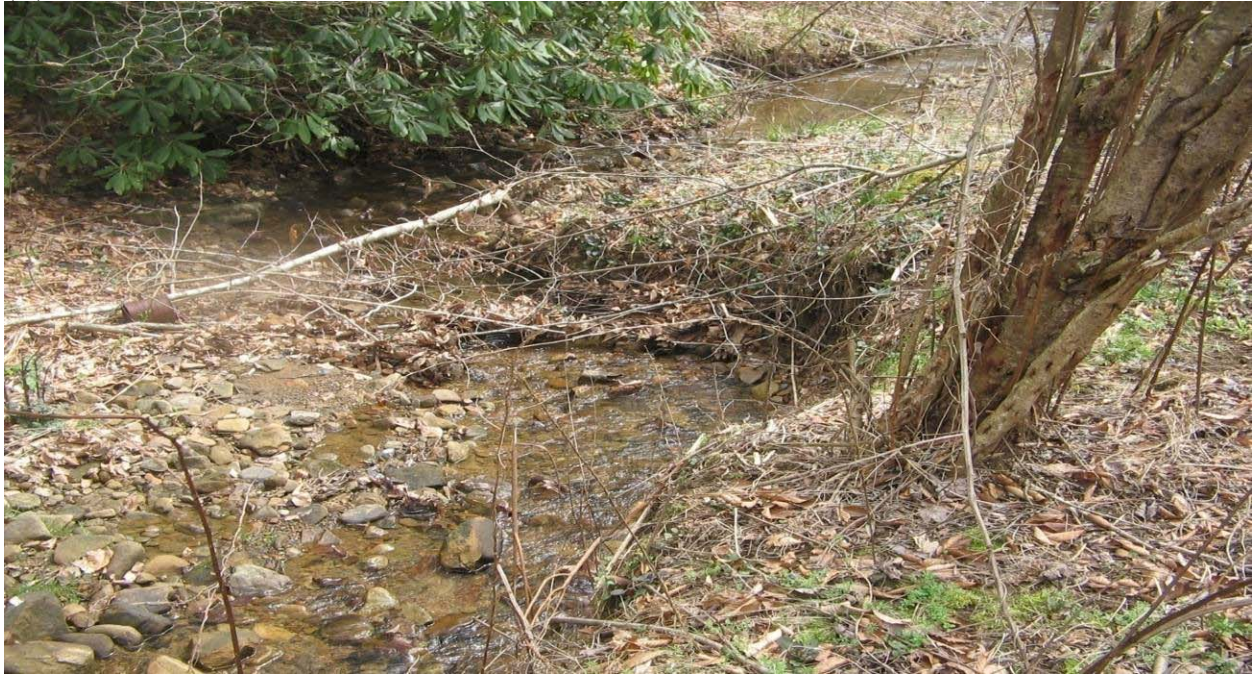
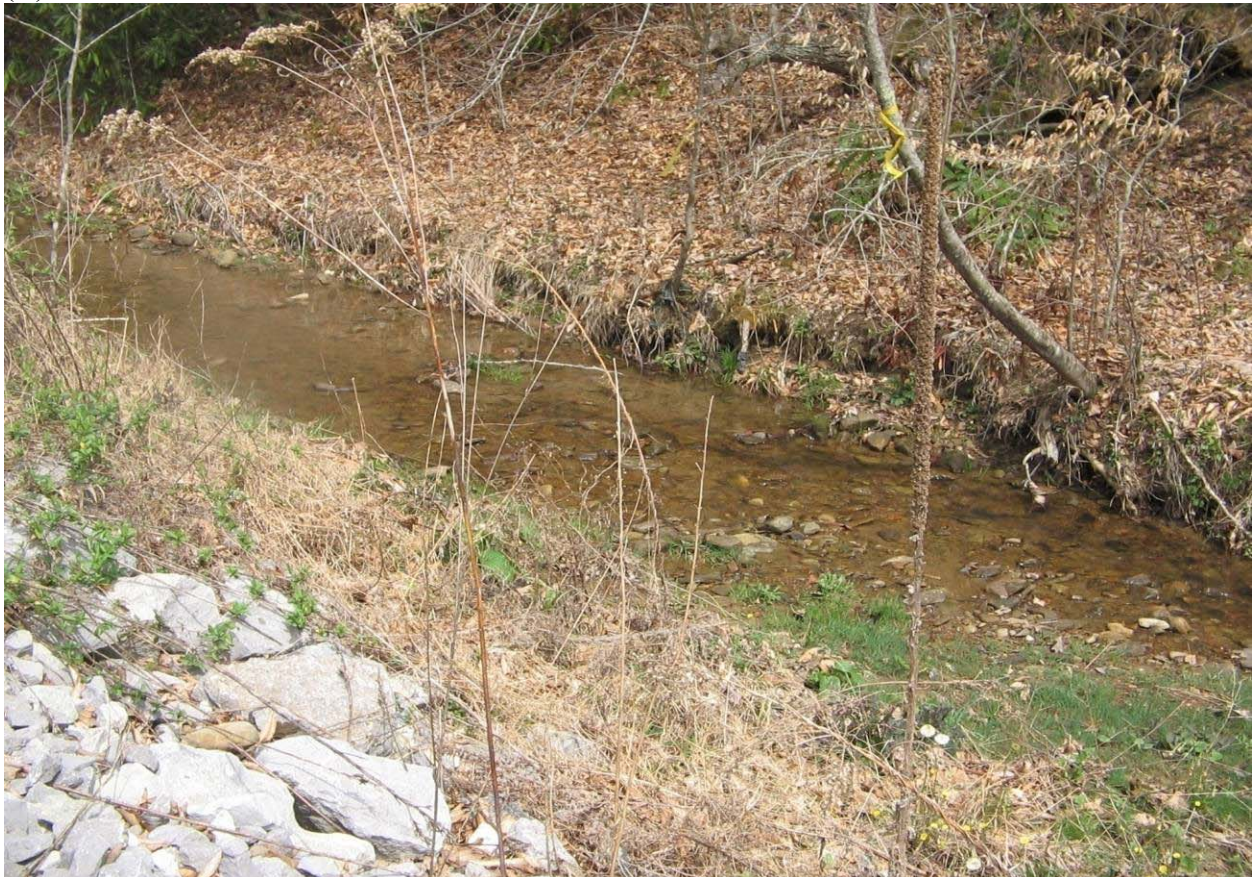
Fig. 7. (A) SW-14 and SW-16 merging view and (B) SW-14/16 combined further downstream.

In Goose Ck, the reference sites SW-14 and SW-16 became intermittent during the bug sampling effort as these two small tributaries merge and then becomes SW-14/16 (Fig. 7 A,B). The Successive Alkalinity Producing System (SAPS) in the remediated area is shown in Fig. 8 A as it is along the right side of the county road by the SW-8 site, and the wetland area in the SAPS parallel to SW-8 is found in Fig. 8 B. The “notorious” SW-8 site of the 1990’s is shown in Fig. 9 A as it flows parallel to the county road on the left with the massive remediated area on the right. The close-up view of SW-8 shows the prevalent nature of the orange, iron precipitate in Goose Ck (Fig. 9 B). The current seep into SW-8 emerges from an old AMD seep in the highwall area parallel to the right side of the county road (facing upstream) that flows under the road through a culvert into Goose Ck (Fig. 10 A). This old AMD seep was not addressed in the remediation efforts probably due to the massive discharges of the two old seeps that emerged from the wetlands. In Fig. 10 B the Goose Ck confluence into Ely Ck is seen. In Fig. 11, Ely Ck flows beyond the Goose Ck confluence (A) at the SW-11 Dn site and the SAPS discharge point is also seen (B). Another view of Ely Ck parallel to the SAPS discharge area is shown in Fig. 12 A, B with Rt 765 parallel along the left side. Beyond this point, the SW-7 site is shown at various angles above and below the church (Fig. 13 A, B). At this point, the Bean Ck confluence enters the Ely Ck mainstem. The other major remediation effort is located just above SW-9 in Bean Ck (Fig. 14 A), and as it enters Ely Ck one can notice the change in water clarity into the orange/iron influenced area from the SW-8 site upstream (Fig. 14 B).

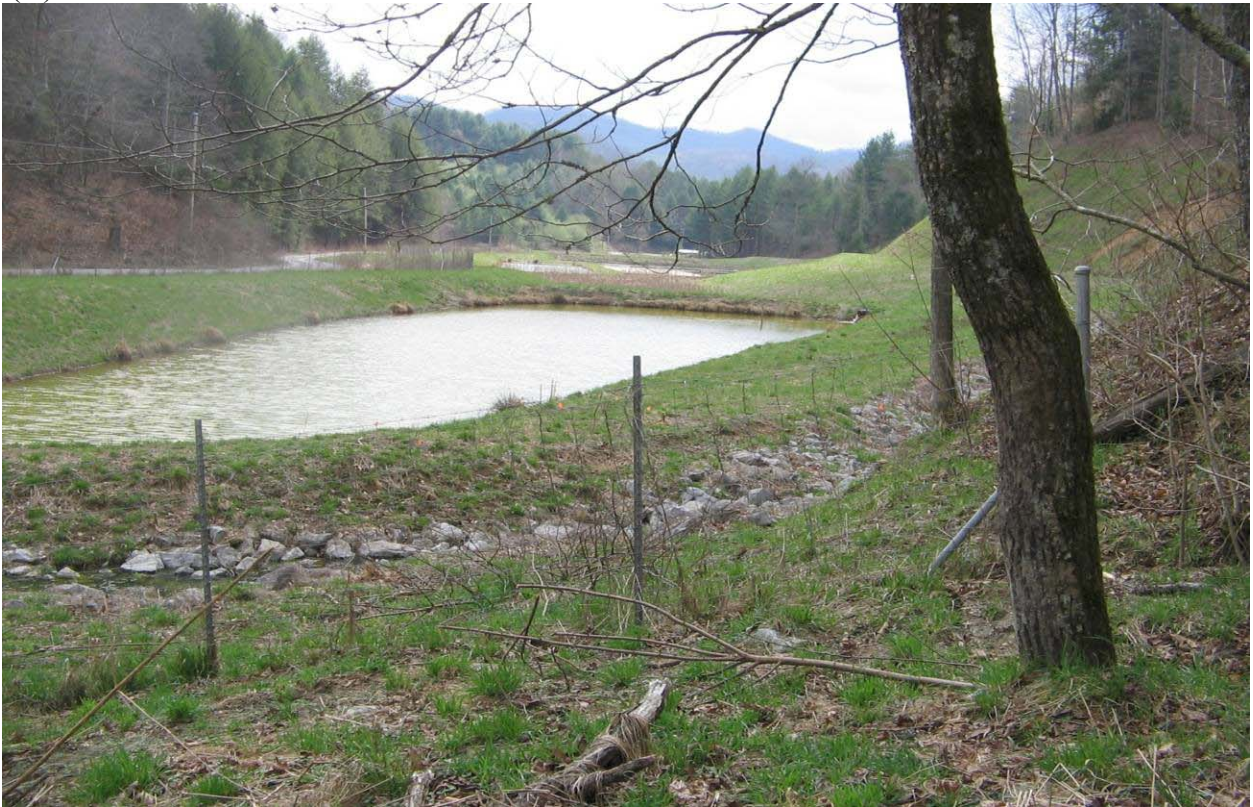
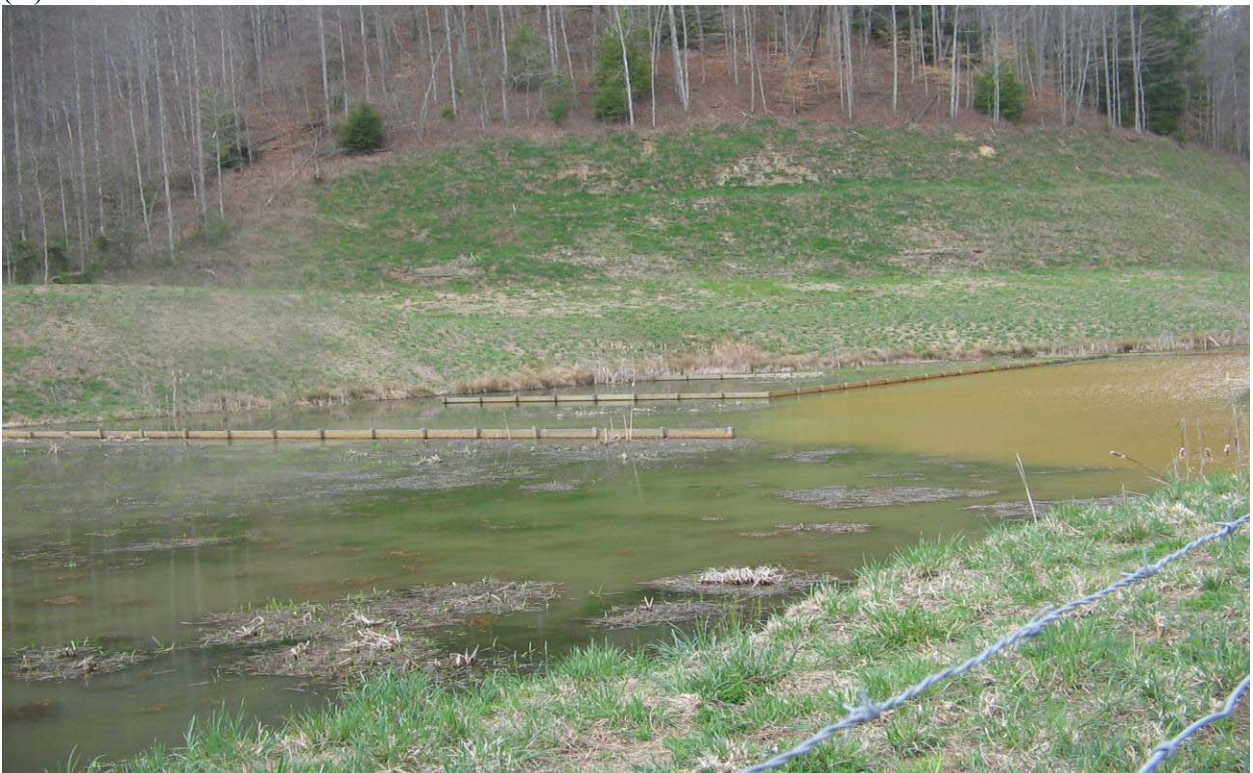
Fig. 8. (A) Discharge point to SAPS at SW-8 site and (B) wetland in SAPS at SW-8 site.

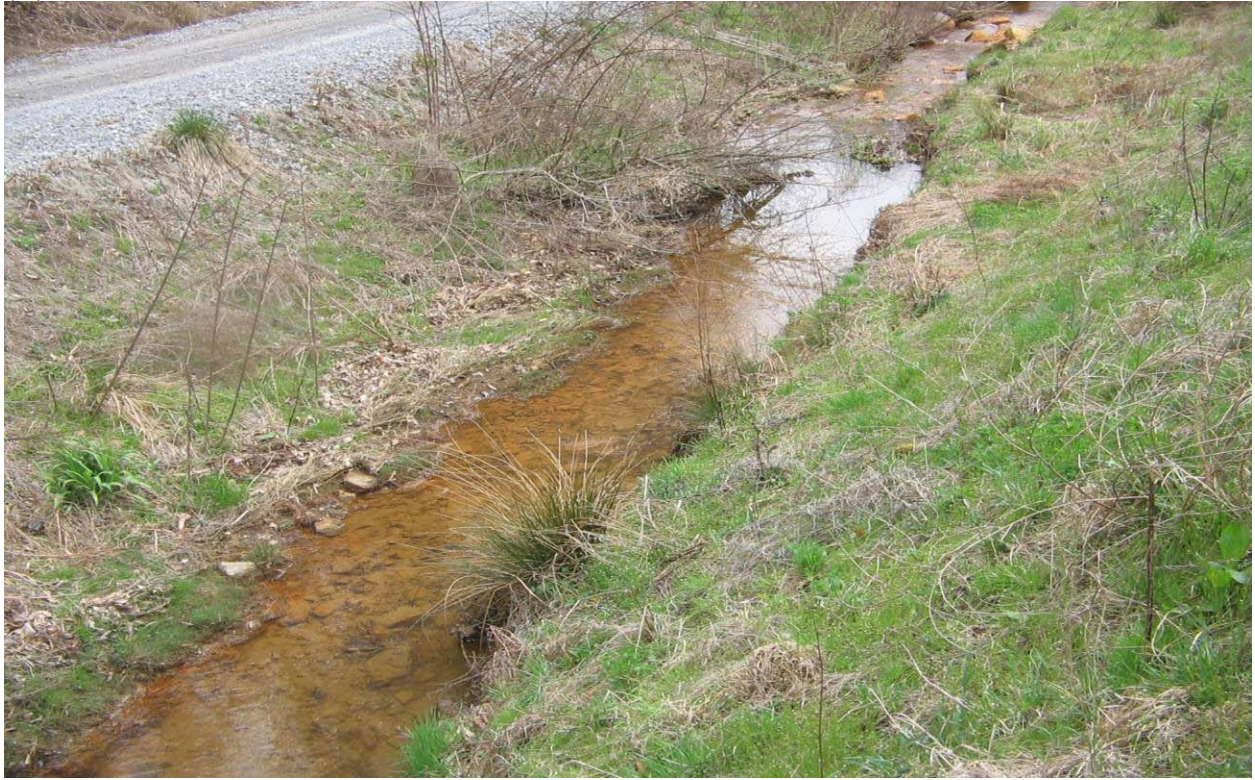
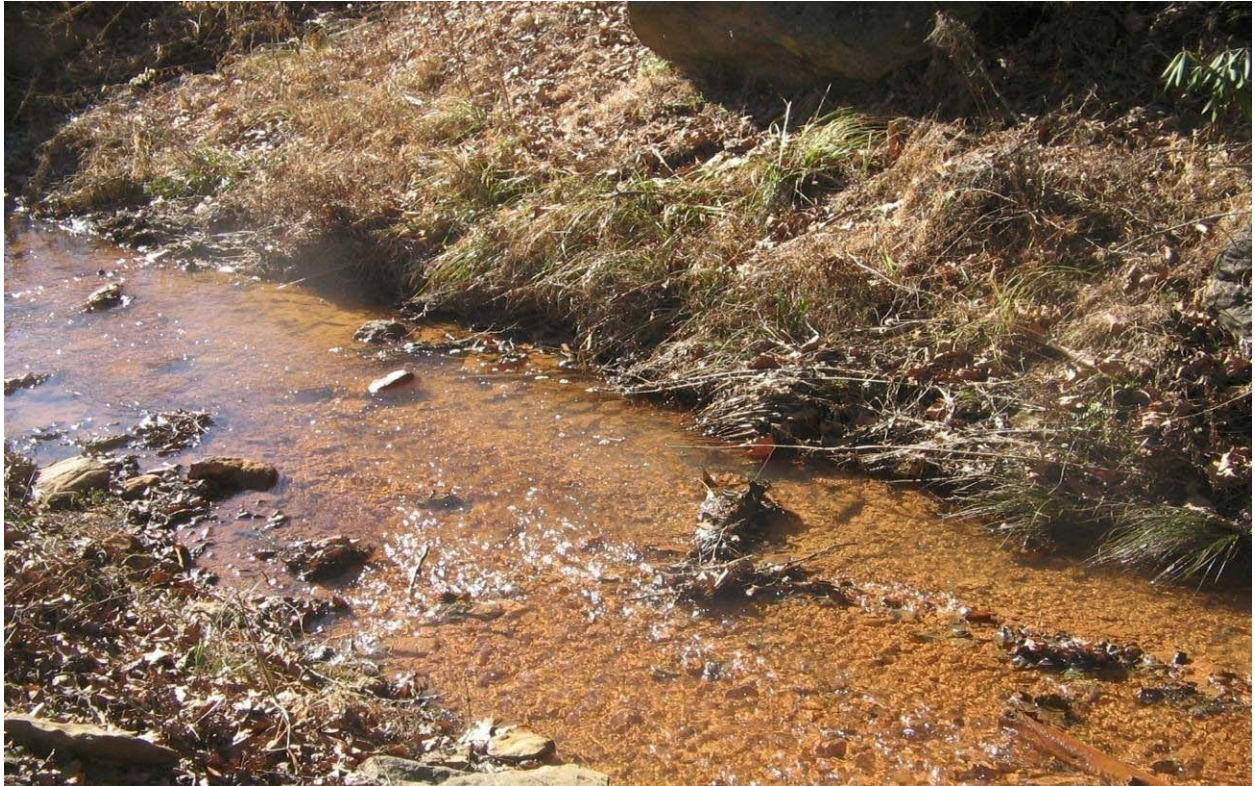
Fig. 9. (A) Downstream view of SW-8 and (B) close up of SW-8 water and sediment.

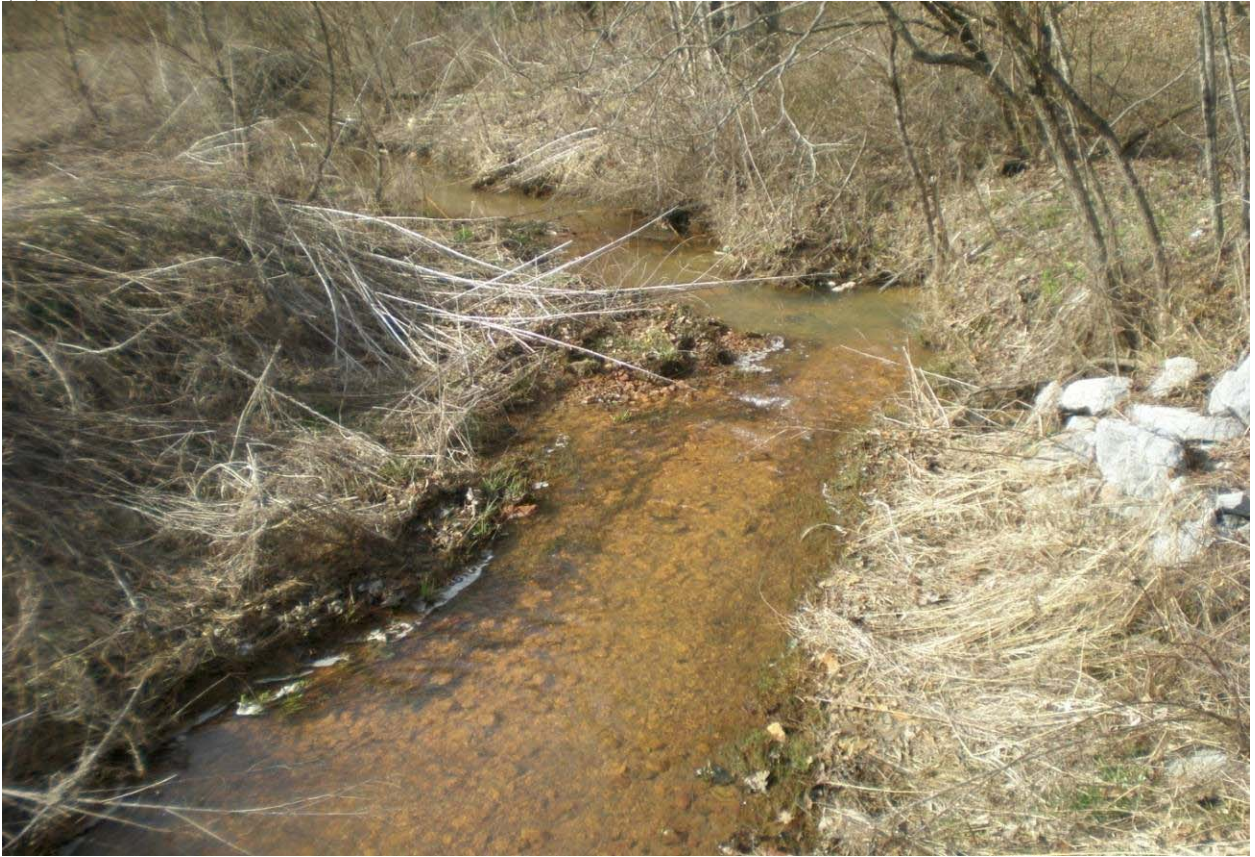
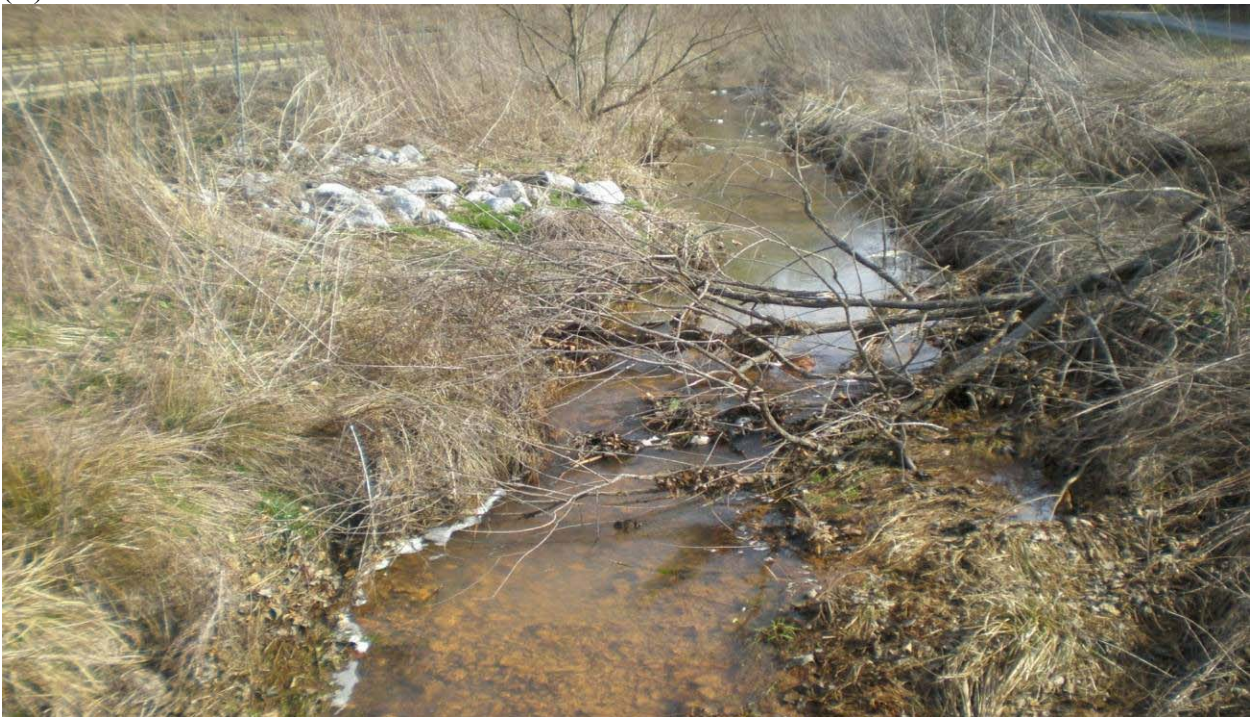
Fig. 12. (A) SW-11 Dn in Ely Ck mainstem and (B) SW-11 Dn just after SAPS discharge.[cz10]

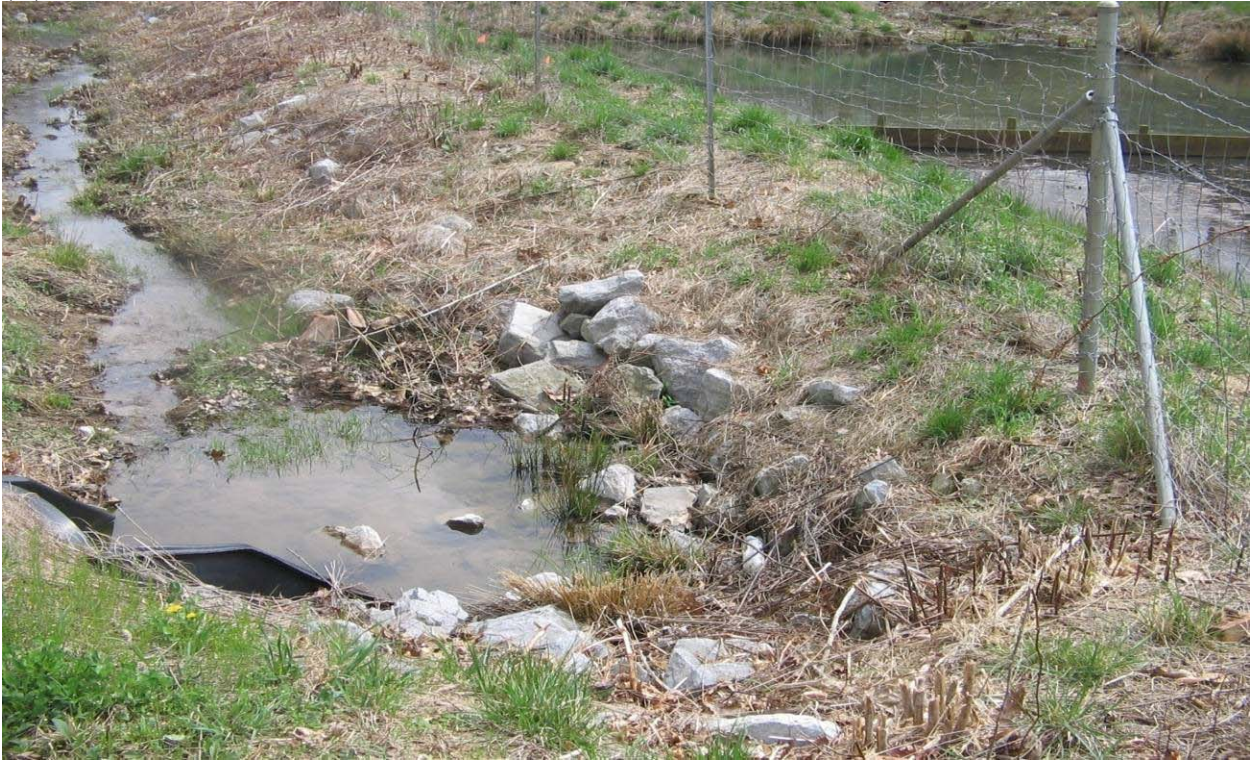
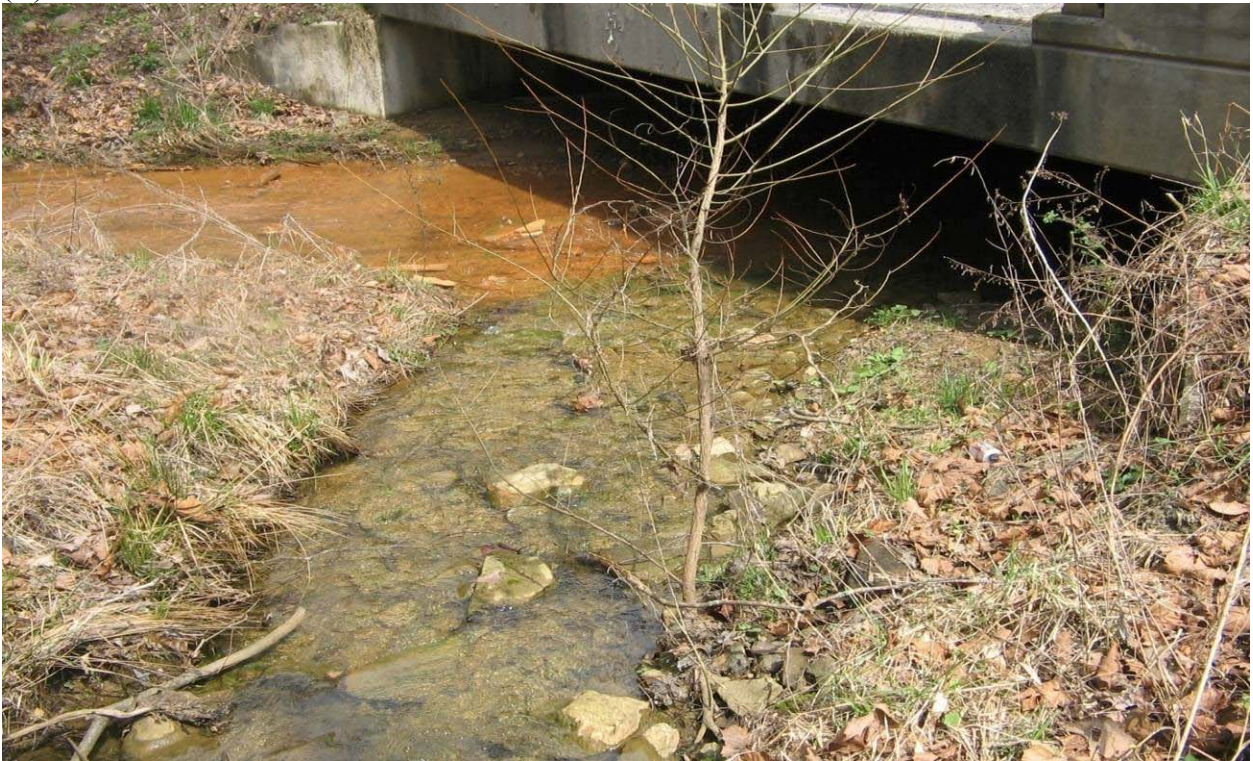
Fig. 14. SW-9 site in Bean Ck with downstream view and part of SAPS and (B) Bean Ck confluence with Ely Ck.

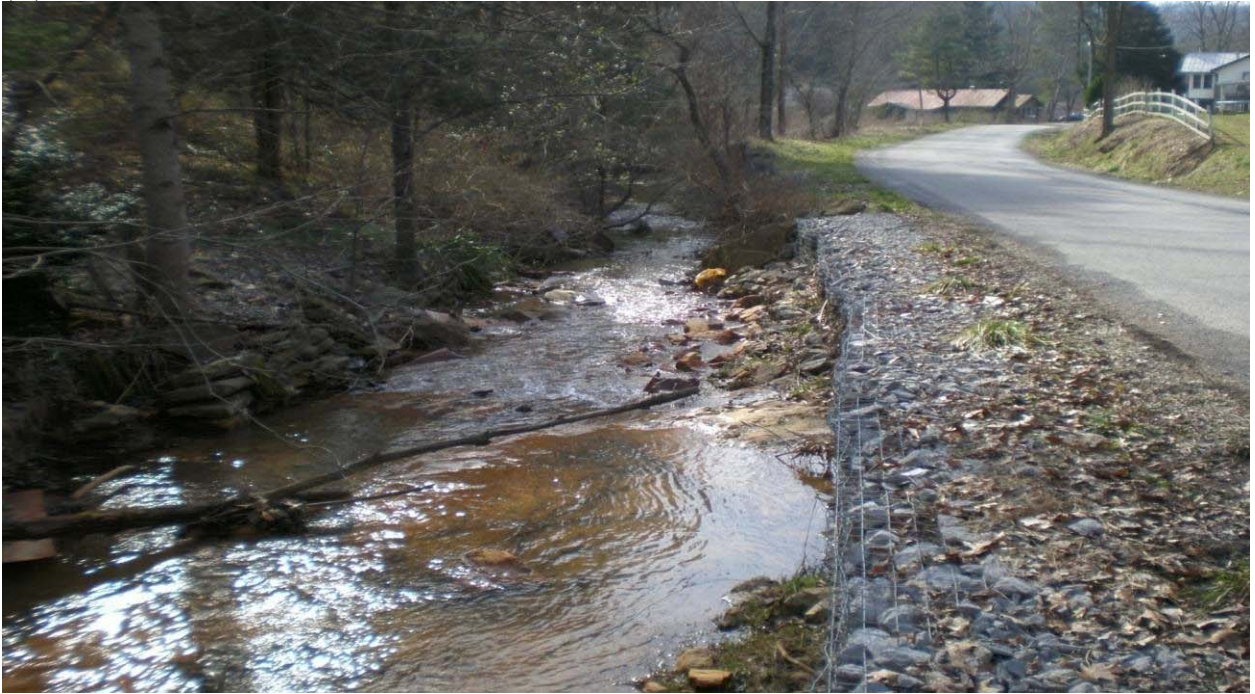
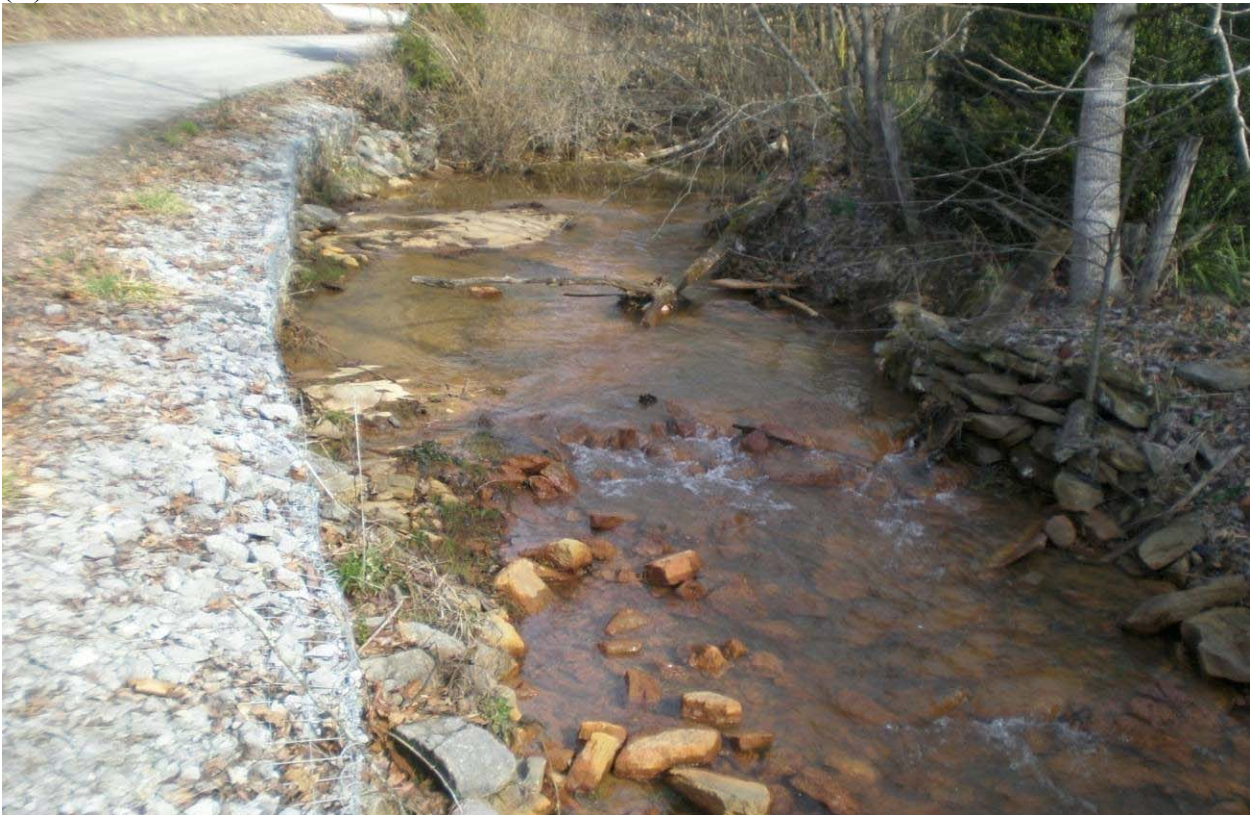
Fig. 15. (A) Downstream and (B) Upstream view at SW-3 in the Ely Ck mainstem.

Below the Bean Ck confluence into Ely Ck is site SW-3 adjacent to Rt 765 (Fig. 15 A, B) with rip-rap reinforcement along the edge of the mainstem. Just prior to Ely Ck entering Stone Ck an upstream view is presented in Fig. 16. At the Ely Ck confluence with Stone Ck, one can see the difference in water quality/ color from Ely Ck (Fig. 17) relative to the more pristine area

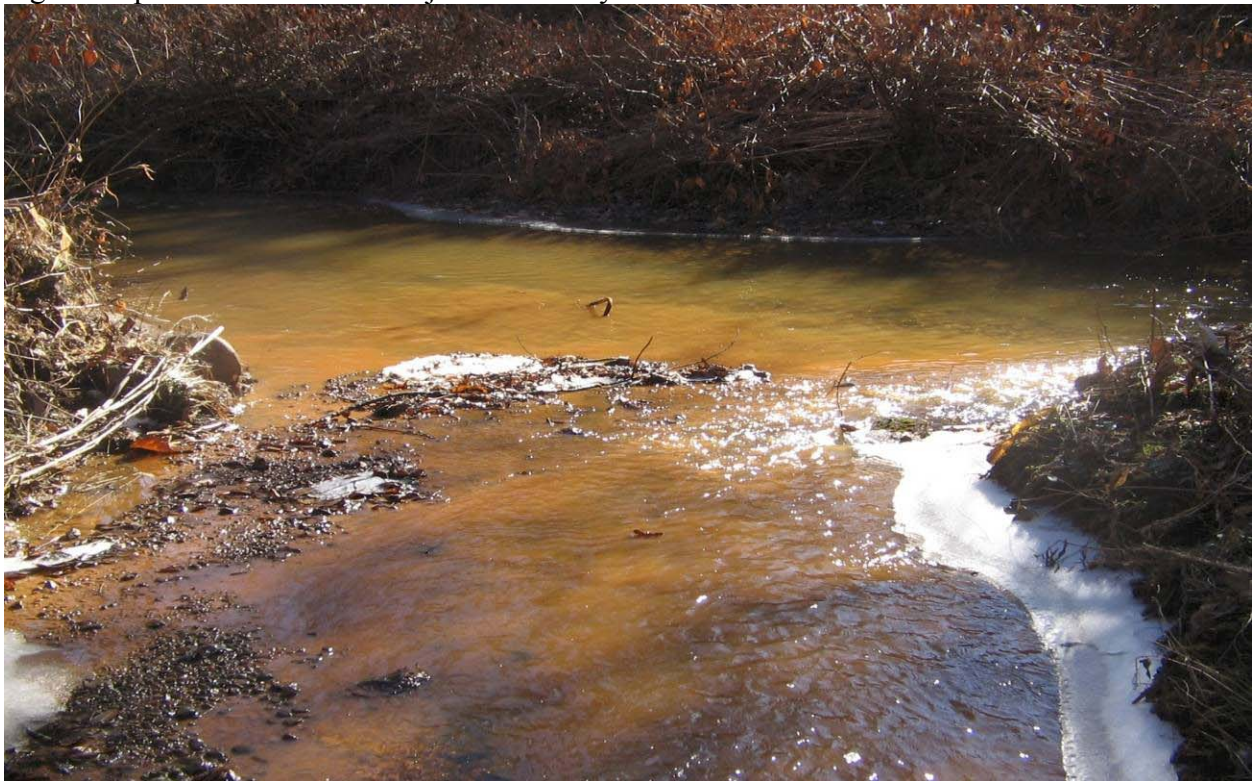
Fig. 17. View of Ely Creek and Stone Ck confluence from SW-4 in Ely Ck.

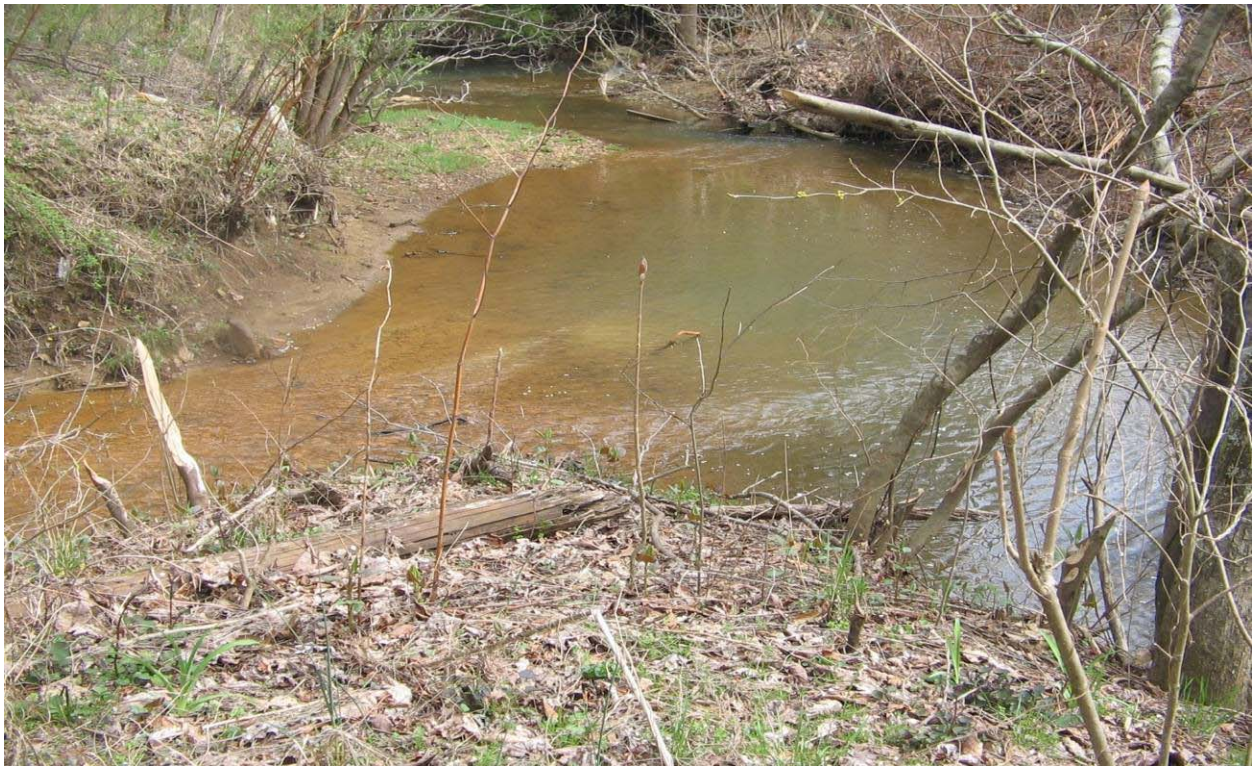
Fig. 19. Ely Ck confluence with Stone Ck and first downstream site in Stone Ck at SW-1Dn.

upstream in Stone Ck. (Fig. 18). Another view of the Ely Ck confluence into Stone Ck is shown clearly in Fig. 19 relative to the SW-1 Dn site below the mixing zone area in Stone Ck. The next to last sampling site (SW-17) downstream in Stone Ck is shown in Fig. 20. Then another mile thereafter is SW-18 further downstream in Stone Ck (Fig. 21).

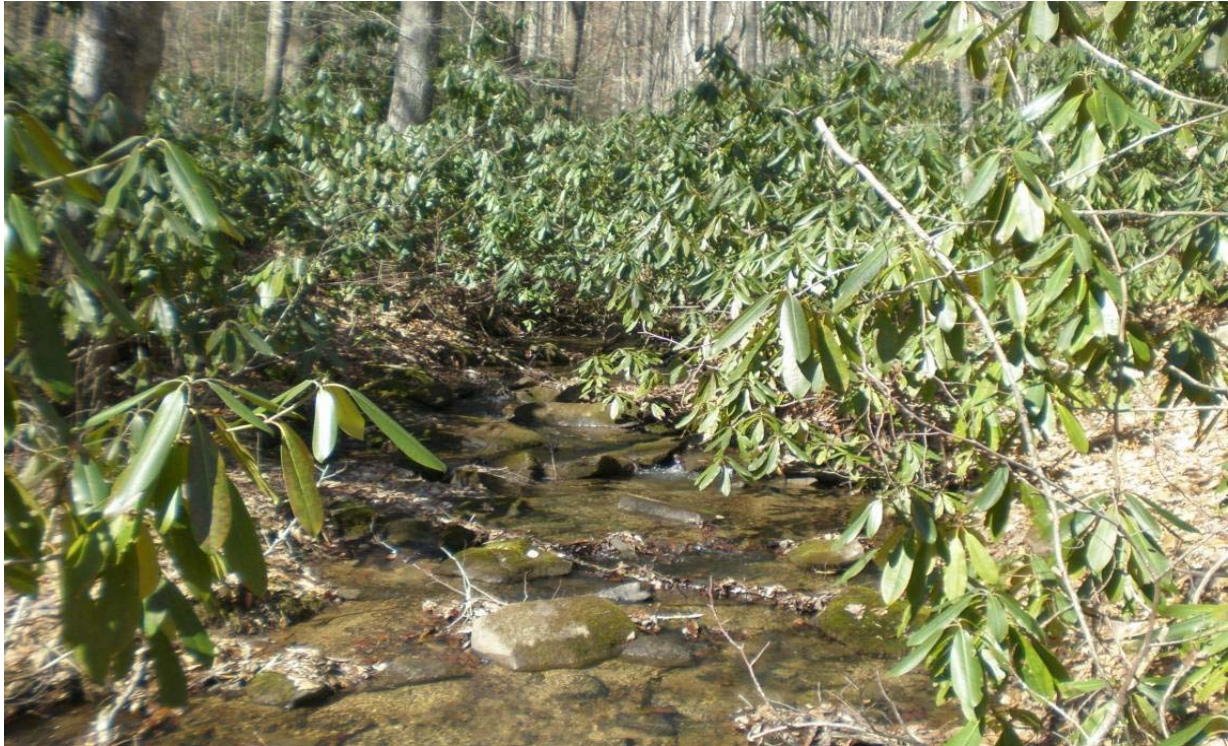
A photograph with the widest point of the UBC-1 reference site just before the confluence into Black Creek Lake (BCL) indicated that the riparian vegetative zone is natural and $\geq 18\text{m}$ wide on each side of the mainstem (Fig. 2). However, water flow in the channel was limited and the average width of the riffles were $\sim 1\text{m}$ wide due to the effects of prolonged drought condition.

Fig. 2. Upstream mainstem site UBC-1 with riparian vegetation.
