**Determining the Ecotoxicological Recovery of Black Creek (Wise County) and
Ely Creek
(Lee County) after Watershed Restoration of Abandoned Mine Lands and
Acid Mine Drainage: Final Report**

This report is submitted to Virginia Department of Mines, Minerals and Energy to fulfill the requirements of Applied Science Grant Funding.

Submitted March 26, 2008

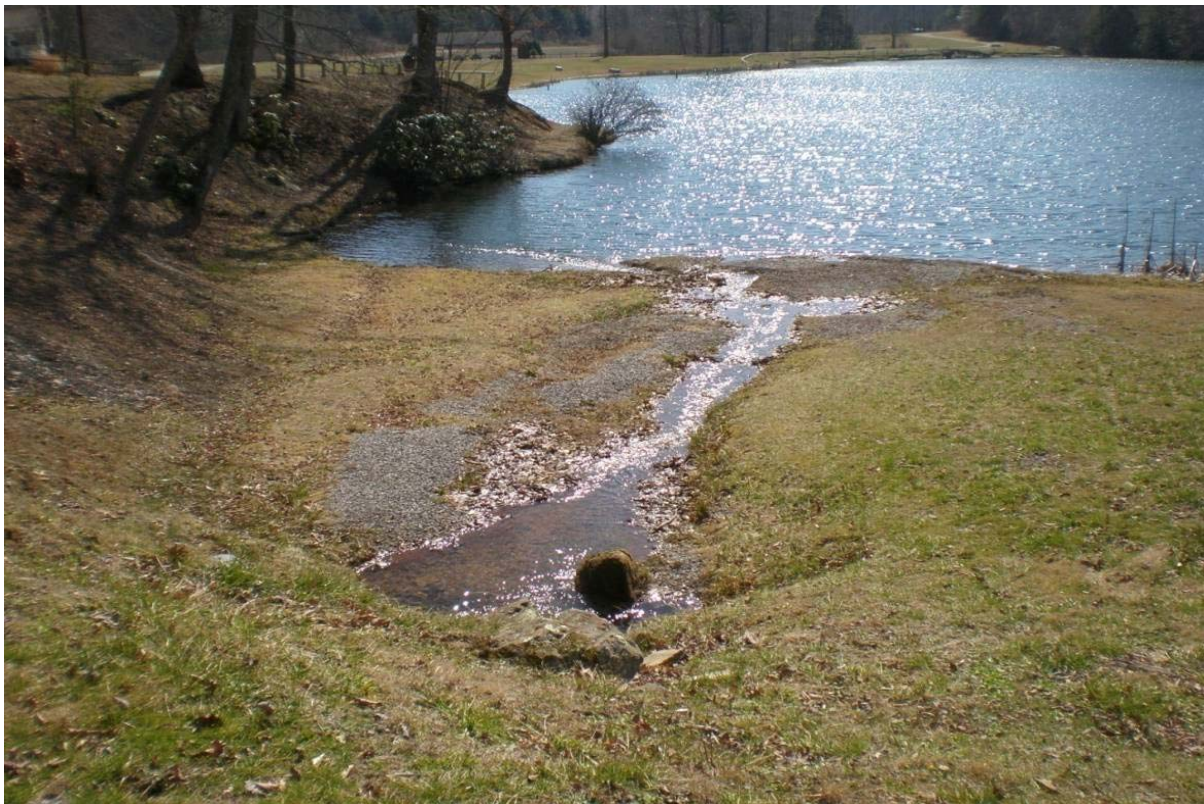
The UD-1 discharge into BCL was clear without any orange coloration of the iron precipitate that was highly prevalent in the photograph found in the Cherry et al (1997) report (Fig. 3). Flow was quite strong into the lake due to runoff from a recent rain event. The seep is fed from two separate tributaries with heavy vegetation that combine on the opposite side of the road into a culvert that discharges into the lake.

Fig. 3. Upstream seep UD-1 discharge into Black Creek Lake.

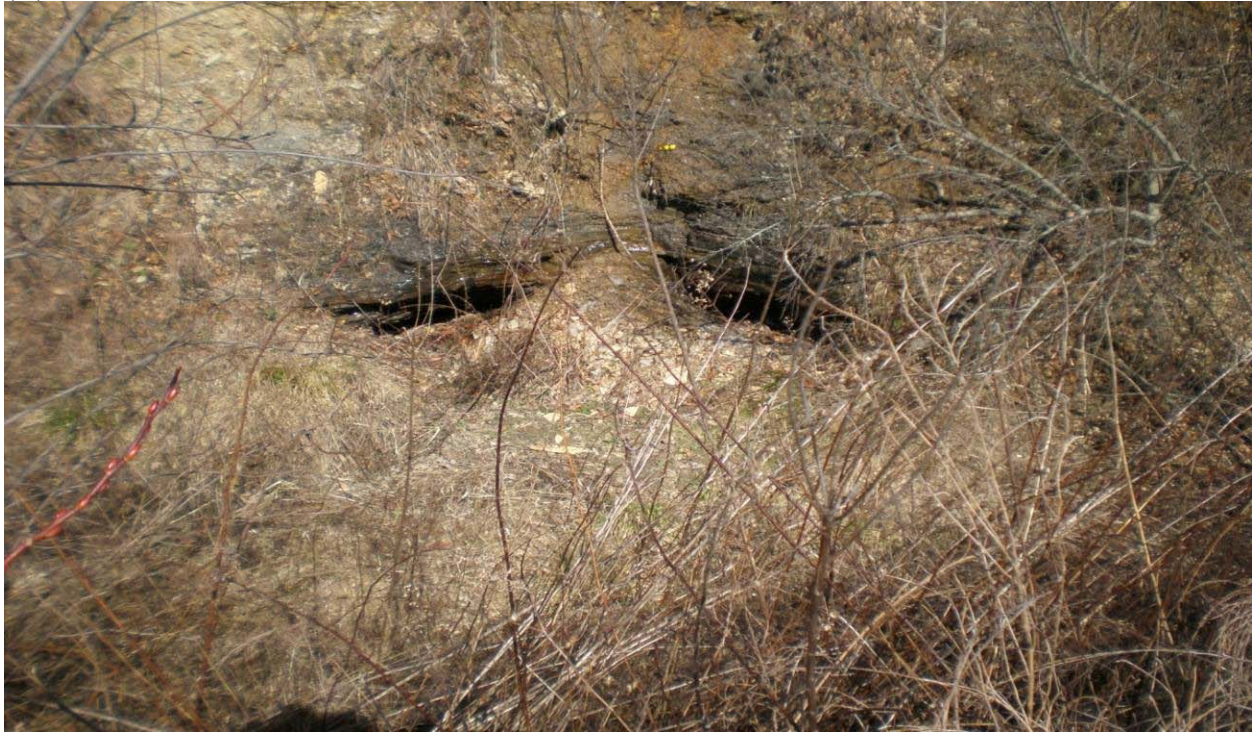
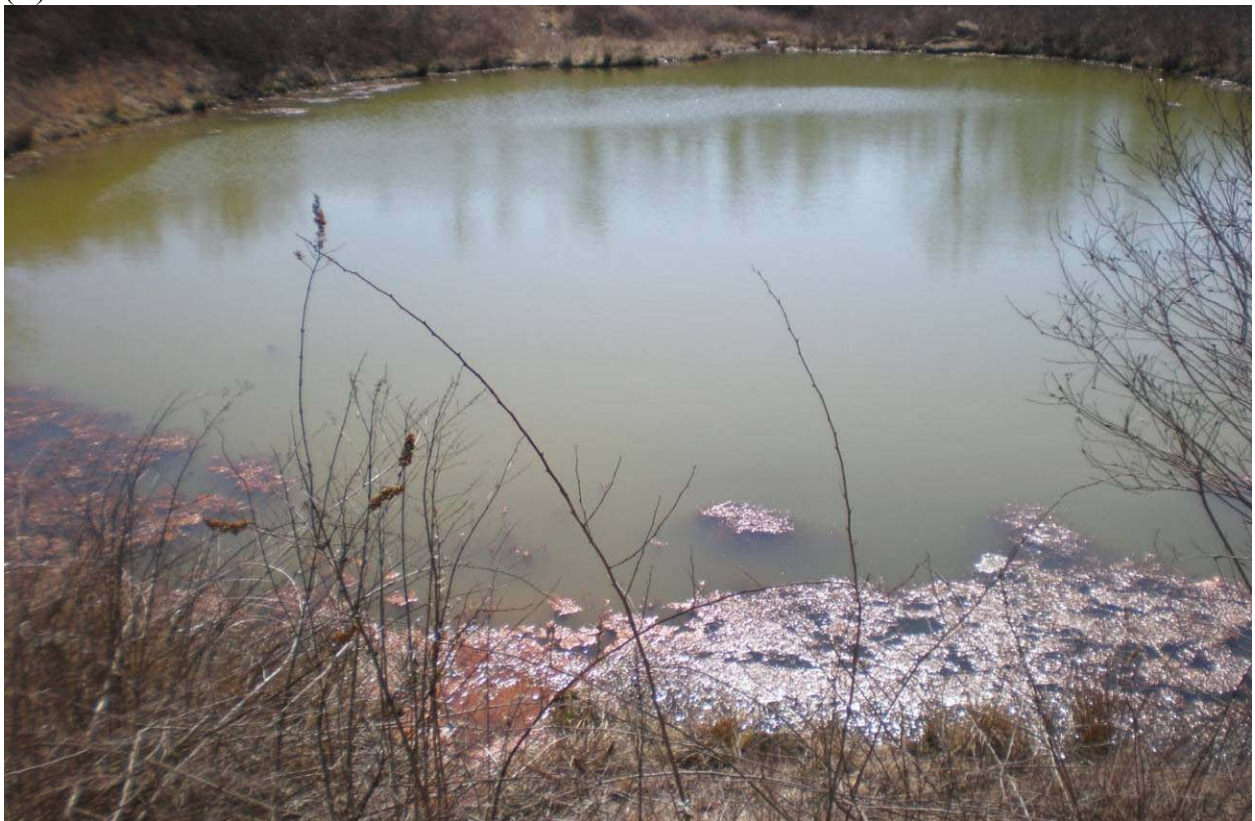
The UD-6 deep mine hole is now ~ 80% filled with soil and the discharge is not readily prevalent and probably is in a trench deeper underground (Fig. 7). However, the eroded landscape outside of the mine entrance has been repaired along with a new settling pond that receives the UD-6 discharge. One new orange precipitate site (UD-6c) was found adjacent to the bottom of the holding pond along the road that leaves the lodge and was brilliantly shining as well in the sun (Fig. 8). This newest seep area was just recently discovered on 3/3/08 after the recent heavy rain event.

Fig. 7. (A) UD-6 deep mine site remediated and (B) UD-6a holding pond for UD-6 discharge.

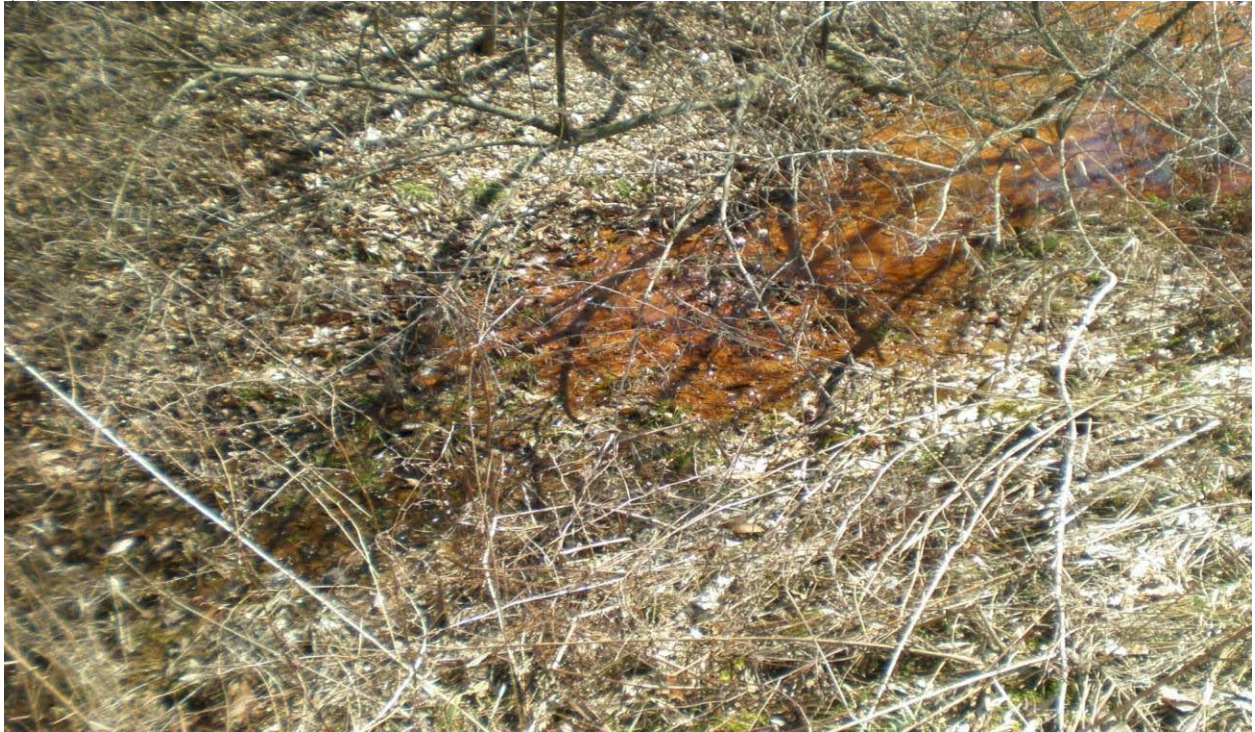
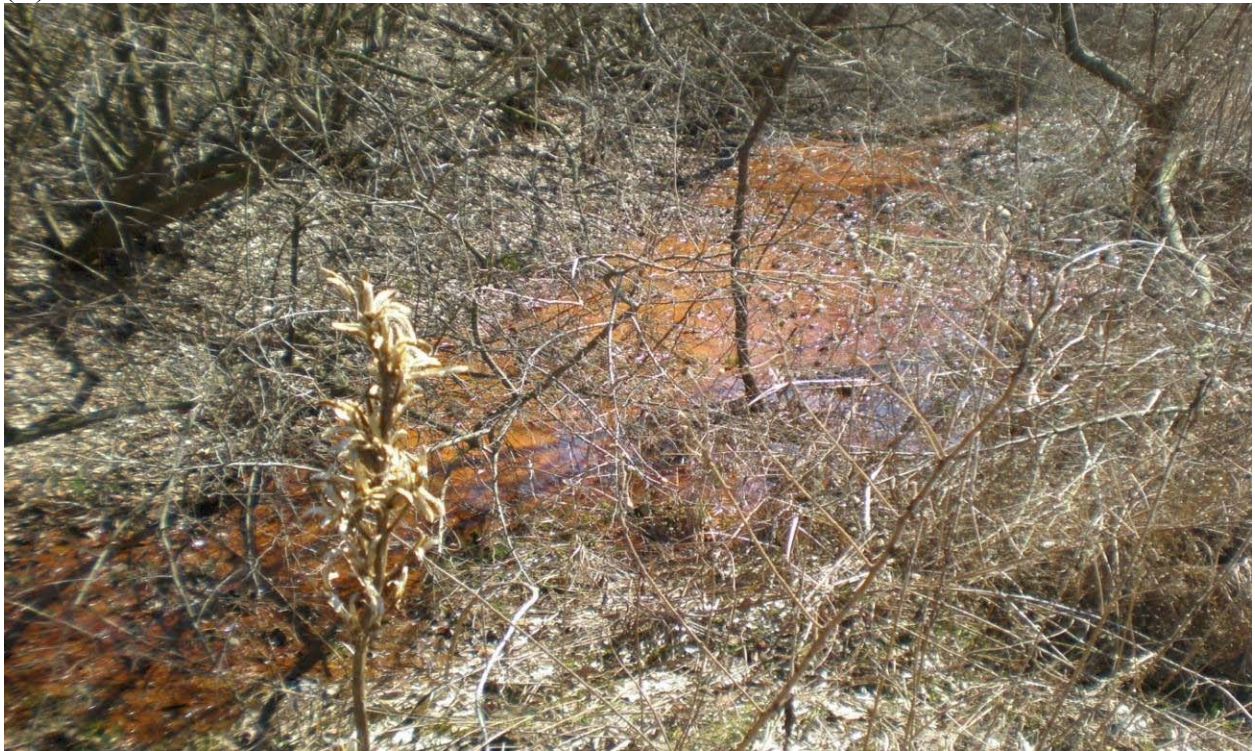
Fig. 8. (A) Start of new seep at UD-6c and (B) downstream view of UD-6c.

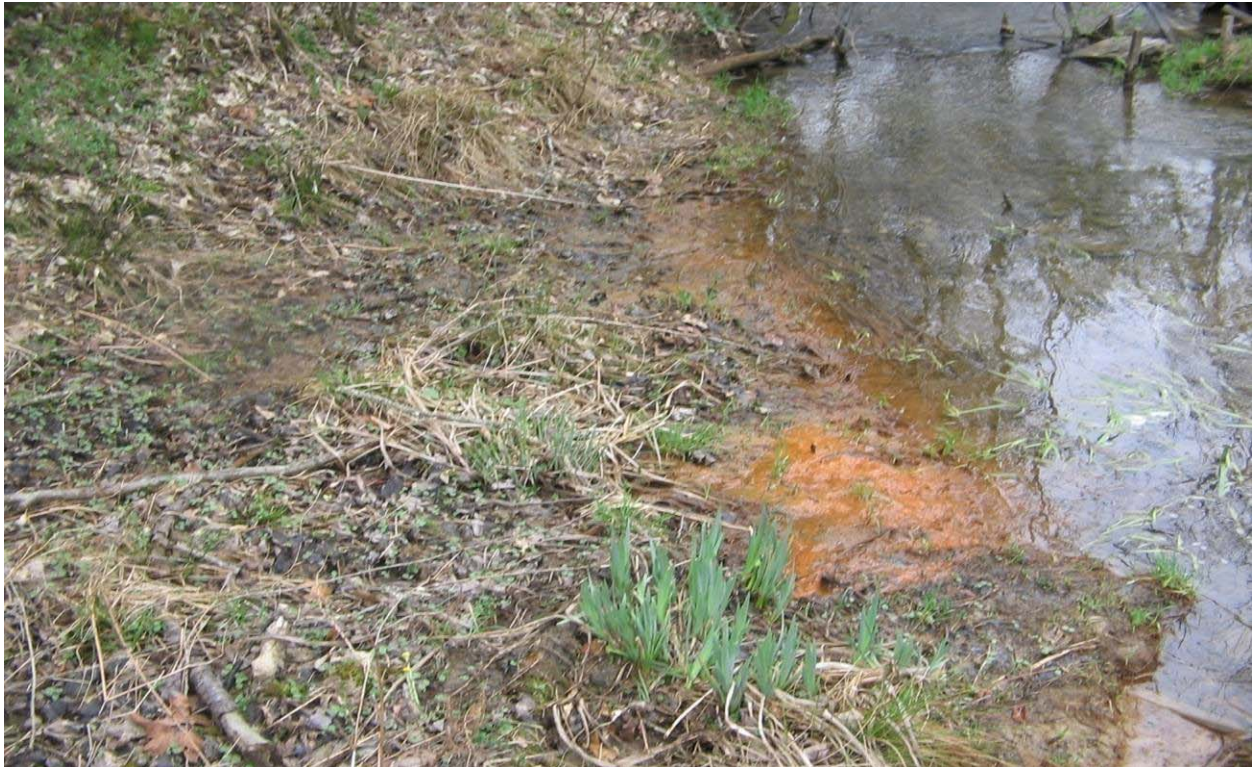
Below the beaver pond area where the mainstem emerges again is LBC-3 and a newly found intermittent seep (LD-3 Seep) with a colorful orange precipitate (Fig. 12). Toward the end of Black Ck is LBC-4 with some remediated vegetation on both sides of the mainstem that covers 2-5 m of width. The quite active flow here (Fig. 13) from other tributaries that feed the creek resulted in riffle areas being ~6m wide or ~6X wider than that found at the upper reference site, UBC-1 (Fig. 2).

Fig. 12. New seep LD-3 Seep at LBC-3.

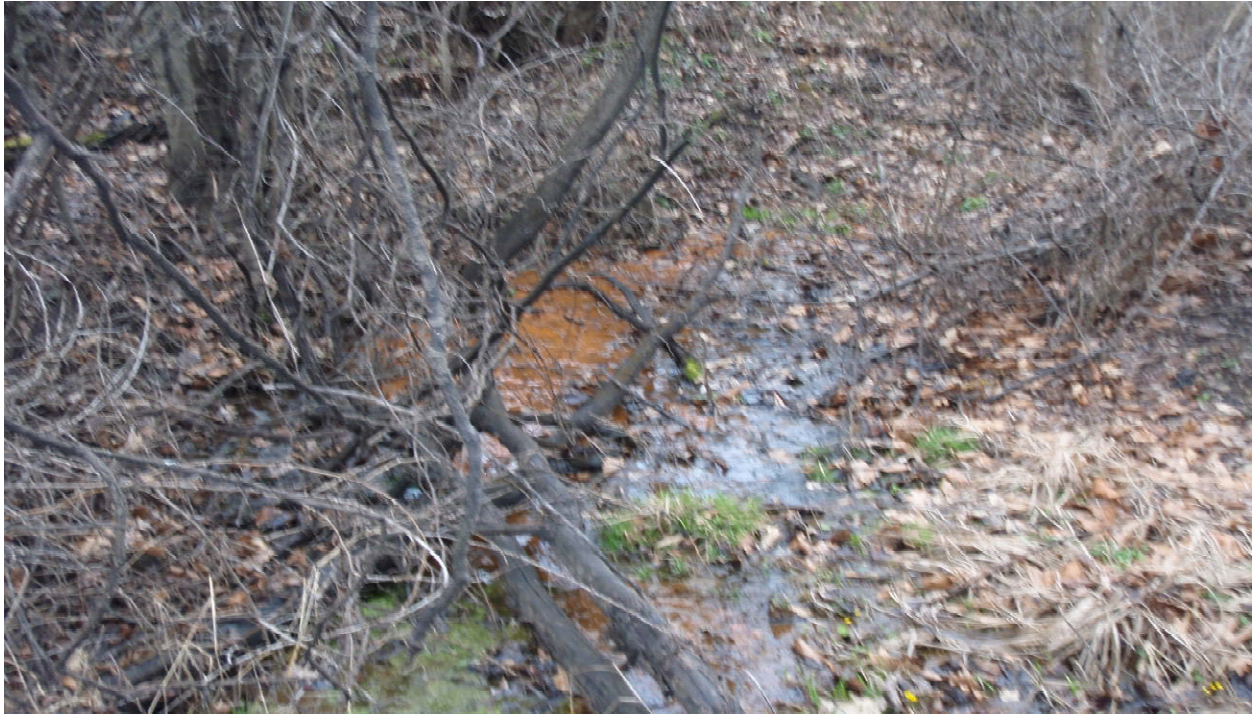
Fig. 15. Intermittent AMD seep above LBC-5 (photograph provided by coal company personnel)

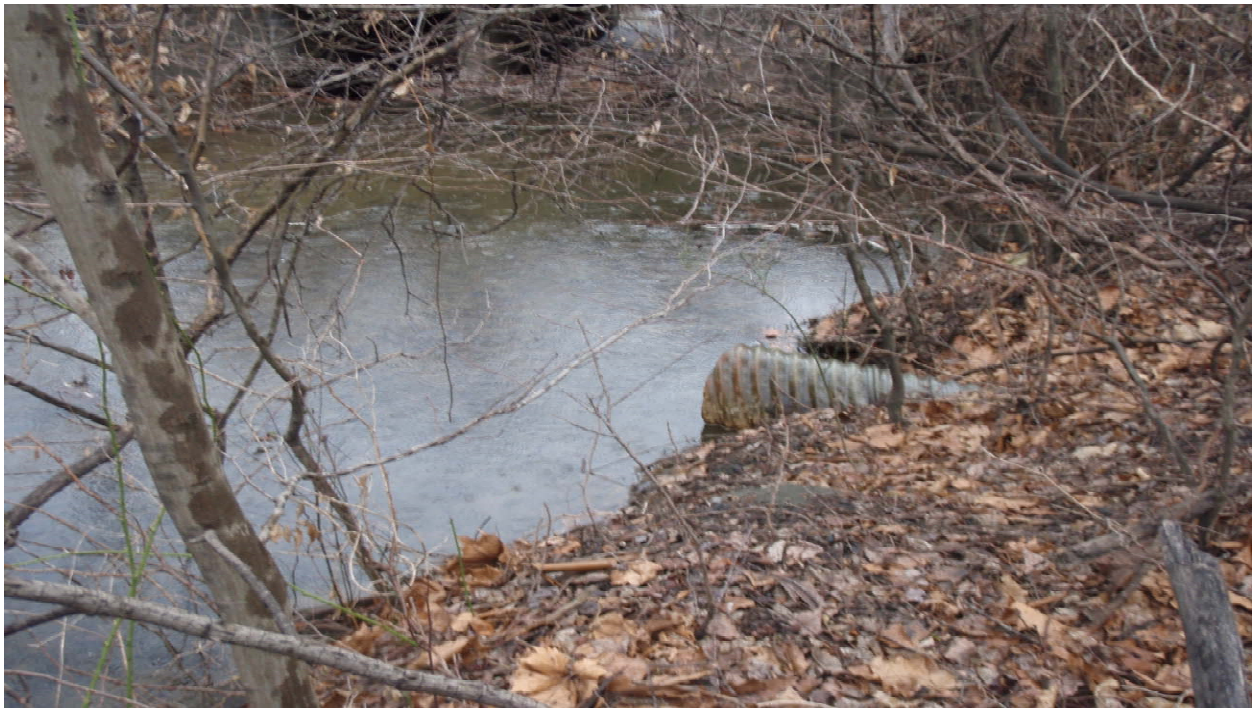
Fig. 18. Culvert that discharges runoff from vehicle turnaround to Black Creek near LBC-5 (photograph provided by coal company personnel).

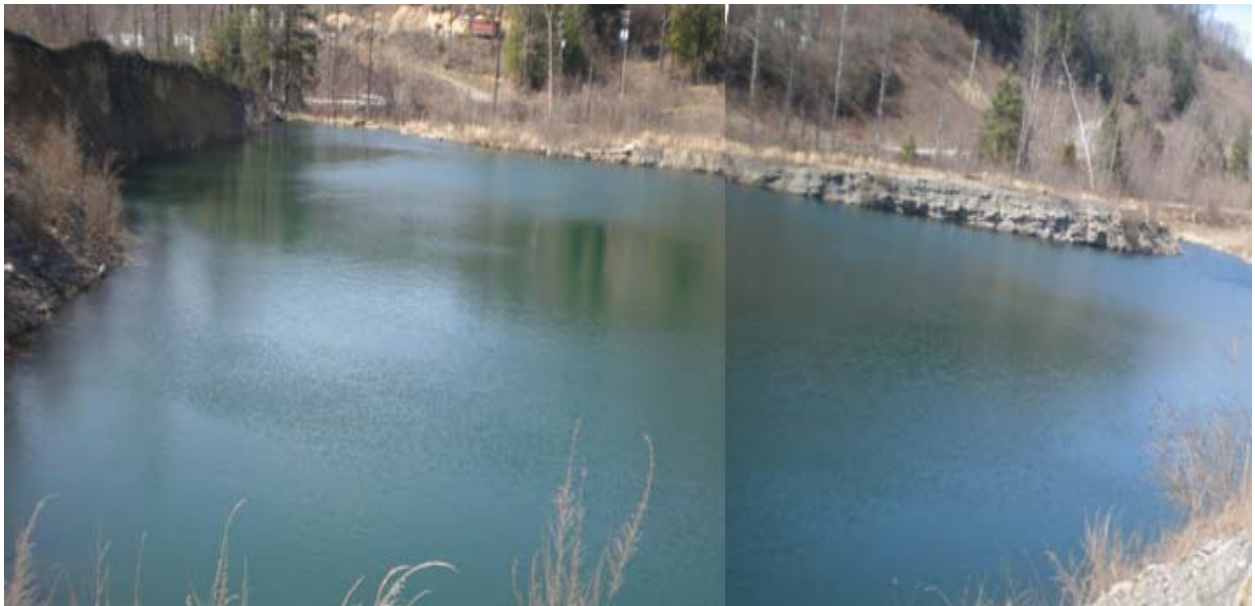
On 3/3/08, we discovered an unusual feature occurring at the LBC-5 site in that water was cascading through and down the outer perimeter wall of the primary settling pond into the creek. A view of this outer wall from within the pond is shown in a combined picture effect in Fig. 20. The perimeter wall along the upper right side is >1 meter above the pond water surface while the lower, left side end has the perimeter wall descending to the pond surface as one approaches Rt 58 on the opposite side. At this far left end is where the new, cascading discharge was found at LBC-5. From the opposite side of the primary pond, one can see the descending landscape along the pond where little natural vegetation has developed since remediation was completed ~4 years ago (Fig. 21 A,B). During a rain event, water must flow rapidly down the denuded surrounding landscape and be deposited into this pond.

Fig. 20. Combined pictures of LD-5a, so that the entire pond wall closest to Black Ck can be seen.

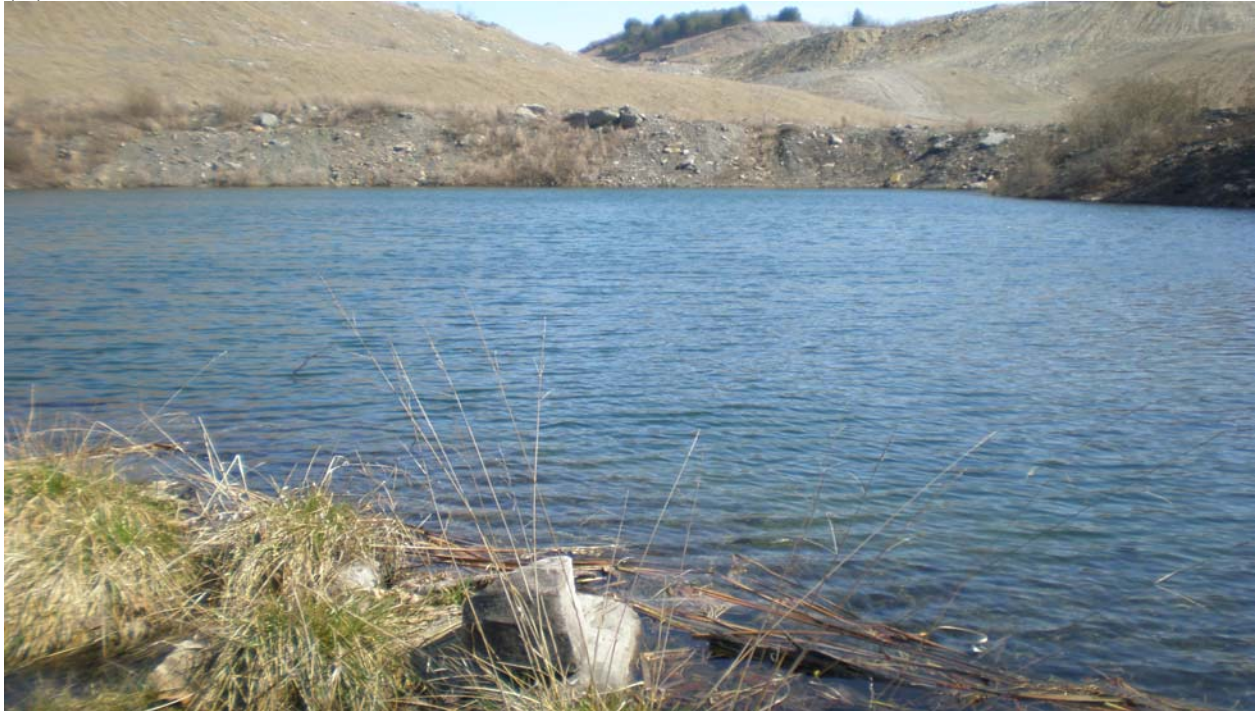
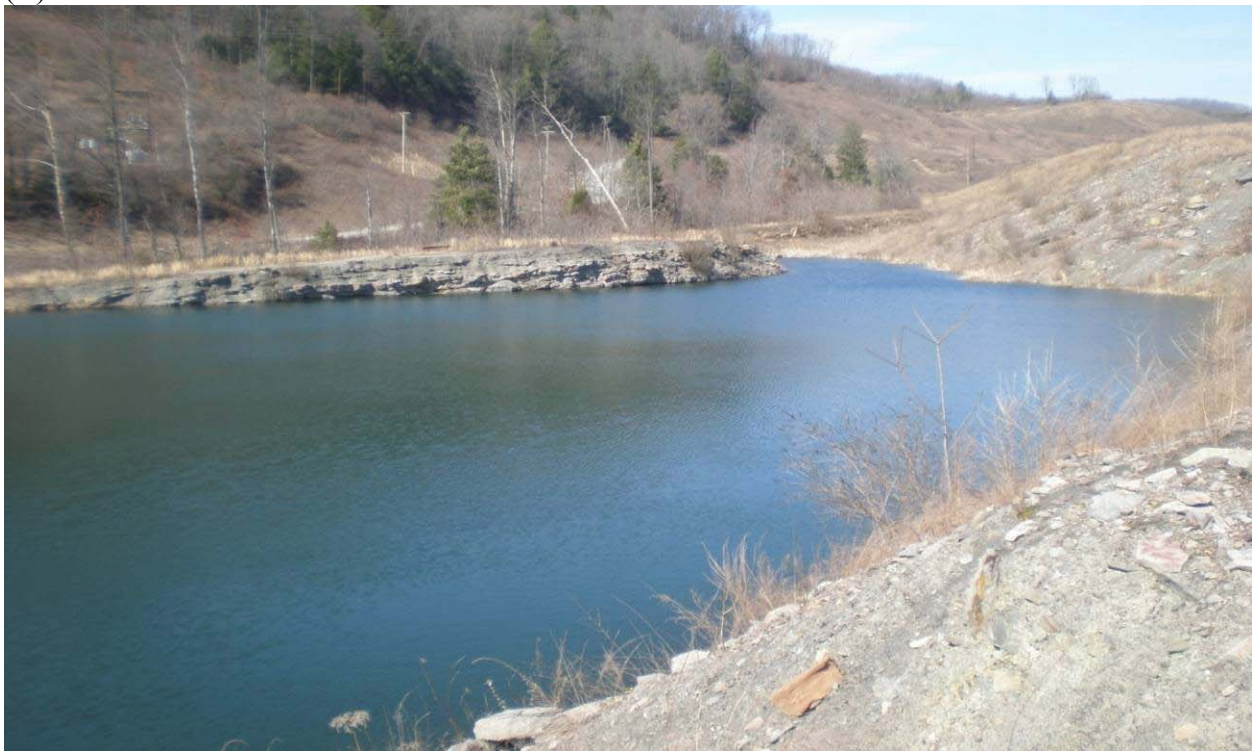
Fig. 21. (A)&(B) Views of LD-5a showing the barren landscape surrounding the settling pond.

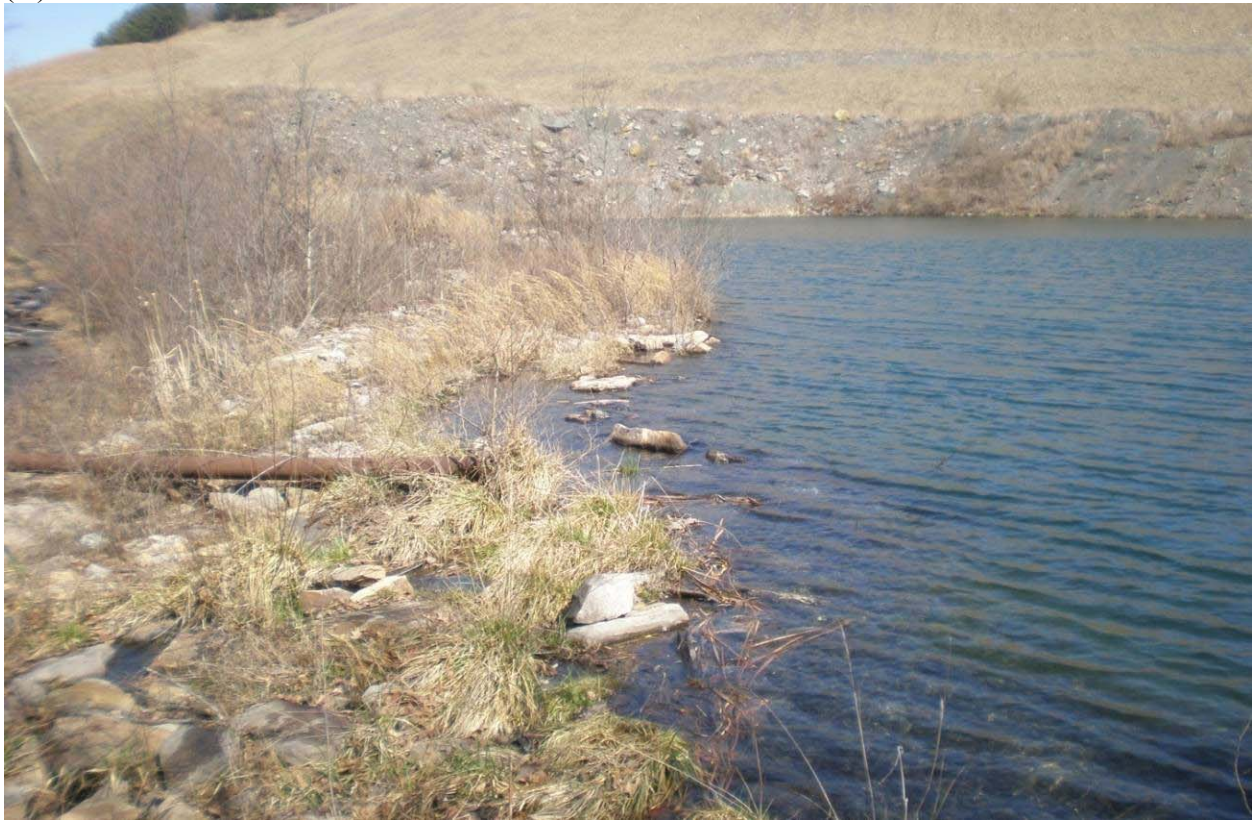
A close up of the far right hand pond wall shows an overflow pipe located at/above the pond uppermost surface that was designed to discharge water into the LD-5 secondary pond located on the opposite side of the creek (Fig. 22 A). Then, again at the far left end of the descending pond perimeter wall near Rt 58, a close-up is shown. The pond upper water surface is nearly equal to or overflowing at the top of the perimeter wall (Fig. 22 B). This is the point within the pond where the cascading discharge is found flowing into the upper LBC-5 site. A partial view of the coal truck turnaround circle near the coal preparation plant adjacent to RT 58 and the Powell River can also be seen relative to the full view in Fig. 16 and in Fig. 22 A. After the recent rain event just before the 3/3/08 trip, this pond was ~ full and discharging directly into the Black Ck LBC-5 site through a system of heavy rocks, forming a spillway ~20 m long / ~5m high, with sand/ soil immersed between the rocks which allowed a substantial discharge through this pond edge perimeter to cascade directly down the slope into the Black Ck mainstem just above the LBC-5 site (Fig. 23).

Fig. 22. (A) Discharge point of LD-5a and (B) view from other side of pond toward discharge.

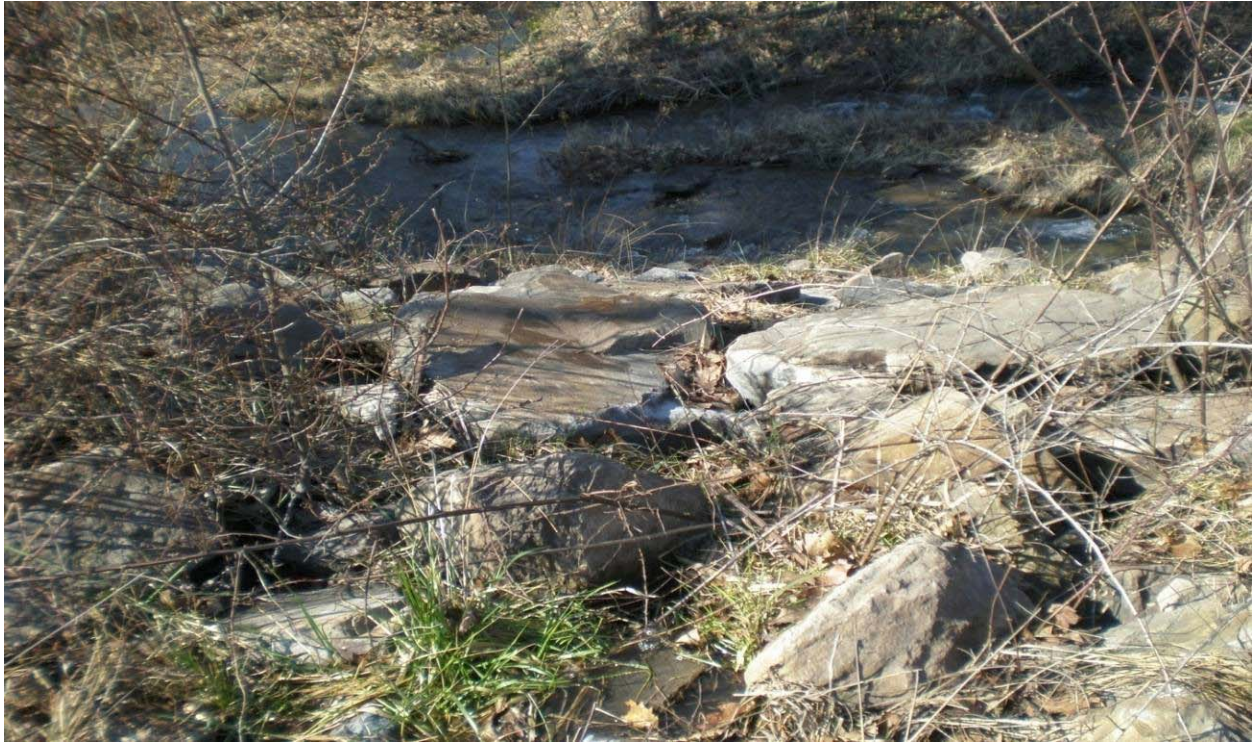
Fig. 23. View from LD-5a discharge to creek just above LBC-5.

Unfortunately, this newly found observation that results with intermittent slugs of its primary settling pond water after a rain event to flow directly into the mainstem occurred at the end of this study. The last sampling site, LBC-6, is located a very short distance on the other side of Rt 58 that confluences into the Powell River and also had the same new overt toxicity to *D. magna* and Asian clam *in situ* tests (Fig. 24).

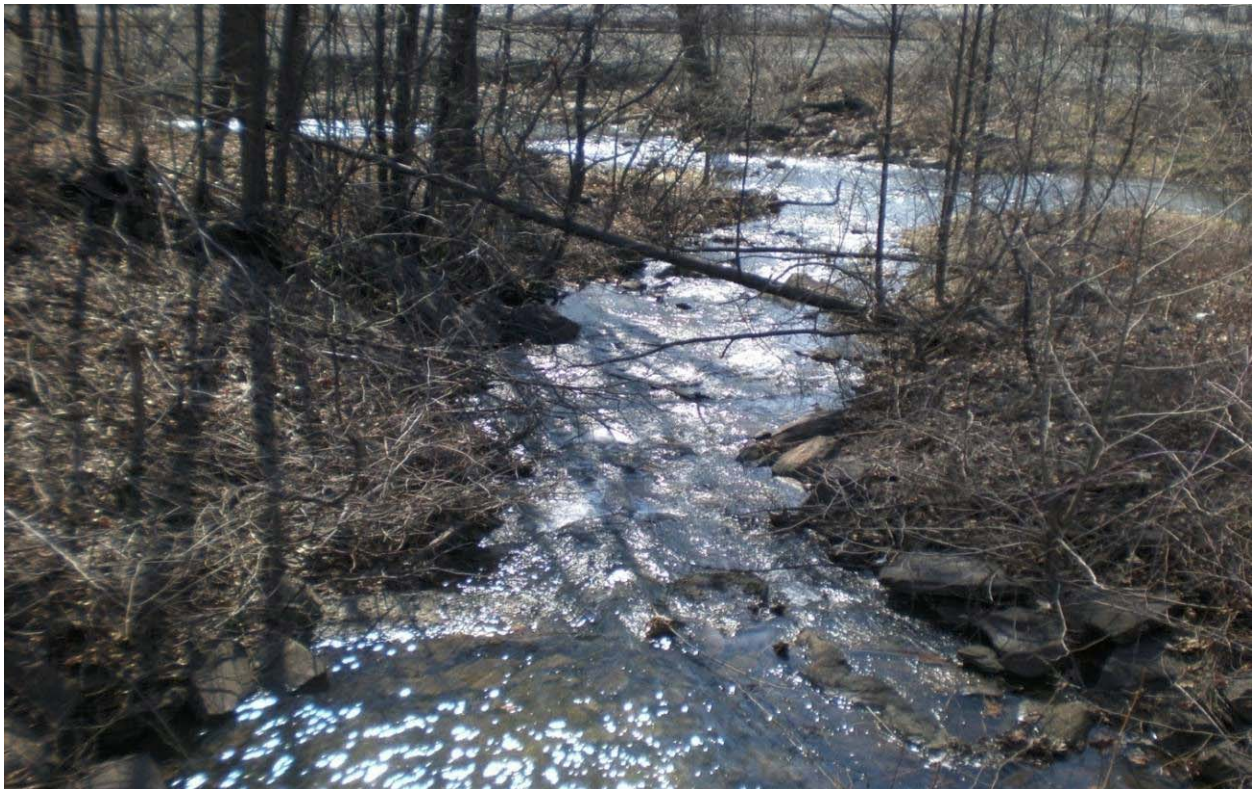
Fig. 24. LBC-6 at the confluence with the Powell River.
