Report Title: An Evaluation of BMP Efficiencies in Reducing TDS Loads from Active and Abandoned Mine Lands and Acid Mine Drainage

OSM Project Number: S06PC12055

Type of Report: Final

Name and address of submitting organization: MapTech, Inc.
3154 State Street
Blacksburg, VA 24060

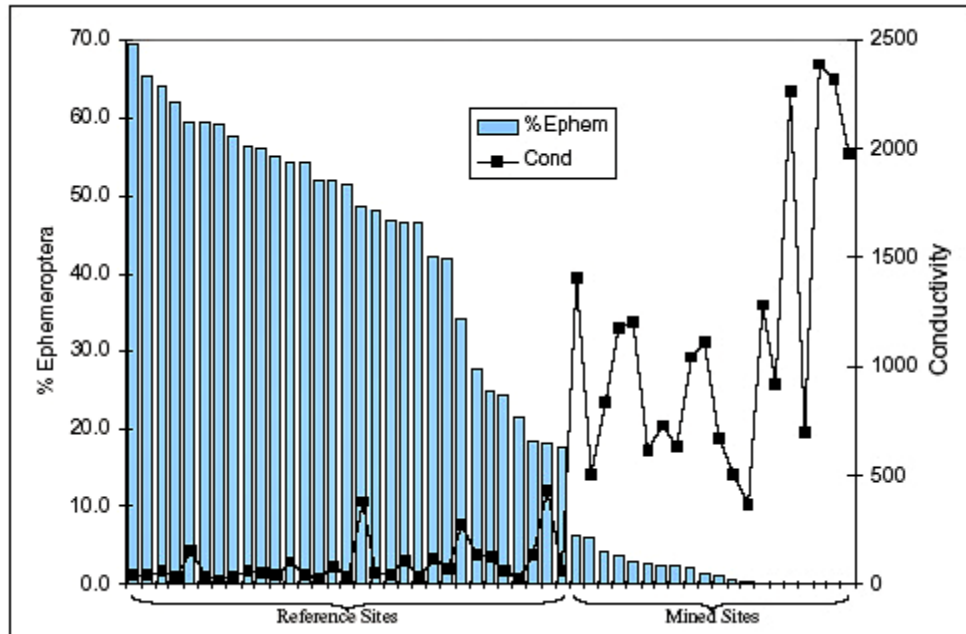
Figure 1. The relationship between % Ephemeroptera and conductivity from reference and mined sites (Pond, 2004).

A study of TDS toxicity in a coal-mining watershed in southeastern Ohio found the lowest observed effect concentration (LOEC) on the test organism *Isonychia bicolor* (a species of Mayfly) was 1,066 mg/L (Kennedy, 2002). The author carefully noted that this concentration was specific to the watershed studied, but noted that similar studies with the same test organism and TDS with varying ionic compositions were toxic between 1,018 and 1,783 mg/L (Kennedy, 2002). Kennedy referenced a study that suggested aquatic organisms should be able to tolerate TDS concentrations up to 1,000 mg/L; however, the test organism used was *Chironomous tentans*, which is considerably more pollution tolerant than *Isonychia bicolor* (Kennedy, 2002). Research also indicates that the likely mechanism(s) of TDS benthic macroinvertebrate mortality is from gill and internal tissue dehydration, salt accumulation, and compromised osmoregulatory function. In fact, the rate of change in TDS concentrations may be more toxic to benthic macroinvertebrates than the TDS alone (Kennedy, 2002). A recent report on the effects of surface mining on headwater stream biotic integrity in Eastern Kentucky noted that one of the pollutants of concern in these watersheds was elevated TDS (Pond, 2004). Elevated TDS concentrations impact pollution sensitive mayflies more than other species. Figure 1, extracted from this report, shows that “drastic reductions in mayflies occurred at sites with conductivities generally above 500 umhos/cm” (approximately 375 mg/L TDS) (Pond, 2004). Pond speculated that the increased salinity may irritate the gill structures on mayflies and inhibit the absorption of oxygen but research has not confirmed this.

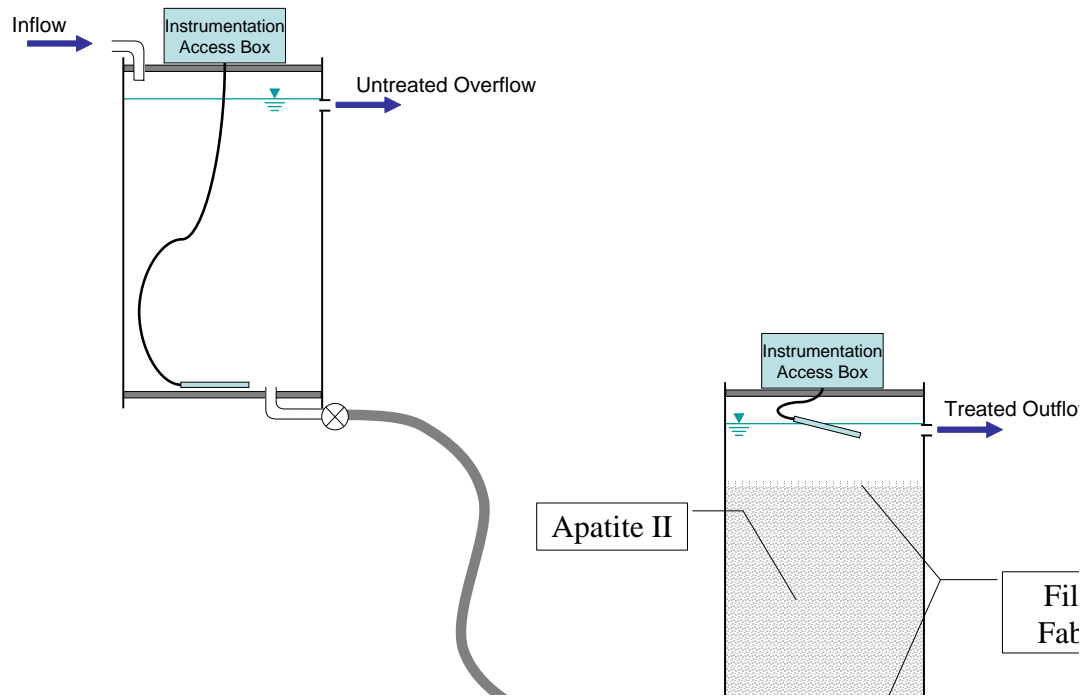
The treatment apparatus was designed to ensure a constant pressure head difference between the inlet and outlet of the system, and consequently a constant flow rate through the treatment (Figures 4 and 5). The system was comprised of two 55-gallon drums connected by a flexible hose. The first drum provided a reservoir for influent water, while the second drum contained the Apatite II treatment. The elevation difference of the two drums was measured. Pressure, temperature and conductivity were continuously monitored in each drum. Pressure was used to calculate the depth of water in each drum, and the resulting pressure difference in the system. A gate valve controlled the flow rate through the treatment and was adjusted to achieve a 2 gallon per hour flow rate.

Figure 4. Schematic depiction of Apatite II treatment apparatus.

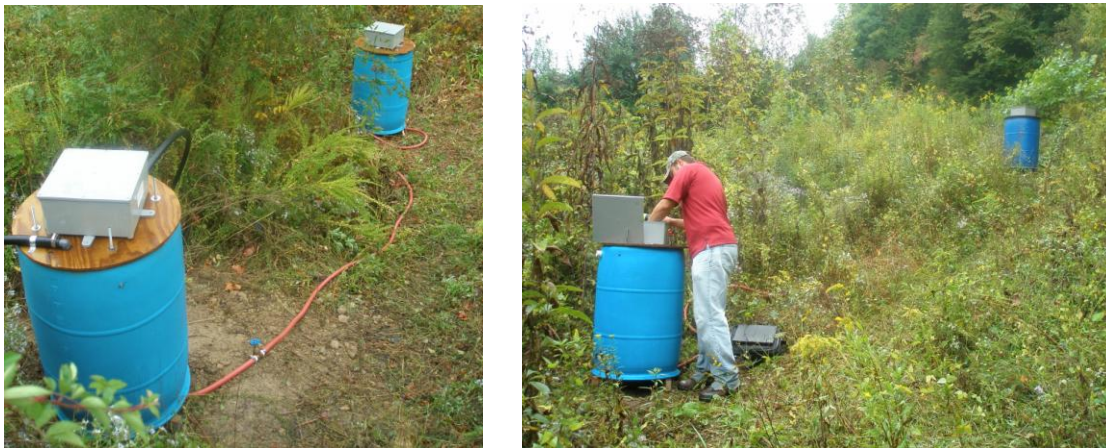
Figure 5 shows two of the systems in place. Shortly after installation, a site visit was conducted with Jack Fellbinger of OSM and Joey O'Quinn of VADMME to inspect/demonstrate the site installations. Some problems were identified and corrected at the Apatite II units. Problems included expansion/swelling of the Apatite II (50% to 100%), which resulted in substantially decreased flow through the system, disruption of input flow at some sites, and wildlife disturbance (bear) at one site. Input flow disruptions were corrected during the visit. A second visit was required to remove enough of the Apatite II to restore the intended flow through the system, and repair damage caused by the bear incident.

Figure 5. Installation of Apatite II treatment apparatus.

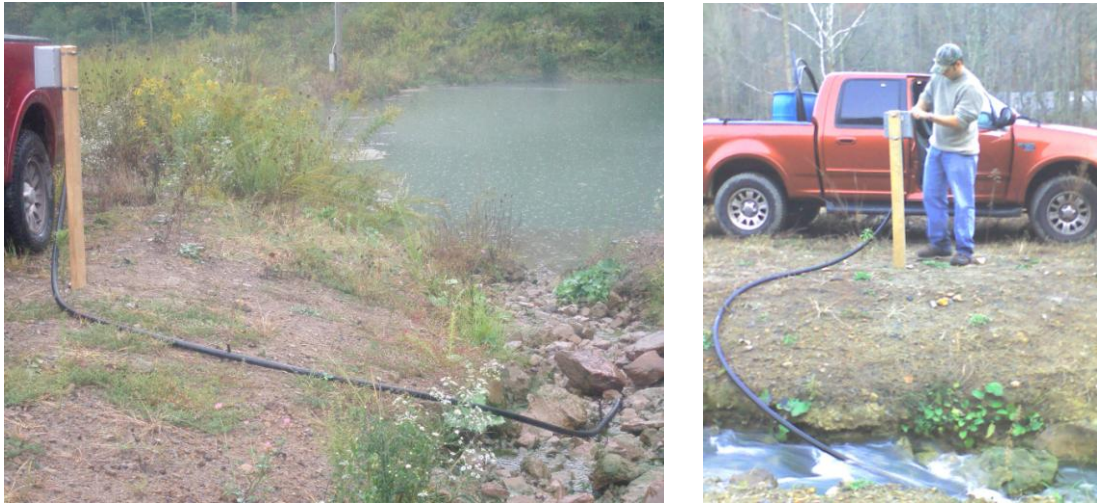
The *In-Situ* monitors were used to monitor upstream and downstream of three ponds and two constructed wetlands (Figure 6). The location and description of each site is presented in Figure 7 and Table 4. The three ponds were the same ponds used to provide input to the Apatite II treatment units (Figure 3). The wetlands were located on Black Creek in Wise County, VA.

Figure 6. Installation of in-stream monitoring device.

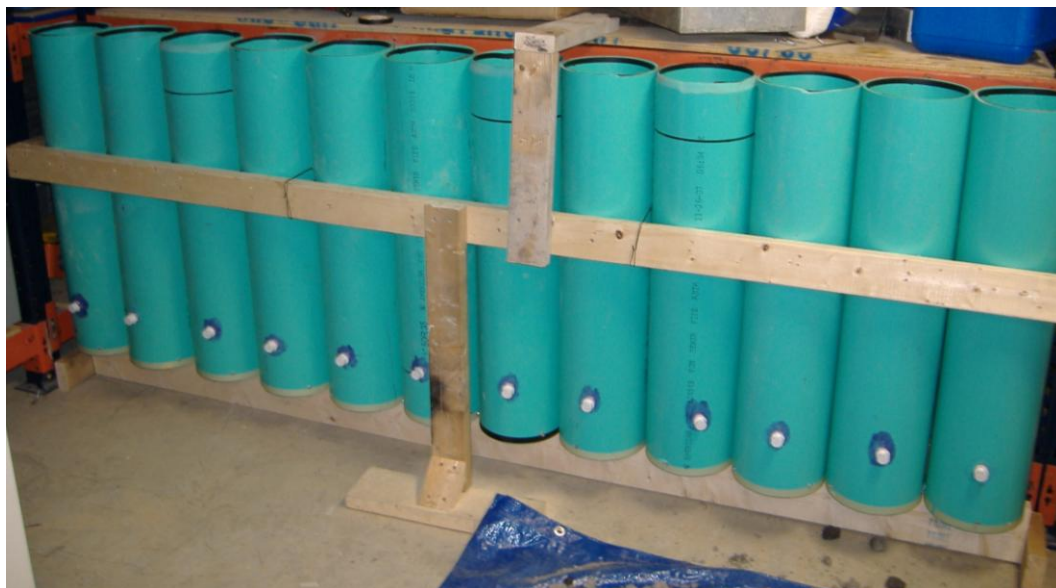
Twelve leaching columns were constructed to assess the potential for the polymer treatment (Figures 8 and 9). The columns were constructed of 8" PVC pipe, with a bottom drain and a side access point near the bottom of the column for collecting samples. Six of the columns were instrumented with the *In-Situ* monitors at the side access point to continually measure conductivity. Twelve columns allowed for four replicates of three treatments (*i.e.*, Control, Treatment 1 – surface application, and Treatment 2 – distributed application). Two types of fill material were collected for the experiment (Figure 10). The parent material of one is primarily sandstone, while the parent material of the other is primarily shale. These samples were collected from fill areas through cooperation from a local mining company. Each of the three treatments was applied to two replicates of each fill material.

Figure 9. Leaching columns for polymer treatment experiment.

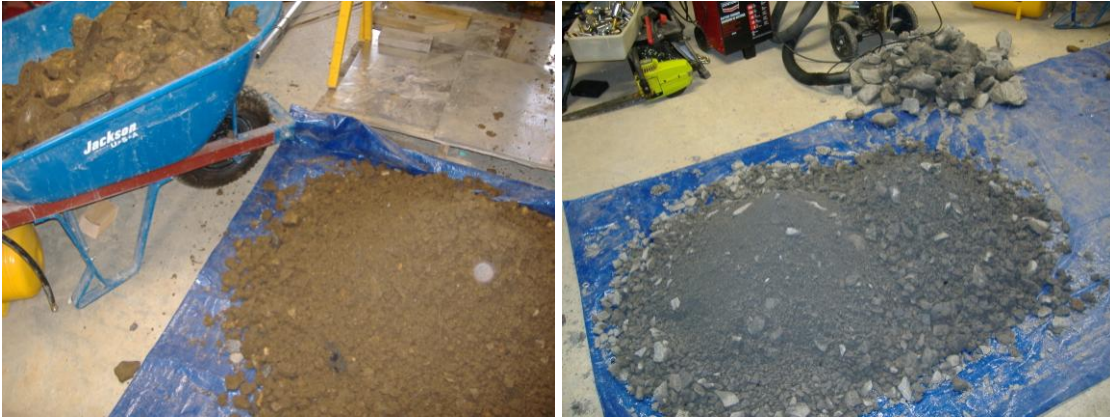
Figure 10. Fill material for polymer treatment experiment.

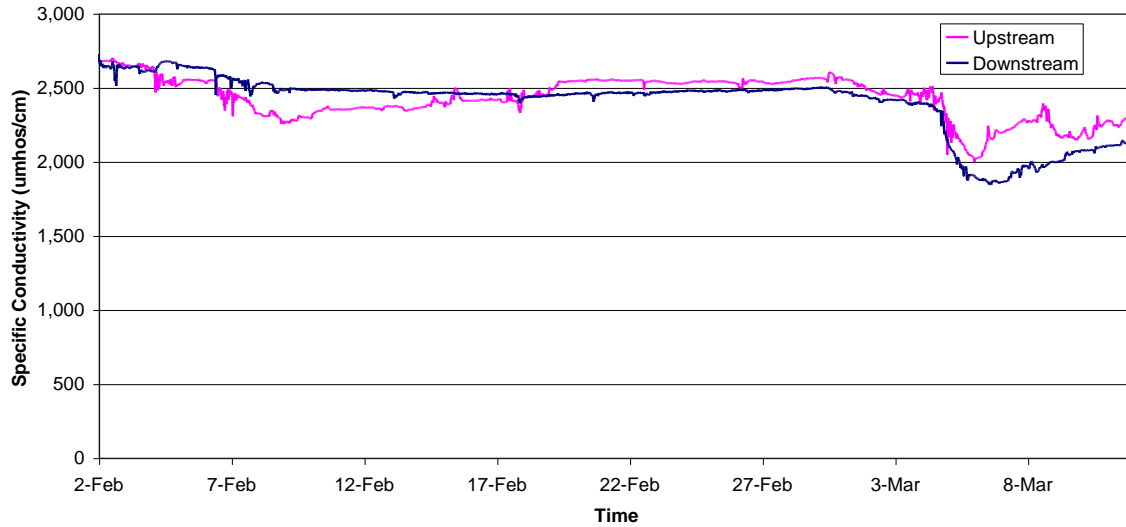
Figure 18. Specific conductivity measured upstream and downstream from a pond controlling runoff from hollow fill area.

Three ponds and two sections of wetlands were monitored (Figure 7 and Table 4). Pond 1 treated water from a deep-mine discharge. Pond 2 treated water draining from an active surface mine site. Pond 3 treated water draining from a large fill area. The two constructed wetlands are located on Black Creek in Wise County, VA, operate in series and treat an area with AMD and active mining impacts. Figures 16 through 19 show the results of monitoring. A paired T-test was used to determine if conductivity measured at the outlet (downstream) of each structure was significantly different from conductivity measured at the structure's inlet (upstream). In each case, the difference was statistically significant (Table 8). For the ponds, the differences were marginal (*i.e.*, < 7% average change), but there tended to be an increase, this may have been due to evaporation from the pond. The average increase in specific conductivity for Wetland 1 was considerable (344 uS/cm). Further investigation revealed the potential for continued AMD discharges in this section of the wetlands. The downstream wetland (Wetland 2) did show a decrease in specific conductivity (~ 7%).

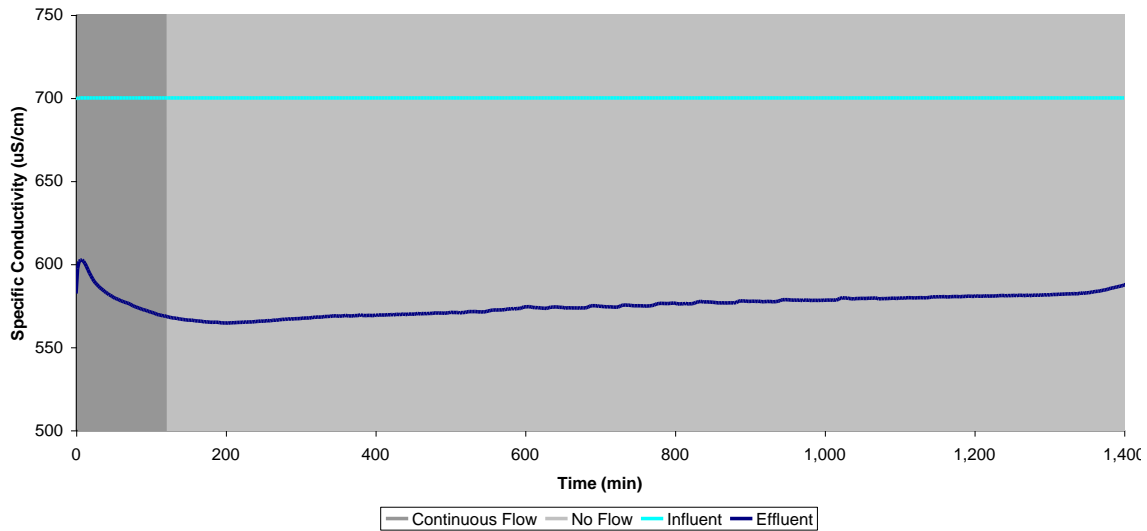
While the peat filter did not produce the 90% reduction suggested by the literature review, it did produce an average 18% reduction with very little variation (Figure 21). During the continuous flow experiment, conductivity decreased, but when flow was stopped, conductivity began to slowly increase, suggesting that a longer contact time would not be beneficial.

Figure 21. Specific conductivity of influent to and effluent from a peat filter.
