Development of a Rapid Geomorphic Assessment Technique to Support the CHIA/PHC Process: A Focus on Model Improvement for Estimating Sediment Loads

**USDoI Office of Surface Mining
Applied Science Program
Contract # CT612054**

University of Tennessee - Knoxville
Department of Civil and Environmental Engineering

May 30, 2008

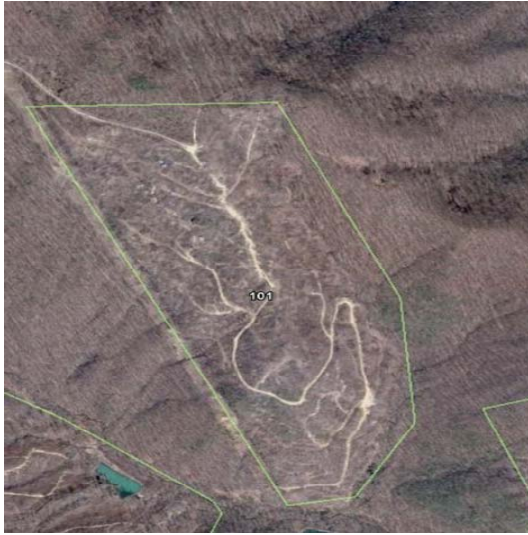
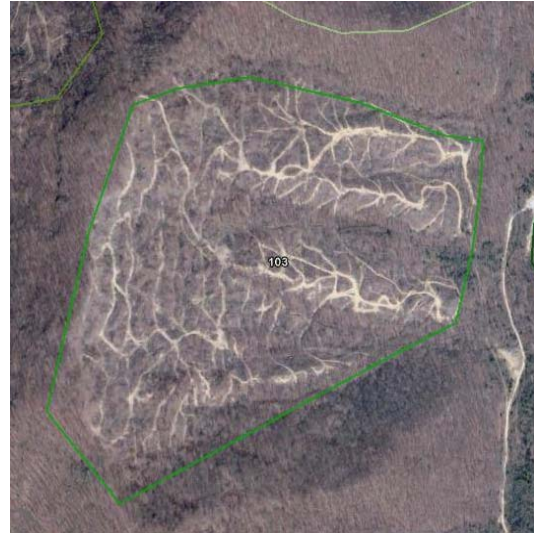
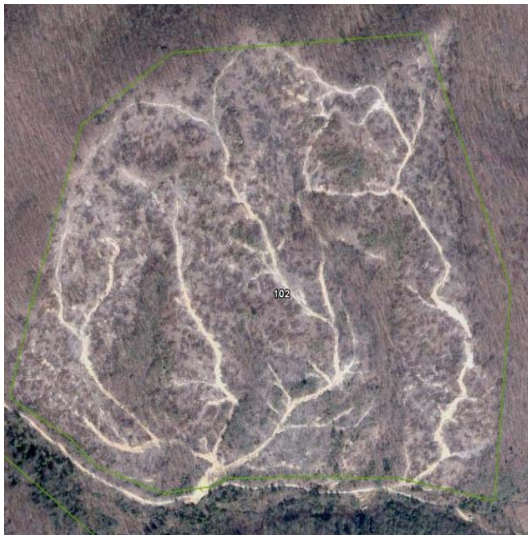
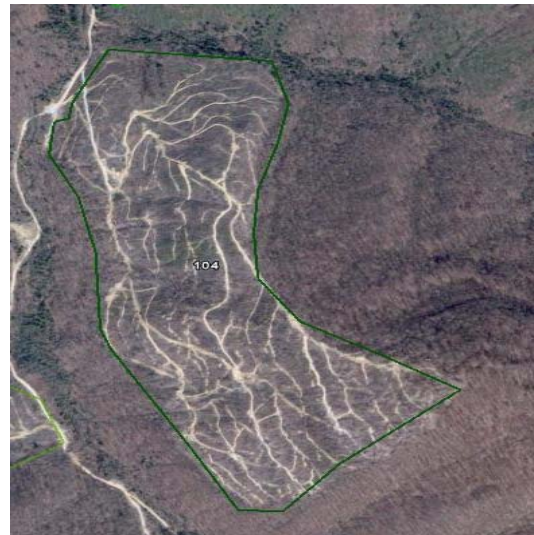
Figure 3. Examples of percent logging or loss of vegetative cover (Google Earth, 2007).

(a) 0-25% Logged Areas

(c) 51-75% Logged Areas

(b) 26-50% Logged Areas

(d) 76-100% Logged Areas

The delivery properties of importance with logging activities include area of timber harvest, and proportion of the logged area that is covered with vegetation. The logging areas were broken into four different groups or bins; they are classified as: 0-25%, 26-50%, 51-75%, and 76-100% percent logging or loss of vegetative cover. To quantify the percent logging, aerial photos were viewed and different levels of logging were captured with GIS polygons, and categorized to represent the four classes noted above. Examples of the different percent logging classifications are shown in Figure 3. Land areas calculated by the GIS software were based on the Quickbird and Google Earth aerial photos for 2006 and 2007.

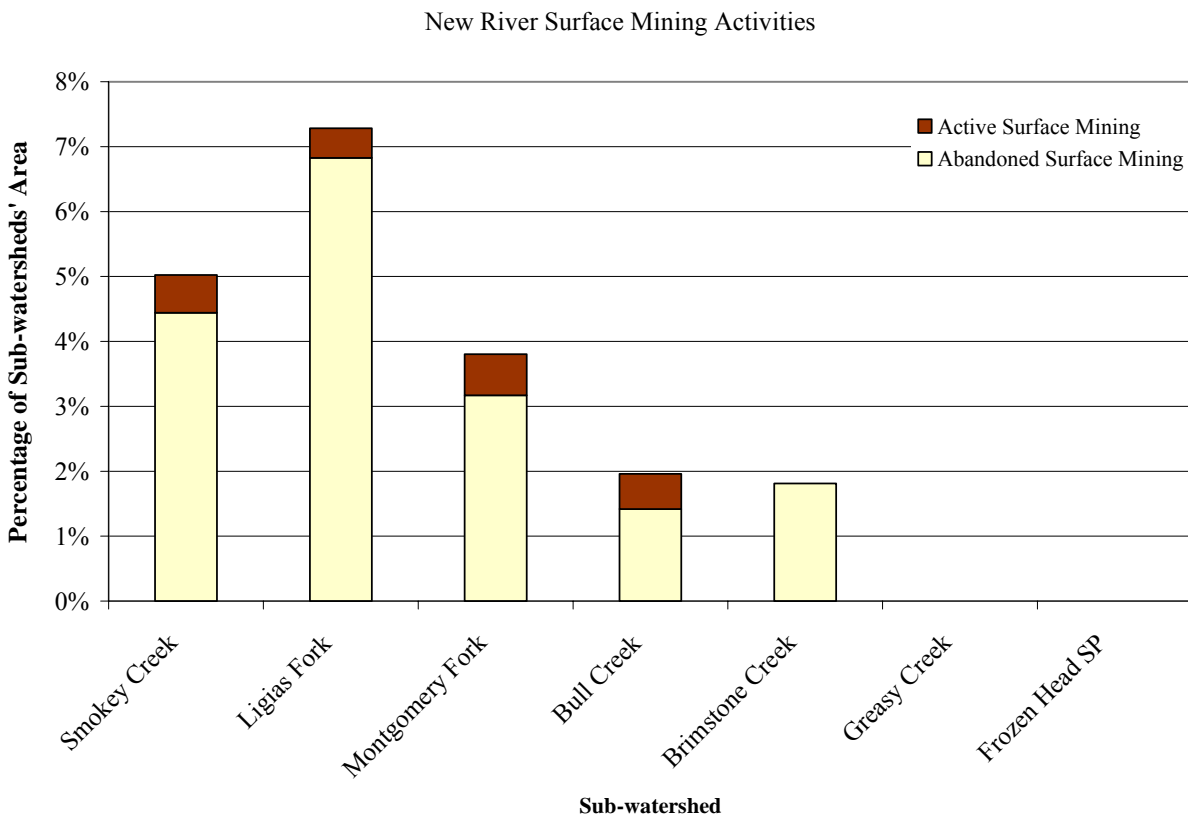
Figure 5: Surface mined lands normalized by total subwatershed area (2006-2007).

Abandoned Mine Lands: The percent of all the abandoned mine areas (normalized by the entire subwatershed’s area) in each sub-watershed is shown in Figure 5. The four non-reference sub-watersheds had permitted mine lands as a percent total area as follow: 4.44% of Smokey Creek, 6.83% of Ligias Fork, 3.17% of Montgomery Fork, 1.42% of Bull Creek. Of the three reference subwatersheds (Brimstone Creek, Greasy Creek, and Frozen Head State Park), Brimstone Creek was the only subwatershed that contained abandoned mining areas, which were found to account for 1.81% of the entire subwatershed’s area (Table 4).

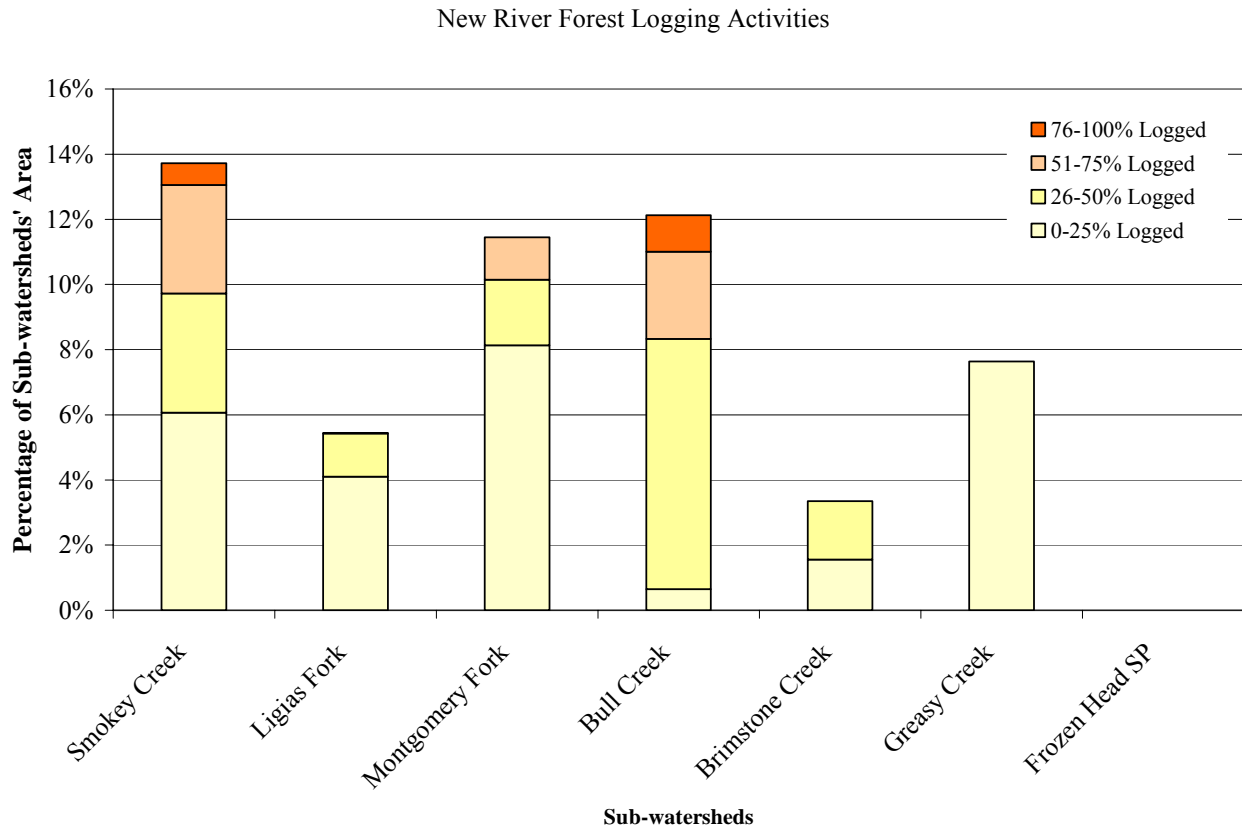
Figure 6: Forest logged lands normalized by total subwatershed area (2006-2007).

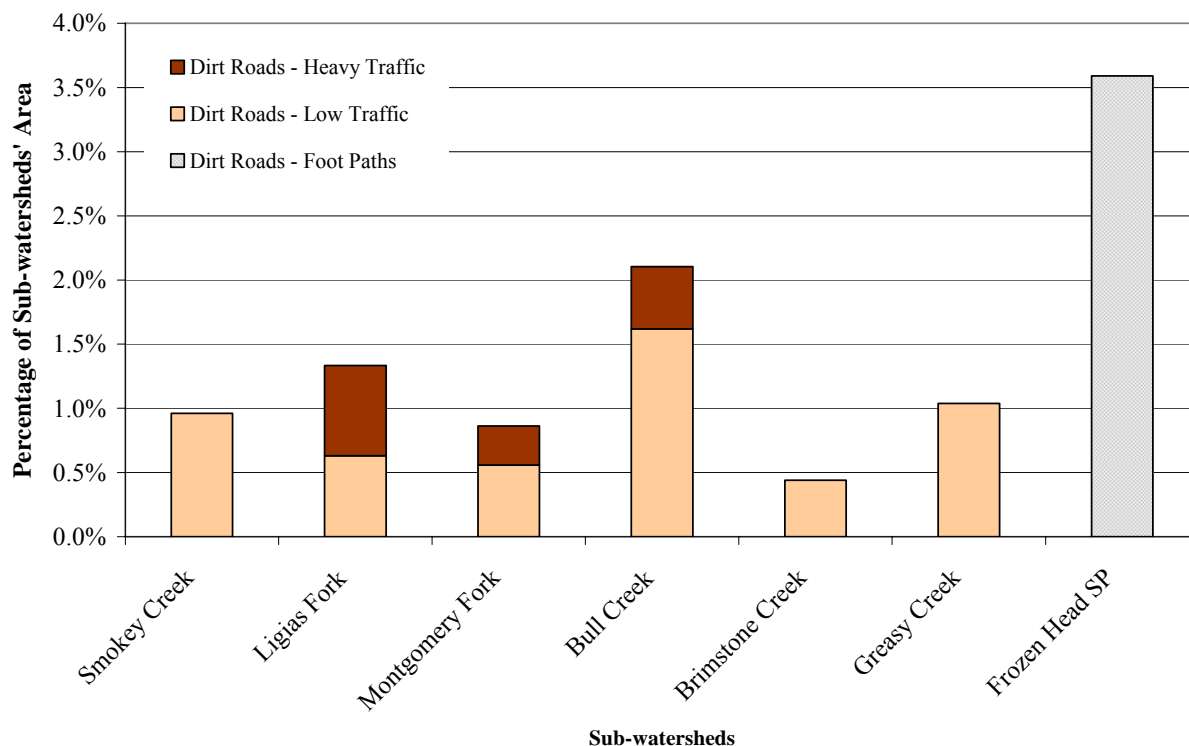
Figure 7: Unpaved/dirt roads normalized by total subwatershed area (2006-2007).

Unpaved/Dirt Roads: Unpaved/dirt roads were identified as one of the potential major sources of sediment loads to the streams. Sediment yield varies potentially due to the road type and use. It was observed that paved road systems did not contribute a significant amount of sediment to the streams, so this analysis focused on dirt or unpaved road networks in each sub-watershed. Unpaved/dirt roads would be typically seen as coal or logging haul roads, natural gas/oil access roads, and general rural transportation routes. For the analysis with unpaved/dirt roads category, all roads were defined on the basis of amount of usage. To simplify the analysis, the different material components on the unpaved road systems were grouped together and classified by traffic intensity. Three general categories of dirt roads considered were: high traffic, low traffic, and foot traffic summarized by area (Table 6). The number of road crossings at various streams was also summarized by each subwatershed (Table 7). From the comparison of different unpaved/dirt road categories, Ligias Fork and Bull Creek subwatersheds contained the largest amounts of dirt roads (normalized by subwatershed's area) used for general vehicle transportation, as well as for haul roads. Frozen Head State Park was the only subwatershed to have a total unpaved road network based solely for foot traffic for outdoor recreation. Though the Frozen Head State Park has a large percentage of this foot traffic within dirt road category, it is assumed that these features do not contribute much sediment into the streams.

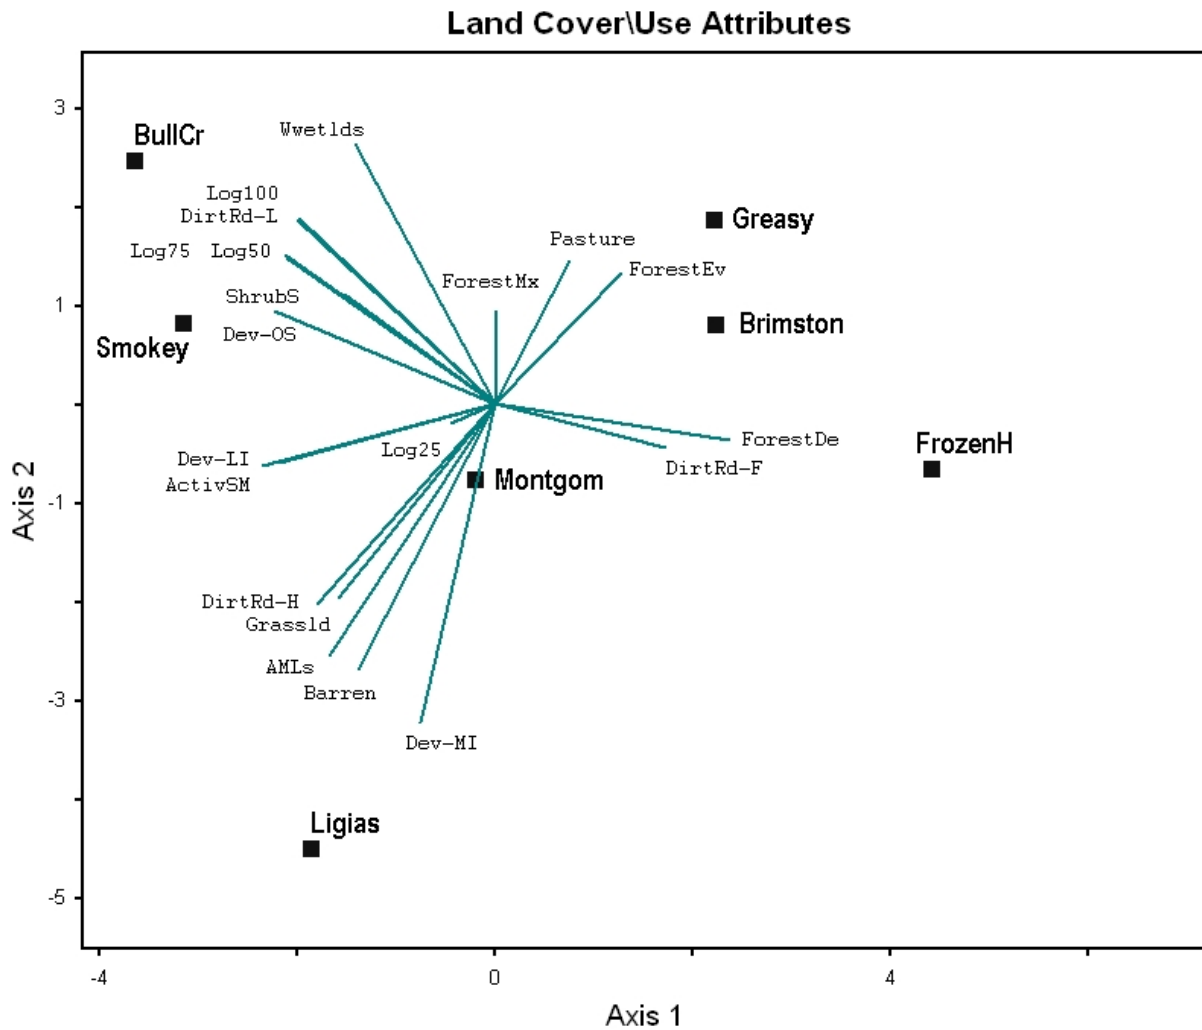
Figure 18. PCA ordination of land cover/use attributes per subwatershed.

Principal Components Analysis (PCA): Data from Tables 2 and 3 consisting of percent area of land cover/use types per subwatershed were used to observe similarity/dissimilarity among subwatersheds based on land cover/use characteristics (Figure 18). On Figure 18, reference subwatersheds (Greasy Creek, Brimstone Creek, and Frozen Head) clustered on the right side of the ordination plot. These subwatersheds clustered together primarily due to forest land cover attributes primarily, as observed by eigenvector lines for evergreen and deciduous forests. In addition, ordination position of Frozen Head was influenced by foot traffic dirt roads, indicated by a higher percentage of this land use type than found in other subwatersheds. Bull and Smokey creeks orientated on the upper left side of the plot, in which land use eigenvector lines included logging, and low-intensity dirt roads. Montgomery Fork and Ligias Creek orientated towards the lower left side of the plot, in which land use eigenvectors included high-intensity dirt (haul) roads and middle-intensity developed land. PCA axis 1 and 2 explained 63.0% of the variance in this dataset.

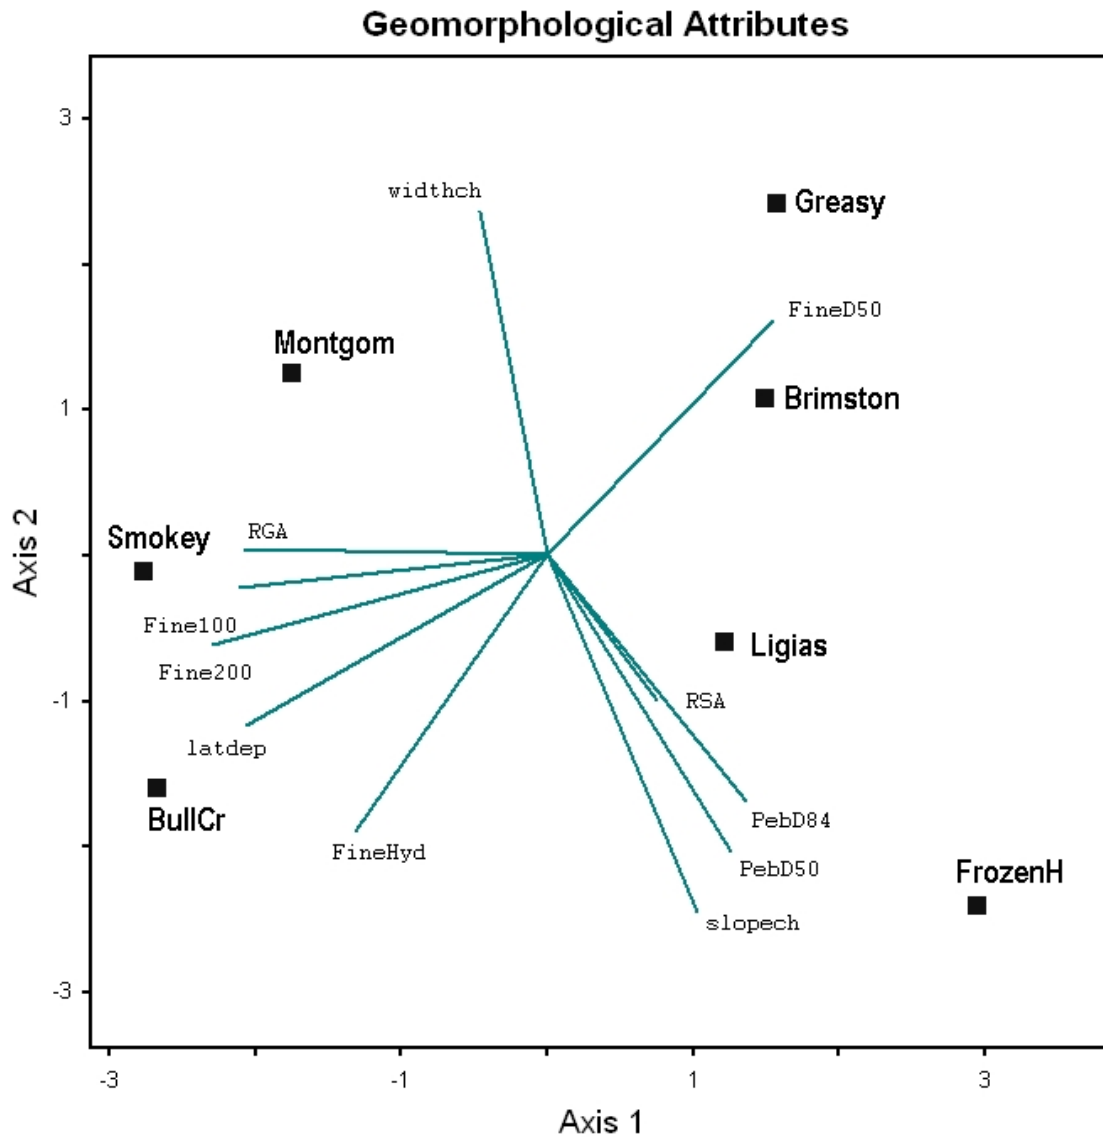
Figure 19. PCA ordination of geomorphological/bed sediment attributes per subwatershed.

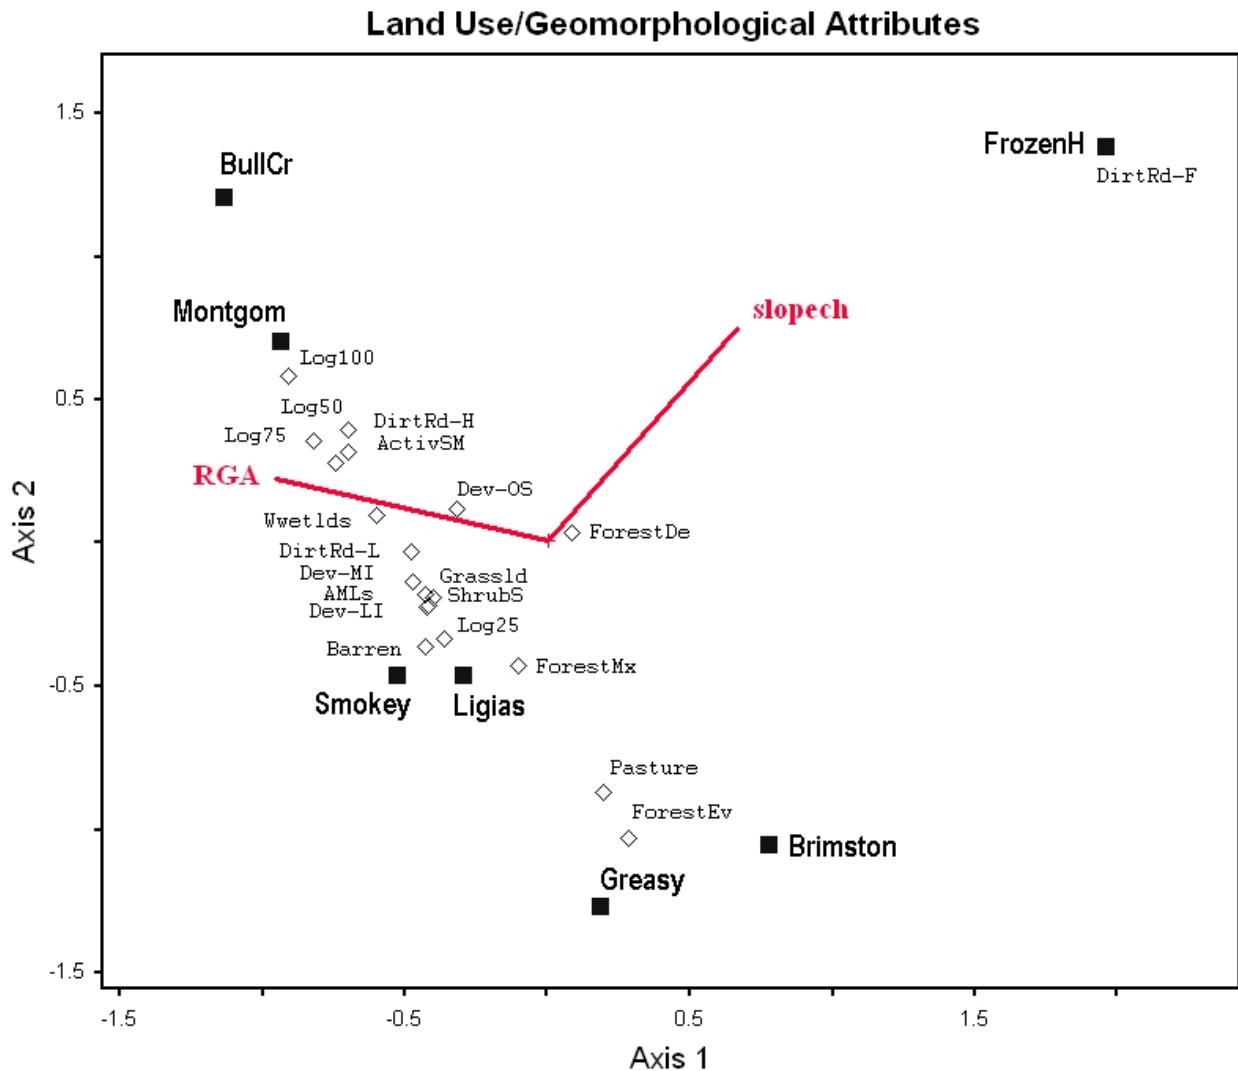
Figure 20. CCA ordination of land cover/use attributes and geomorphological attributes per subwatershed.

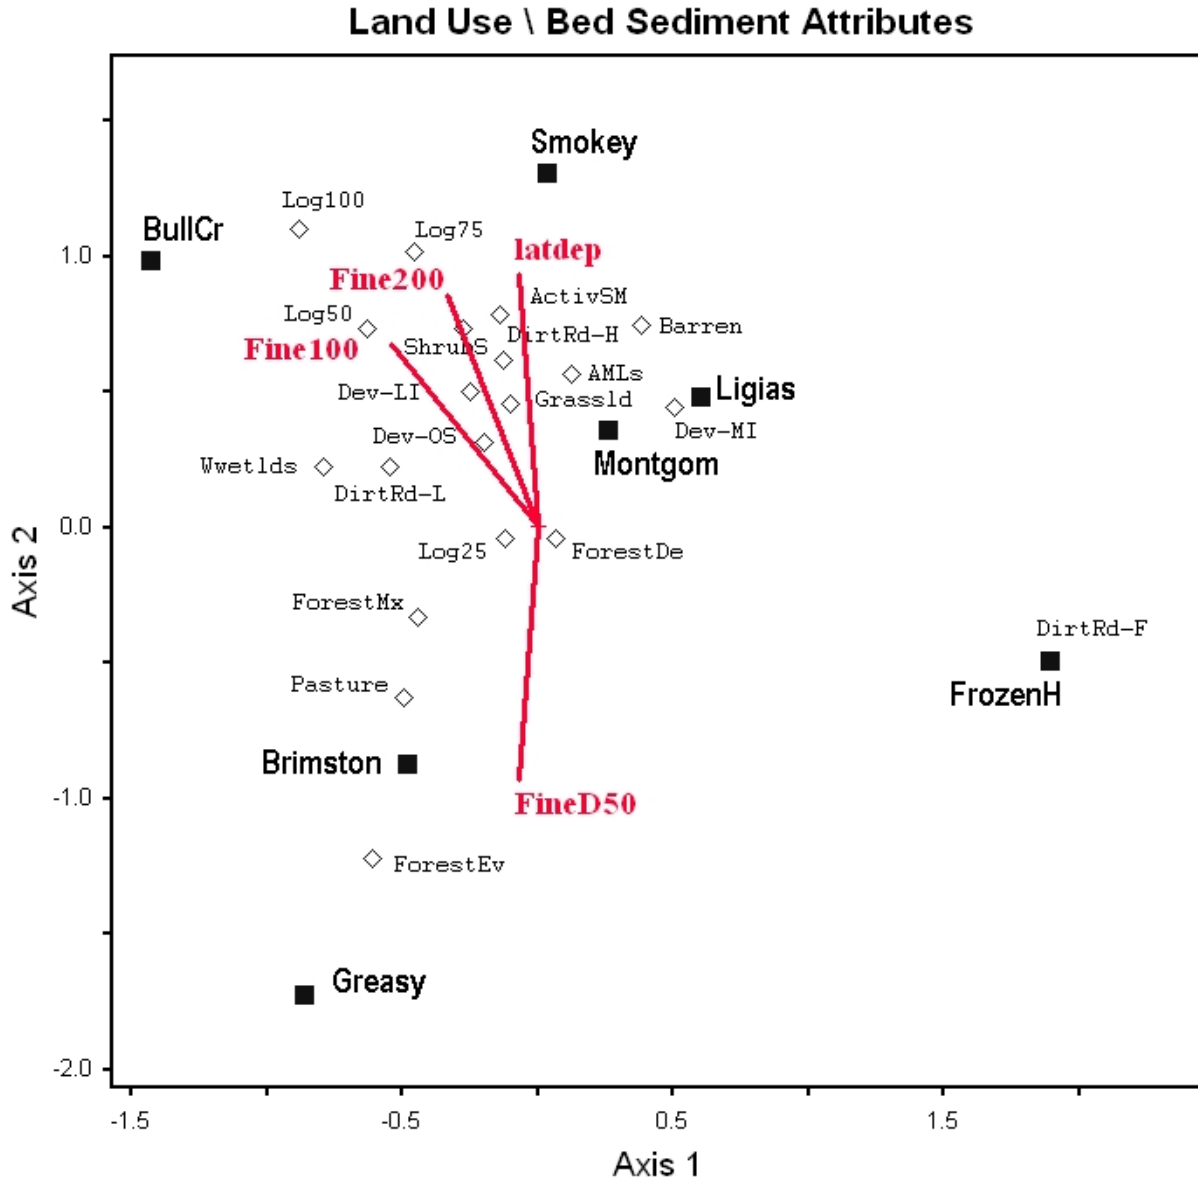
Figure 21. CCA ordination of land cover/use attributes and fine bed sediment attributes per subwatershed.

A second CCA was performed in which subwatersheds were orientated based on data for percent area of land cover/use types per subwatershed (Tables 2 and 3) along fine bed sediment eigenvectors (data from Table 16) in order to test the utility of the fine bed sediment collection technique to distinguish disturbed subwatersheds from logging, mining or other land use

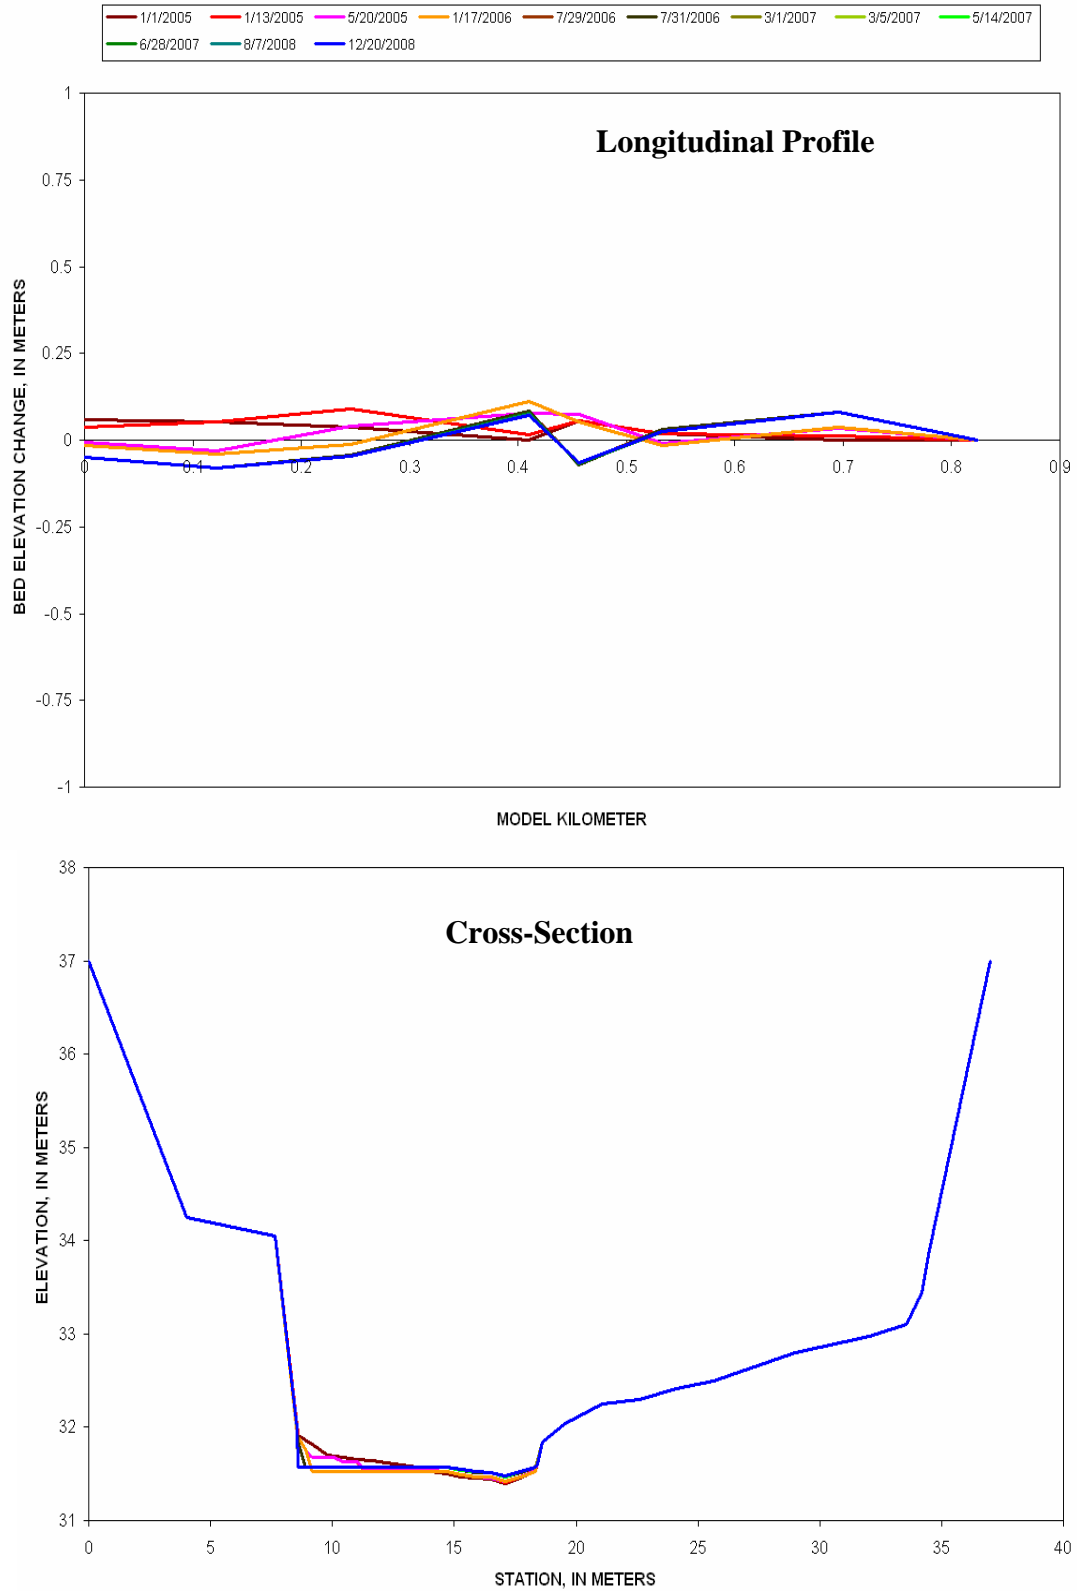
Figure 26: Example of CONCEPTS model output in a New River subwatershed.
 Colored lines represent channel bed/ban for different dates over time.

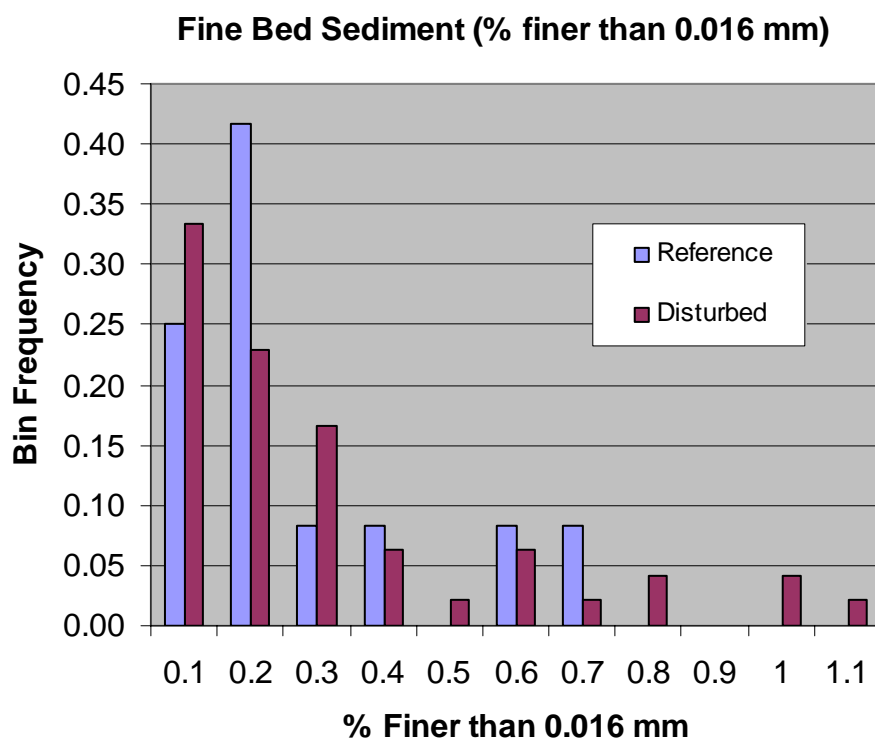
Figure 27. Frequency of occurrence of fine bed sediment, % finer than 0.016 mm by weight, for the study reference and disturbed subwatershed sites. Frequency of occurrence was normalized by number of sites within each subwatershed category (12 reference sites, and 48 disturbed sites).

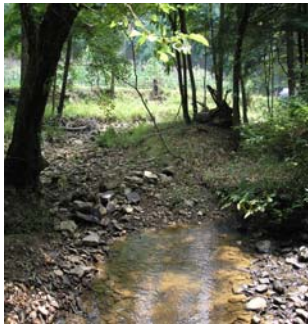
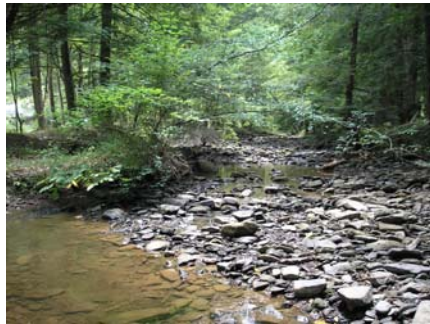
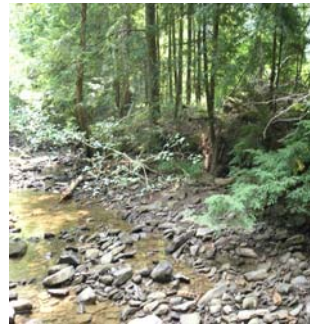
UPSTREAM PHOTO:

BRIEF DISCRIPTION OF SITE: Site is located off of Brimstone Road and is just upstream of the 2nd bridge crossing on Brimstone Road.

ESTIMATED RIGHT BANK SLOPE (DEGREES): 75
ESTIMATED LEFT BANK SLOPE (DEGREES): 75
ESTIMATED RIGHT BANK HEIGHT (METERS): 2.0
ESTIMATED LEFT BANK HEIGHT (METERS): 1.5
BANKFULL HEIGHT (METERS): 1.5
ESTIMATED RIGHT BANK ROOT DEPTH (METERS): 1.75
ESTIMATED LEFT BANK ROOT DEPTH (METERS): 1.25
ESTIMATED RIGHT BANK ROOT DENSITY (%): 75
ESTIMATED LEFT BANK ROOT DENSITY (%): 75
ESTIMATED RIGHT BANK SURFACE PROTECTION (%): 75
ESTIMATED LEFT BANK SURFACE PROTECTION (%): 75

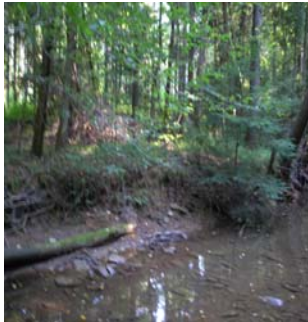
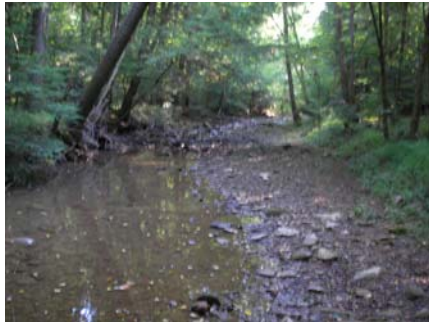
UPSTREAM PHOTO:

BRIEF DISCRPTION OF SITE: Site is located downstream of the junction of Joe Creek and Brimstone Creek.

ESTIMATED RIGHT BANK SLOPE (DEGREES): 45
ESTIMATED LEFT BANK SLOPE (DEGREES): 75
ESTIMATED RIGHT BANK HEIGHT (METERS): 1.0
ESTIMATED LEFT BANK HEIGHT (METERS): 1.5
BANKFULL HEIGHT (METERS): 1.0
ESTIMATED RIGHT BANK ROOT DEPTH (METERS): 0.75
ESTIMATED LEFT BANK ROOT DEPTH (METERS): 1.25
ESTIMATED RIGHT BANK ROOT DENSITY (%): 90
ESTIMATED LEFT BANK ROOT DENSITY (%): 100
ESTIMATED RIGHT BANK SURFACE PROTECTION (%): 90
ESTIMATED LEFT BANK SURFACE PROTECTION (%): 100

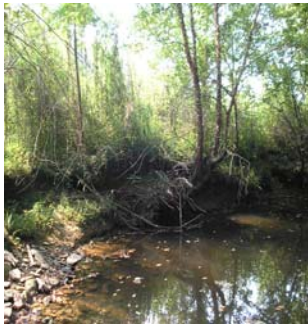
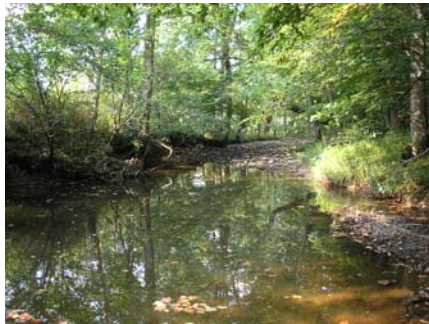
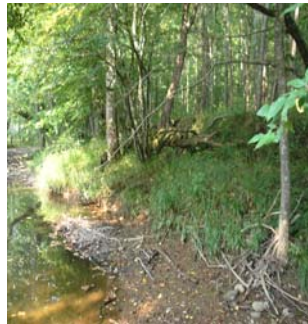
UPSTREAM PHOTO:

BRIEF DISCRIPTION OF SITE: Site is located between Indian Creek junction with Brimstone Creek and downstream of the BSC-1 site.

ESTIMATED RIGHT BANK SLOPE (DEGREES): 45
ESTIMATED LEFT BANK SLOPE (DEGREES): 65
ESTIMATED RIGHT BANK HEIGHT (METERS): 1.0
ESTIMATED LEFT BANK HEIGHT (METERS): 1.5
BANKFULL HEIGHT (METERS): 1.0
ESTIMATED RIGHT BANK ROOT DEPTH (METERS): 0.8
ESTIMATED LEFT BANK ROOT DEPTH (METERS): 1.25
ESTIMATED RIGHT BANK ROOT DENSITY (%): 100
ESTIMATED LEFT BANK ROOT DENSITY (%): 100
ESTIMATED RIGHT BANK SURFACE PROTECTION (%): 100
ESTIMATED LEFT BANK SURFACE PROTECTION (%): 100

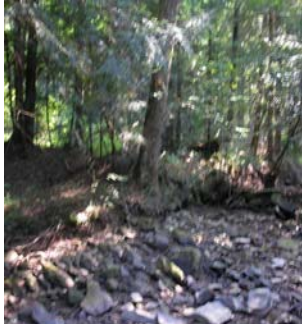
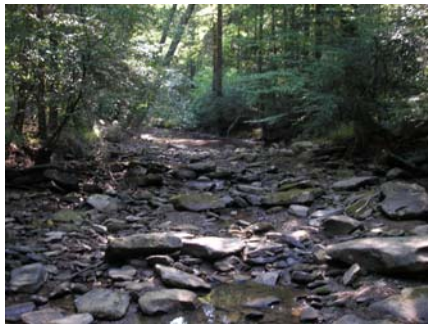
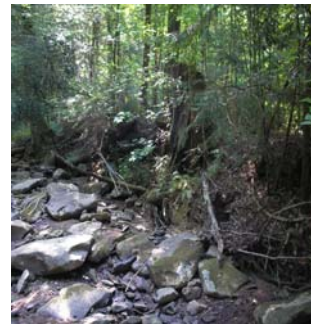
UPSTREAM PHOTO:

BRIEF DISCRIPTION OF SITE: Site is located upstream of the Brimstone Creek and the Joe Creek junction. This site is parallel to a logging trail in the back of the Brimstone Watershed.

ESTIMATED RIGHT BANK SLOPE (DEGREES): 75
ESTIMATED LEFT BANK SLOPE (DEGREES): 80
ESTIMATED RIGHT BANK HEIGHT (METERS): 1.0
ESTIMATED LEFT BANK HEIGHT (METERS): 1.0
BANKFULL HEIGHT (METERS): 1.0
ESTIMATED RIGHT BANK ROOT DEPTH (METERS): 0.5
ESTIMATED LEFT BANK ROOT DEPTH (METERS): 0.5
ESTIMATED RIGHT BANK ROOT DENSITY (%): 100
ESTIMATED LEFT BANK ROOT DENSITY (%): 100
ESTIMATED RIGHT BANK SURFACE PROTECTION (%): 100
ESTIMATED LEFT BANK SURFACE PROTECTION (%): 100

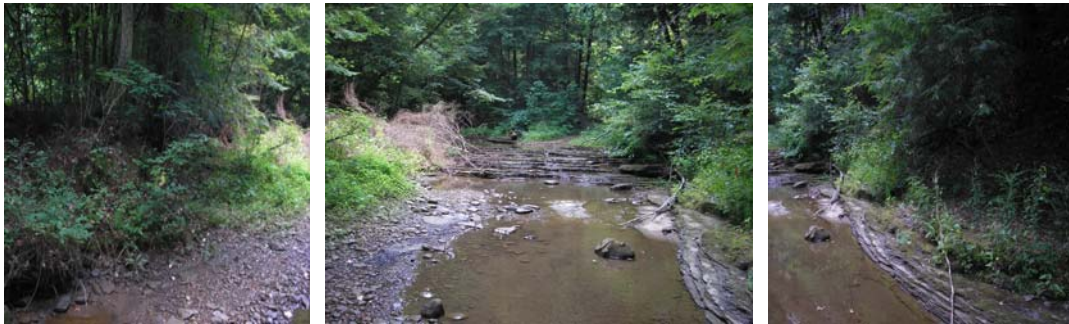
UPSTREAM PHOTO:

BRIEF DISCRIPTION OF SITE: Site is located upstream of the first bridge on Brimstone Road.

ESTIMATED RIGHT BANK SLOPE (DEGREES): 80
ESTIMATED LEFT BANK SLOPE (DEGREES): 75
ESTIMATED RIGHT BANK HEIGHT (METERS): 2.0
ESTIMATED LEFT BANK HEIGHT (METERS): 2.5
BANKFULL HEIGHT (METERS): 2.0
ESTIMATED RIGHT BANK ROOT DEPTH (METERS): 1.85
ESTIMATED LEFT BANK ROOT DEPTH (METERS): 2.35
ESTIMATED RIGHT BANK ROOT DENSITY (%): 100
ESTIMATED LEFT BANK ROOT DENSITY (%): 100
ESTIMATED RIGHT BANK SURFACE PROTECTION (%): 100
ESTIMATED LEFT BANK SURFACE PROTECTION (%): 100

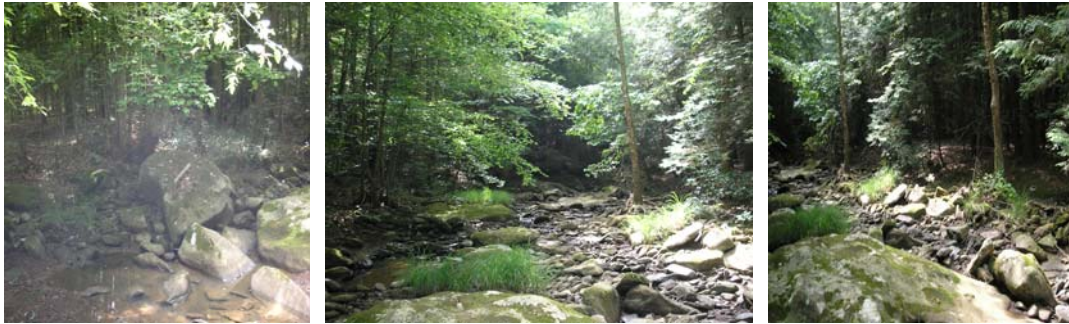
UPSTREAM PHOTO:

BRIEF DISCRPTION OF SITE: Site is located within a logging area. The site is just off of the logging trail, which runs parallel to Big Bull Creek.

ESTIMATED RIGHT BANK SLOPE (DEGREES): 60
ESTIMATED LEFT BANK SLOPE (DEGREES): 60
ESTIMATED RIGHT BANK HEIGHT (METERS): 2.0
ESTIMATED LEFT BANK HEIGHT (METERS): 1.5
BANKFULL HEIGHT (METERS): 1.5
ESTIMATED RIGHT BANK ROOT DEPTH (METERS): 1.75
ESTIMATED LEFT BANK ROOT DEPTH (METERS): 1.25
ESTIMATED RIGHT BANK ROOT DENSITY (%): 100
ESTIMATED LEFT BANK ROOT DENSITY (%): 100
ESTIMATED RIGHT BANK SURFACE PROTECTION (%): 100
ESTIMATED LEFT BANK SURFACE PROTECTION (%): 100

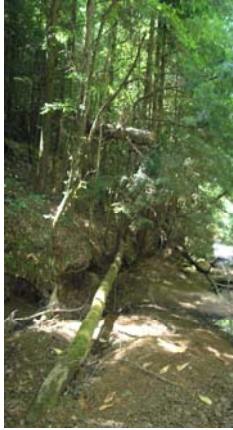
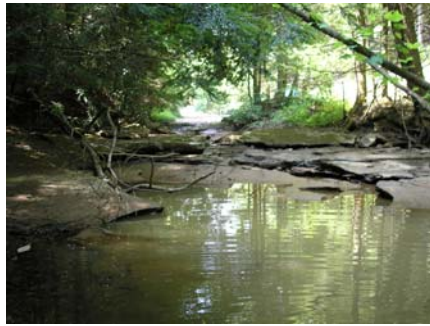
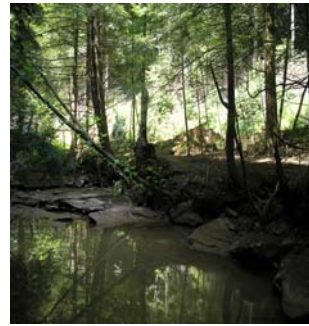
UPSTREAM PHOTO:

BRIEF DISCRPTION OF SITE: Site is located upstream of BBC-1 in a residential community where a large amount of ATV activity and logging are seen. The site is beside of a gravel logging road and is downstream of where it crosses the stream.

ESTIMATED RIGHT BANK SLOPE (DEGREES): 75
ESTIMATED LEFT BANK SLOPE (DEGREES): 90
ESTIMATED RIGHT BANK HEIGHT (METERS): 1.5
ESTIMATED LEFT BANK HEIGHT (METERS): 2.0
BANKFULL HEIGHT (METERS): 1.5
ESTIMATED RIGHT BANK ROOT DEPTH (METERS): 1.0
ESTIMATED LEFT BANK ROOT DEPTH (METERS): 1.0
ESTIMATED RIGHT BANK ROOT DENSITY (%): 100
ESTIMATED LEFT BANK ROOT DENSITY (%): 100
ESTIMATED RIGHT BANK SURFACE PROTECTION (%): 75
ESTIMATED LEFT BANK SURFACE PROTECTION (%): 75

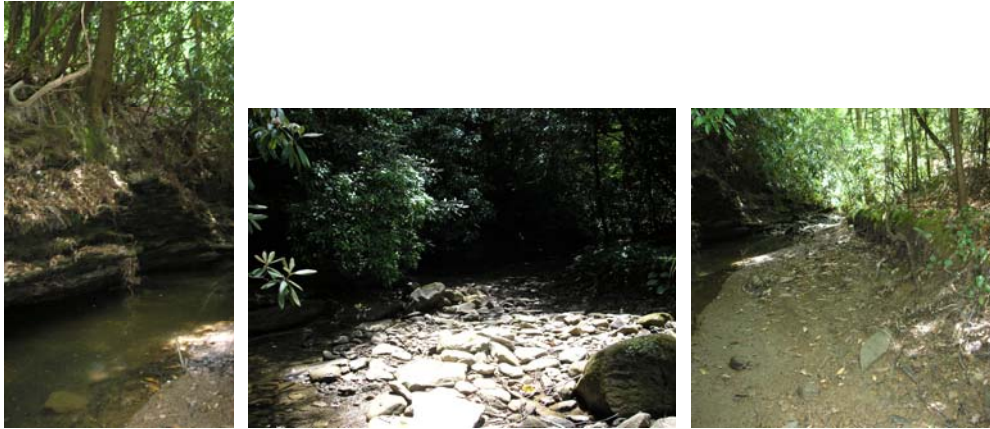
UPSTREAM PHOTO:

BRIEF DISCRIPTION OF SITE: Site is located upstream of a TWRA/logging trail that crosses the Little Bull Creek.

ESTIMATED RIGHT BANK SLOPE (DEGREES): 90
ESTIMATED LEFT BANK SLOPE (DEGREES): 90
ESTIMATED RIGHT BANK HEIGHT (METERS): 1.0
ESTIMATED LEFT BANK HEIGHT (METERS): 2.5
BANKFULL HEIGHT (METERS): 1.0
ESTIMATED RIGHT BANK ROOT DEPTH (METERS): 0.75
ESTIMATED LEFT BANK ROOT DEPTH (METERS): 2.25
ESTIMATED RIGHT BANK ROOT DENSITY (%): 100
ESTIMATED LEFT BANK ROOT DENSITY (%): 100
ESTIMATED RIGHT BANK SURFACE PROTECTION (%): 100
ESTIMATED LEFT BANK SURFACE PROTECTION (%): 100

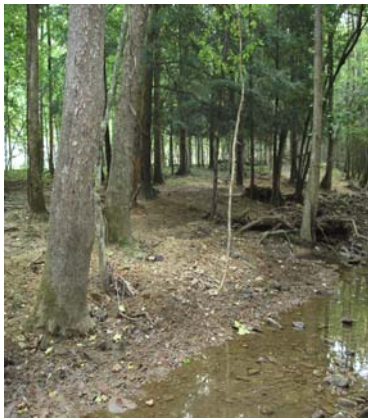
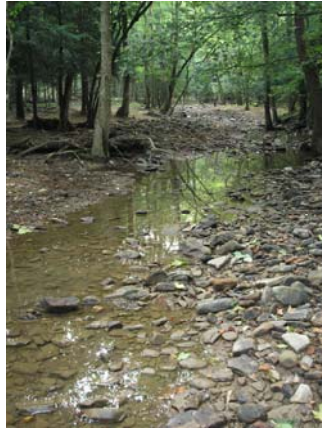
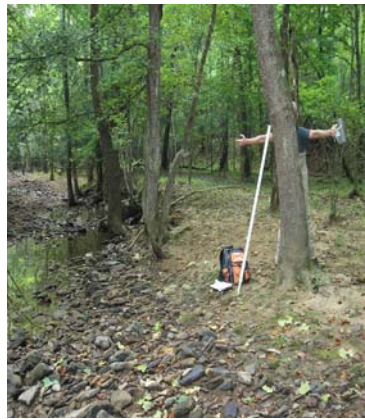
UPSTREAM PHOTO:

BRIEF DISCRIPTION OF SITE: Site is located upstream of the Big Bull and Little Bull Creek junction, which is within a pasture with cattle.

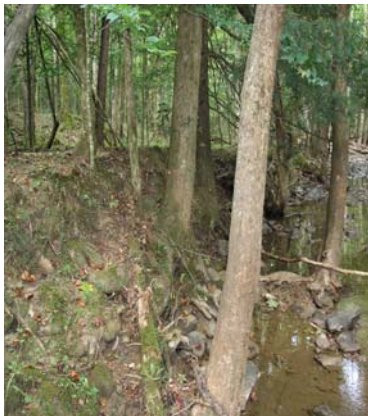
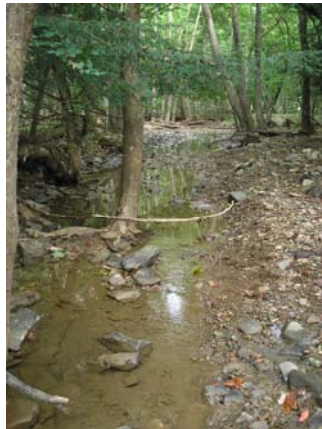
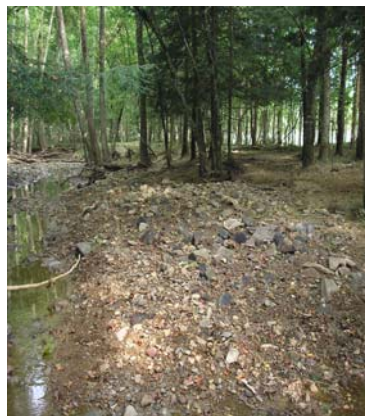
DOWNSTREAM PHOTO:

ESTIMATED RIGHT BANK SLOPE (DEGREES): 50
ESTIMATED LEFT BANK SLOPE (DEGREES): 20
ESTIMATED RIGHT BANK HEIGHT (METERS): 1.0
ESTIMATED LEFT BANK HEIGHT (METERS): 1.0
BANKFULL HEIGHT (METERS): 1.0
ESTIMATED RIGHT BANK ROOT DEPTH (METERS): 0.75
ESTIMATED LEFT BANK ROOT DEPTH (METERS): 0.75
ESTIMATED RIGHT BANK ROOT DENSITY (%): 25
ESTIMATED LEFT BANK ROOT DENSITY (%): 25
ESTIMATED RIGHT BANK SURFACE PROTECTION (%): 30
ESTIMATED LEFT BANK SURFACE PROTECTION (%): 30

LAND USE DISTURBANCE (0 None - 4 Disturbed): 3.0
Note: Cattle found in stream.

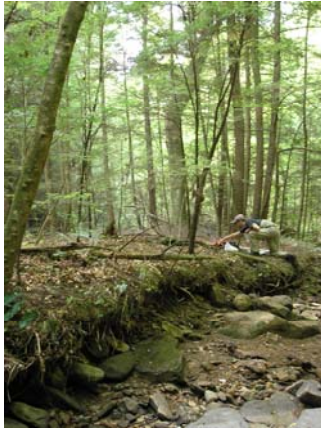
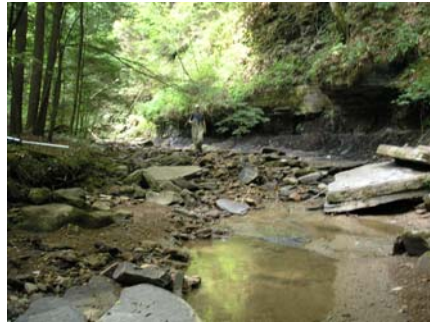
UPSTREAM PHOTO:

BRIEF DISCRPTION OF SITE: Site is located upstream of LF-1 and is further back into the trail that parallels Little Bull Creek.

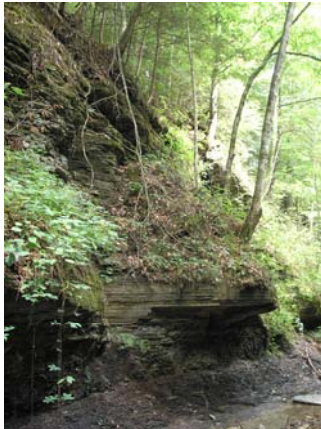
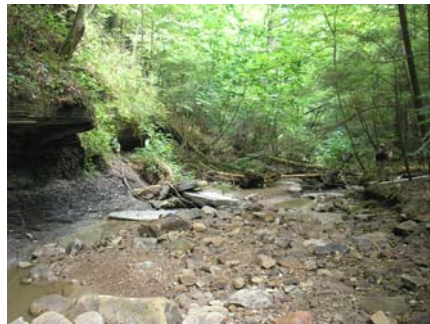
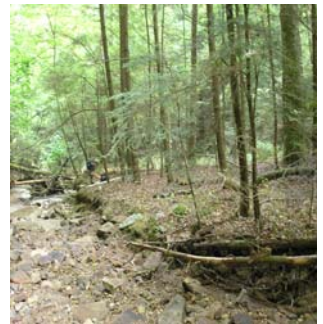
DOWNSTREAM PHOTO:

ESTIMATED RIGHT BANK SLOPE (DEGREES): 90
ESTIMATED LEFT BANK SLOPE (DEGREES): 75
ESTIMATED RIGHT BANK HEIGHT (METERS): 10.0
ESTIMATED LEFT BANK HEIGHT (METERS): 1.0
BANKFULL HEIGHT (METERS): 1.0
ESTIMATED RIGHT BANK ROOT DEPTH (METERS): 8.0
ESTIMATED LEFT BANK ROOT DEPTH (METERS): 0.8
ESTIMATED RIGHT BANK ROOT DENSITY (%): 70
ESTIMATED LEFT BANK ROOT DENSITY (%): 40
ESTIMATED RIGHT BANK SURFACE PROTECTION (%): 100
ESTIMATED LEFT BANK SURFACE PROTECTION (%): 90

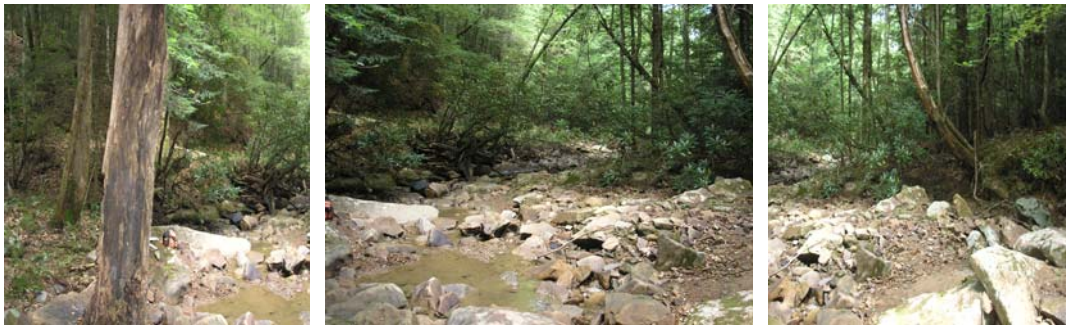
DOWNSTREAM PHOTO:

ESTIMATED RIGHT BANK SLOPE (DEGREES): 80
ESTIMATED LEFT BANK SLOPE (DEGREES): 80
ESTIMATED RIGHT BANK HEIGHT (METERS): 1.25
ESTIMATED LEFT BANK HEIGHT (METERS): 1.25
BANKFULL HEIGHT (METERS): 1.25
ESTIMATED RIGHT BANK ROOT DEPTH (METERS): 1.0
ESTIMATED LEFT BANK ROOT DEPTH (METERS): 1.0
ESTIMATED RIGHT BANK ROOT DENSITY (%): 80
ESTIMATED LEFT BANK ROOT DENSITY (%): 75
ESTIMATED RIGHT BANK SURFACE PROTECTION (%): 100
ESTIMATED LEFT BANK SURFACE PROTECTION (%): 100

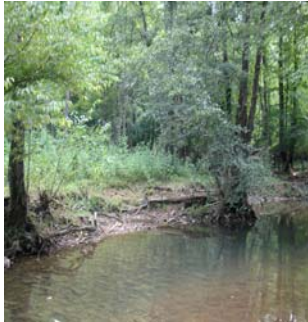
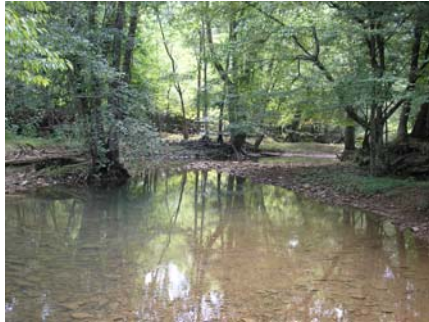
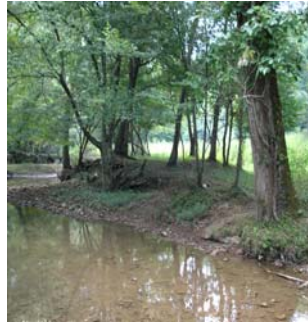
UPSTREAM PHOTO:

BRIEF DISCRIPTION OF SITE: Site is located upstream of the Big and Little Bull junction which leads into the New River. This site is located off of farm land in a property owner's backyard.

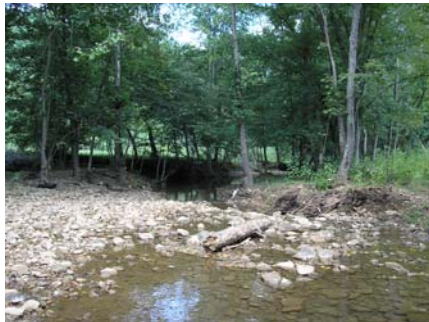
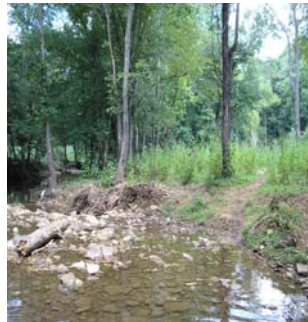
DOWNSTREAM PHOTO:

ESTIMATED RIGHT BANK SLOPE (DEGREES): 45
ESTIMATED LEFT BANK SLOPE (DEGREES): 75
ESTIMATED RIGHT BANK HEIGHT (METERS): 2.0
ESTIMATED LEFT BANK HEIGHT (METERS): 2.0
BANKFULL HEIGHT (METERS): 2.0
ESTIMATED RIGHT BANK ROOT DEPTH (METERS): 1.75
ESTIMATED LEFT BANK ROOT DEPTH (METERS): 1.75
ESTIMATED RIGHT BANK ROOT DENSITY (%): 100
ESTIMATED LEFT BANK ROOT DENSITY (%): 100
ESTIMATED RIGHT BANK SURFACE PROTECTION (%): 75
ESTIMATED LEFT BANK SURFACE PROTECTION (%): 75

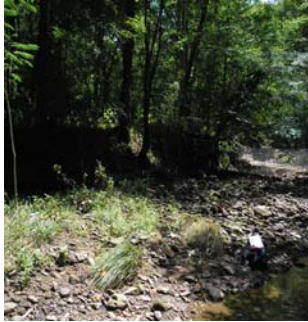
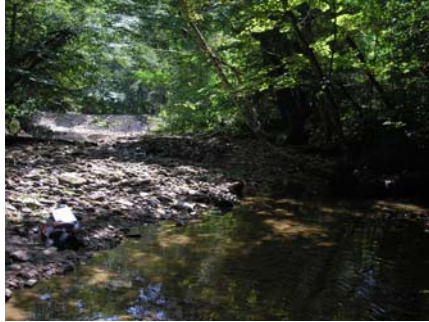
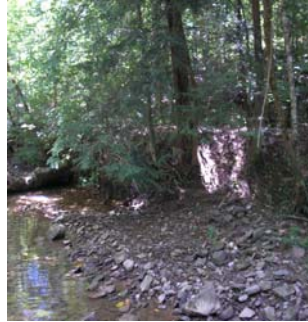
UPSTREAM PHOTO:

BRIEF DISCRPTION OF SITE: Site is located downstream of the junction of Little Bull and Big Bull Creeks.

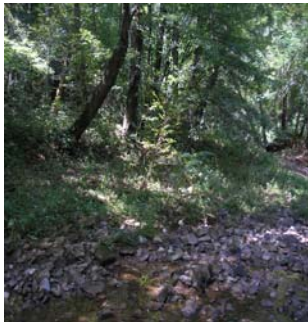
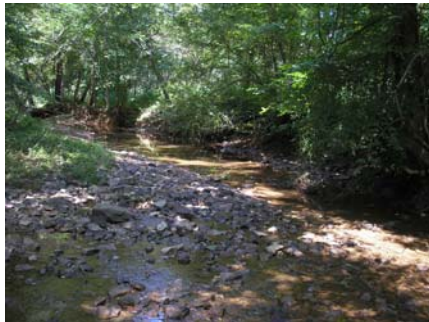
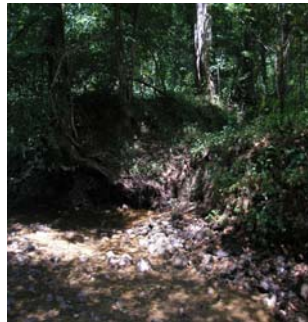
DOWNSTREAM PHOTO:

ESTIMATED RIGHT BANK SLOPE (DEGREES): 75
ESTIMATED LEFT BANK SLOPE (DEGREES): 90
ESTIMATED RIGHT BANK HEIGHT (METERS): 3.0
ESTIMATED LEFT BANK HEIGHT (METERS): 3.0
BANKFULL HEIGHT (METERS): 3.0
ESTIMATED RIGHT BANK ROOT DEPTH (METERS): 2.0
ESTIMATED LEFT BANK ROOT DEPTH (METERS): 2.0
ESTIMATED RIGHT BANK ROOT DENSITY (%): 75
ESTIMATED LEFT BANK ROOT DENSITY (%): 75
ESTIMATED RIGHT BANK SURFACE PROTECTION (%): 50
ESTIMATED LEFT BANK SURFACE PROTECTION (%): 50

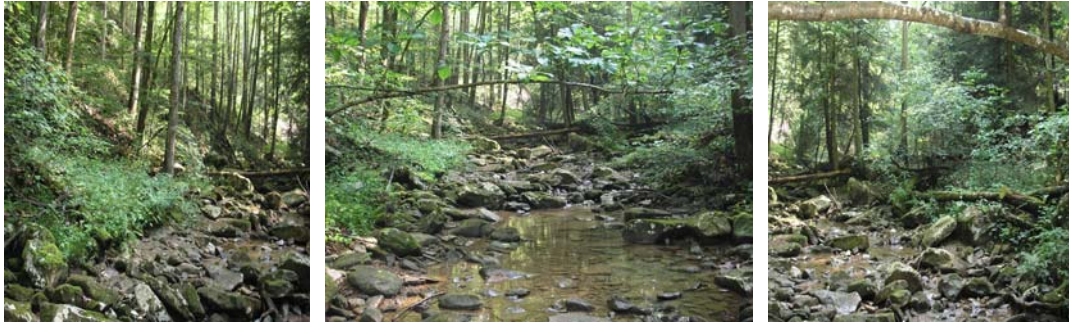
UPSTREAM PHOTO:

BRIEF DISCRIPTION OF SITE: Site is located off a hiking trail that goes to Emory Falls.

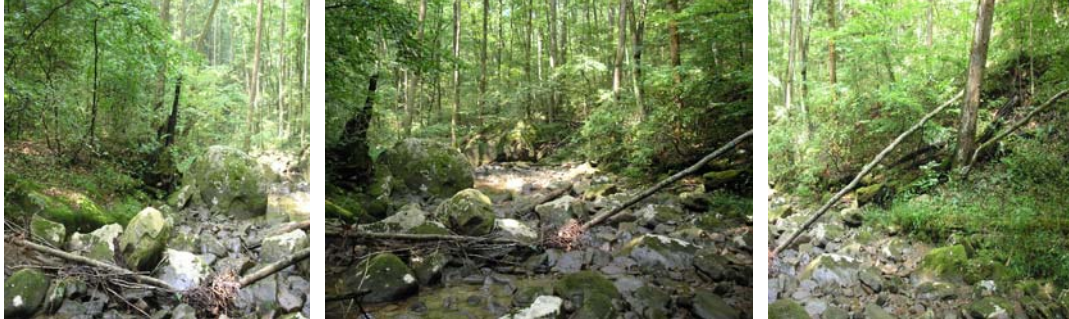
DOWNSTREAM PHOTO:

ESTIMATED RIGHT BANK SLOPE (DEGREES): 60
ESTIMATED LEFT BANK SLOPE (DEGREES): 75
ESTIMATED RIGHT BANK HEIGHT (METERS): 1.5
ESTIMATED LEFT BANK HEIGHT (METERS): 1.5
BANKFULL HEIGHT (METERS): 1.5
ESTIMATED RIGHT BANK ROOT DEPTH (METERS): 1.4
ESTIMATED LEFT BANK ROOT DEPTH (METERS): 1.4
ESTIMATED RIGHT BANK ROOT DENSITY (%): 100
ESTIMATED LEFT BANK ROOT DENSITY (%): 100
ESTIMATED RIGHT BANK SURFACE PROTECTION (%): 100
ESTIMATED LEFT BANK SURFACE PROTECTION (%): 100

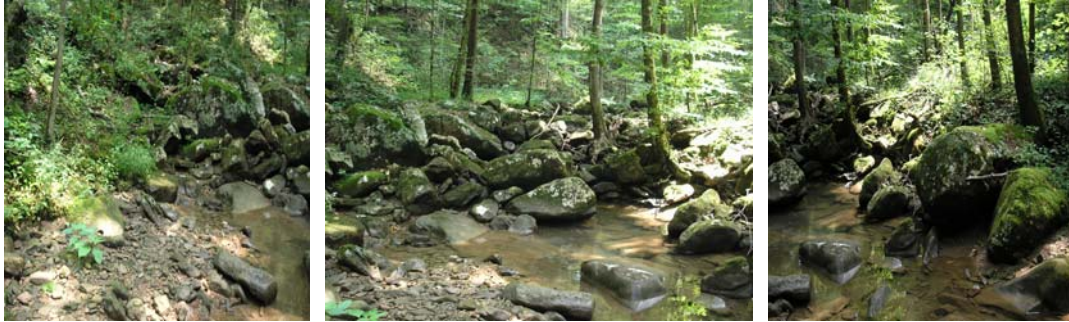
UPSTREAM PHOTO:

BRIEF DISCRPTION OF SITE: Site is located upstream of NPFF-1 and the first set of waterfalls on the hiking trail to Emory Falls.
