Development of a Rapid Geomorphic Assessment Technique to Support the CHIA/PHC Process: A Focus on Model Improvement for Estimating Sediment Loads

**USDoI Office of Surface Mining
Applied Science Program
Contract # CT612054**

University of Tennessee - Knoxville
Department of Civil and Environmental Engineering

May 30, 2008

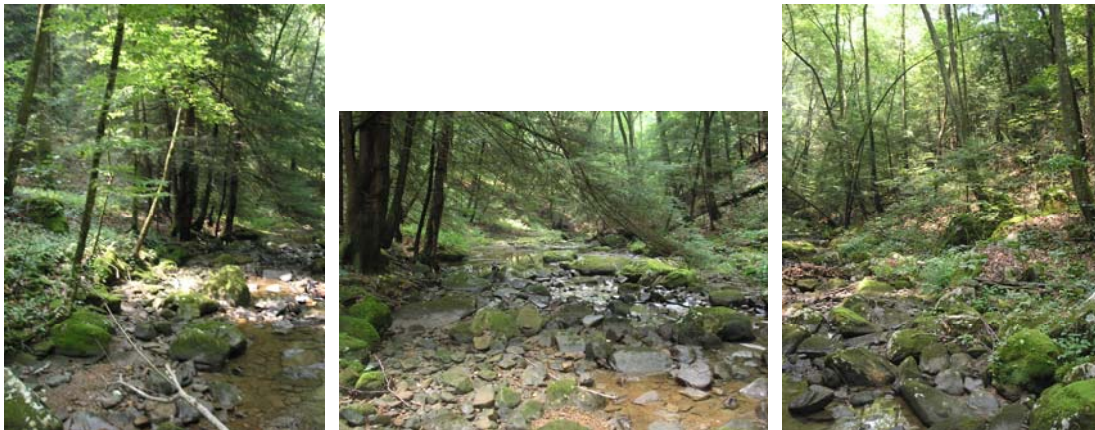
DOWNSTREAM PHOTO:

ESTIMATED RIGHT BANK SLOPE (DEGREES): 75
ESTIMATED LEFT BANK SLOPE (DEGREES): 75
ESTIMATED RIGHT BANK HEIGHT (METERS): 1.5
ESTIMATED LEFT BANK HEIGHT (METERS): 2.0
BANKFULL HEIGHT (METERS): 1.5
ESTIMATED RIGHT BANK ROOT DEPTH (METERS): 1.25
ESTIMATED LEFT BANK ROOT DEPTH (METERS): 1.75
ESTIMATED RIGHT BANK ROOT DENSITY (%): 100
ESTIMATED LEFT BANK ROOT DENSITY (%): 100
ESTIMATED RIGHT BANK SURFACE PROTECTION (%): 100
ESTIMATED LEFT BANK SURFACE PROTECTION (%): 100

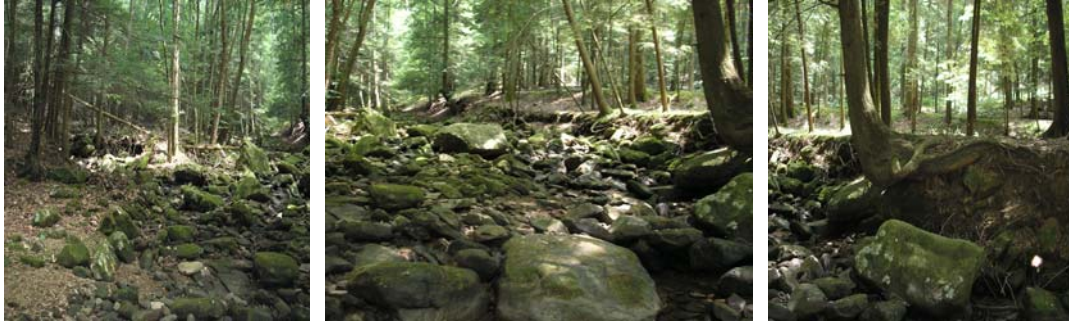
UPSTREAM PHOTO:

BRIEF DISCRPTION OF SITE: Site is located at the outlet of the reference watershed within the Frozen Head State Park.

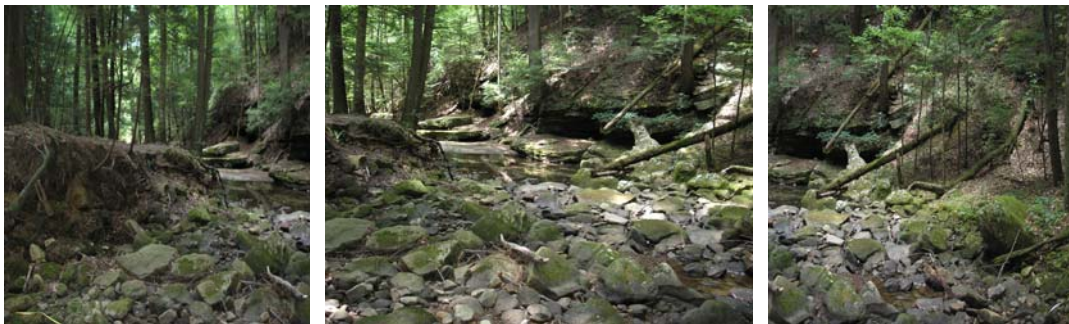
DOWNSTREAM PHOTO:

ESTIMATED RIGHT BANK SLOPE (DEGREES): 75
ESTIMATED LEFT BANK SLOPE (DEGREES): 30
ESTIMATED RIGHT BANK HEIGHT (METERS): 1.8
ESTIMATED LEFT BANK HEIGHT (METERS): 1.0
BANKFULL HEIGHT (METERS): 1.0
ESTIMATED RIGHT BANK ROOT DEPTH (METERS): 1.5
ESTIMATED LEFT BANK ROOT DEPTH (METERS): 0.75
ESTIMATED RIGHT BANK ROOT DENSITY (%): 100
ESTIMATED LEFT BANK ROOT DENSITY (%): 100
ESTIMATED RIGHT BANK SURFACE PROTECTION (%): 100
ESTIMATED LEFT BANK SURFACE PROTECTION (%): 100

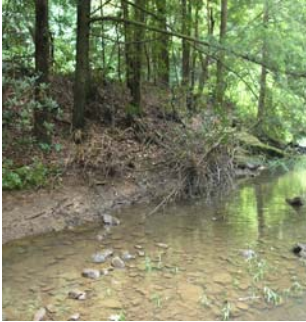
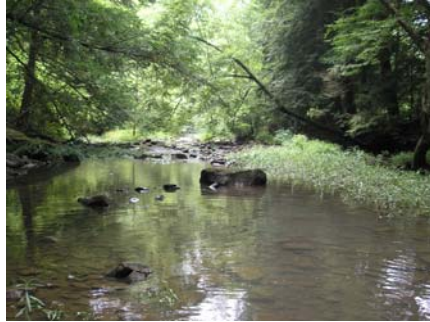
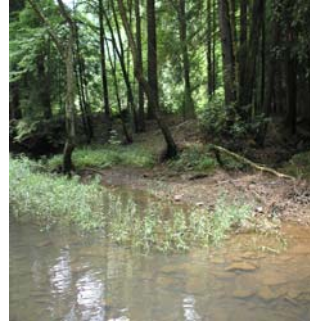
UPSTREAM PHOTO:

BRIEF DISCRPTION OF SITE: Site is located upstream of a bridge and wetland area. The site is just off of the Greasy Creek Road.

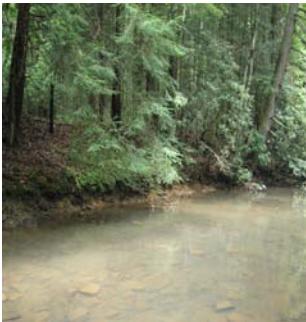
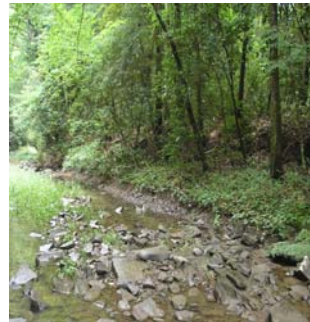
DOWNSTREAM PHOTO:

ESTIMATED RIGHT BANK SLOPE (DEGREES): 75
ESTIMATED LEFT BANK SLOPE (DEGREES): 75
ESTIMATED RIGHT BANK HEIGHT (METERS): 3.5
ESTIMATED LEFT BANK HEIGHT (METERS): 2.5
BANKFULL HEIGHT (METERS): 2.5
ESTIMATED RIGHT BANK ROOT DEPTH (METERS): 2.5
ESTIMATED LEFT BANK ROOT DEPTH (METERS): 2.25
ESTIMATED RIGHT BANK ROOT DENSITY (%): 100
ESTIMATED LEFT BANK ROOT DENSITY (%): 100
ESTIMATED RIGHT BANK SURFACE PROTECTION (%): 100
ESTIMATED LEFT BANK SURFACE PROTECTION (%): 100

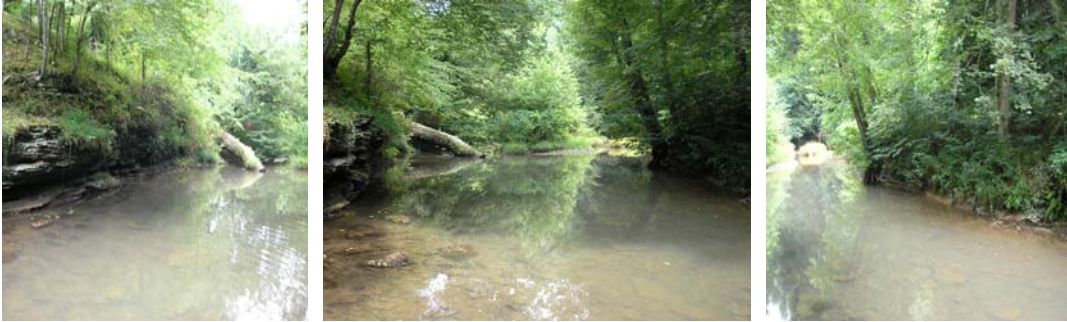
UPSTREAM PHOTO:

BRIEF DISCRPTION OF SITE: Site is located beside Greasy Creek Road. A white house sits on the left side of the creek looking upstream.

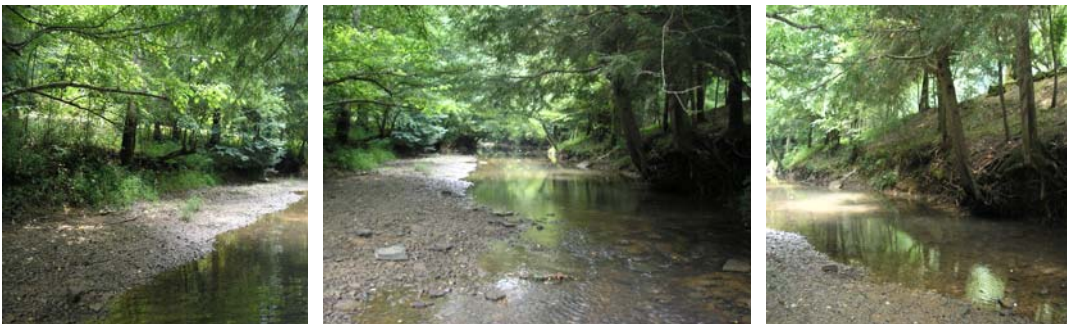
DOWNSTREAM PHOTO:

ESTIMATED RIGHT BANK SLOPE (DEGREES): 75
ESTIMATED LEFT BANK SLOPE (DEGREES): 60
ESTIMATED RIGHT BANK HEIGHT (METERS): 1.8
ESTIMATED LEFT BANK HEIGHT (METERS): 3.0
BANKFULL HEIGHT (METERS): 1.8
ESTIMATED RIGHT BANK ROOT DEPTH (METERS): 1.6
ESTIMATED LEFT BANK ROOT DEPTH (METERS): 2.9
ESTIMATED RIGHT BANK ROOT DENSITY (%): 100
ESTIMATED LEFT BANK ROOT DENSITY (%): 75
ESTIMATED RIGHT BANK SURFACE PROTECTION (%): 100
ESTIMATED LEFT BANK SURFACE PROTECTION (%): 85

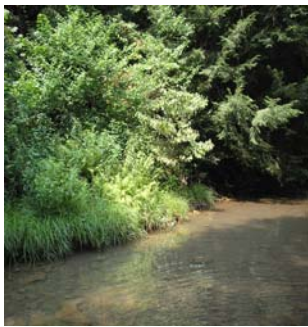
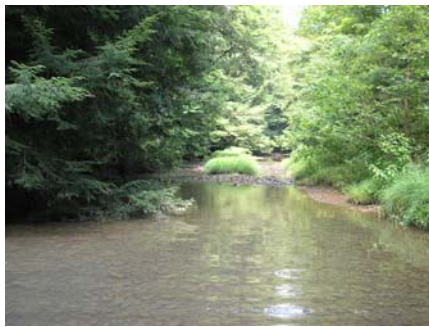
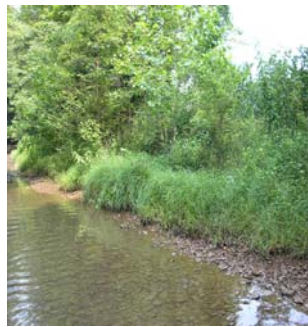
UPSTREAM PHOTO:

BRIEF DISCRIPTION OF SITE: Site is located off of Greasy Creek Road. The site is downstream of a wetland / floodplain area. The site is found at the end of a dirt driveway across the stream and into a field.

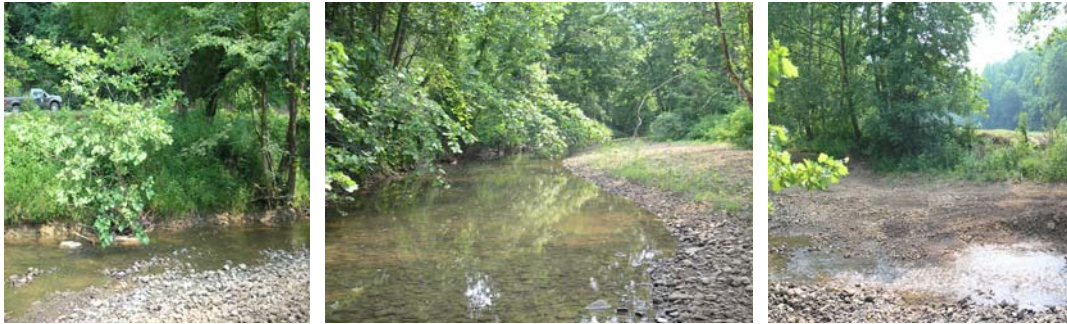
UPSTREAM PHOTO:

BRIEF DISCRPTION OF SITE: Site is located upstream of bridge with culverts.
About 20 meters upstream of bridge.

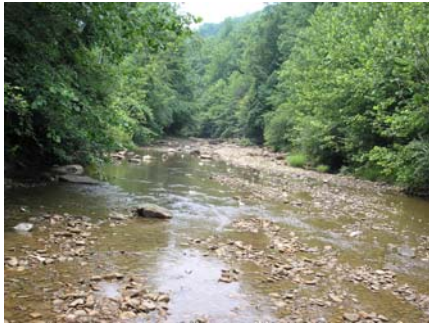
UPSTREAM PHOTO:

BRIEF DISCRPTION OF SITE: Site is located upstream of LF-1 and parallel to the same road.

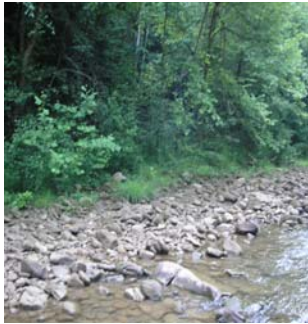
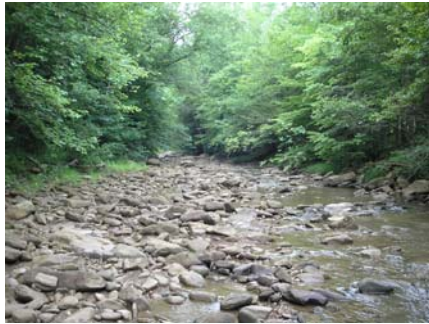
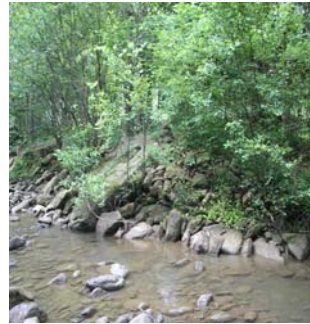
UPSTREAM PHOTO:

BRIEF DISCRPTION OF SITE: Site is located just upstream of first Ligias Fork Road crossing.

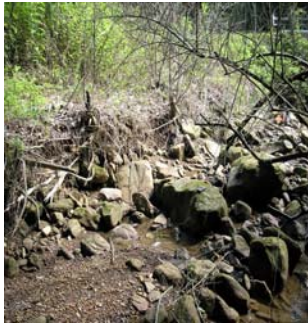
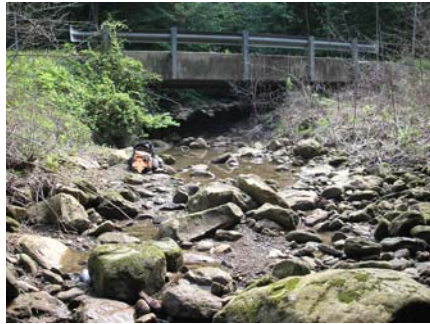
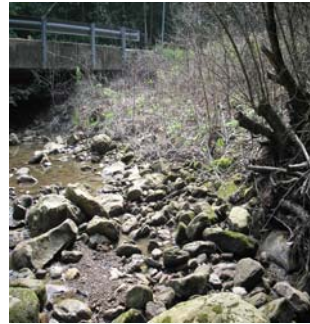
UPSTREAM PHOTO:

BRIEF DISCRPTION OF SITE: Site is located just downstream of the State Route 116 Bridge crossing.

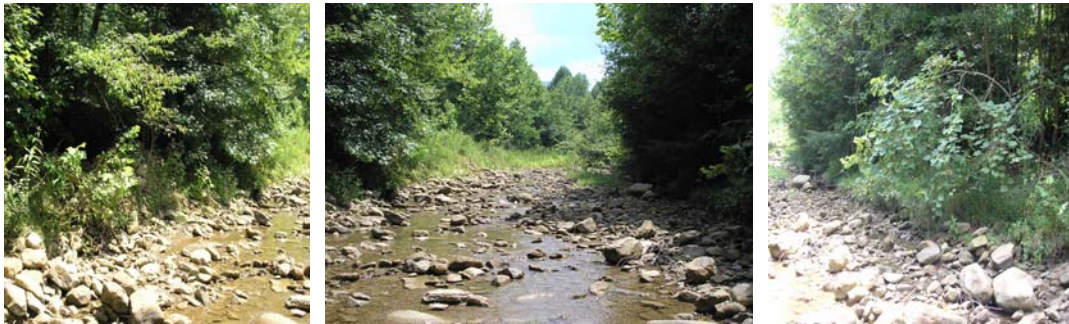
UPSTREAM PHOTO:

BRIEF DISCRIPTION OF SITE: Site is located just upstream of the Ligias Fork and Graves Gap Branch junction and just upstream of the Ligias Fork Road / Trail.

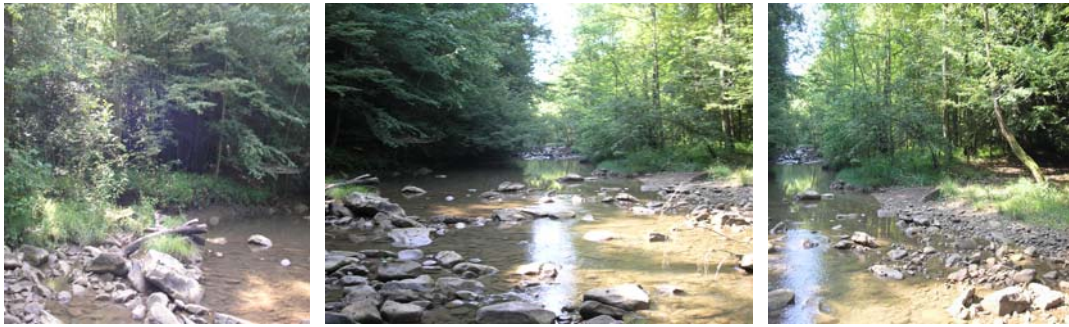
UPSTREAM PHOTO:

BRIEF DISCRIPTION OF SITE: Site is located upstream of LF-3 on the TWRA and Coal Creek ATV trail. Just above the second creek crossing.

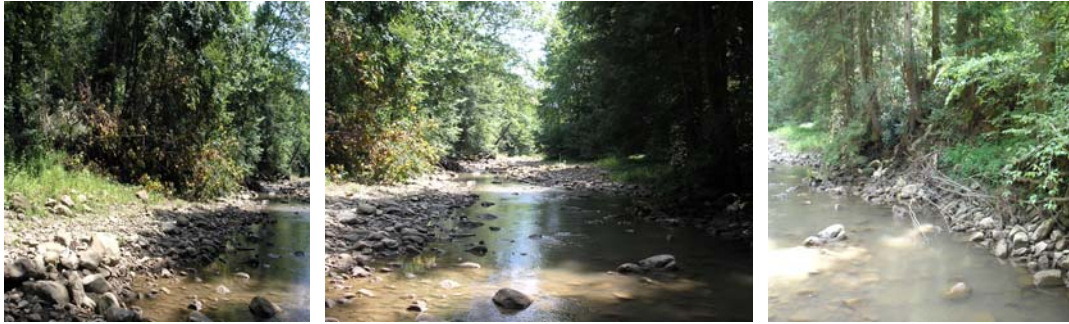
UPSTREAM PHOTO:

BRIEF DISCRIPTION OF SITE: Site is located behind the Pilot Church on SR-116.

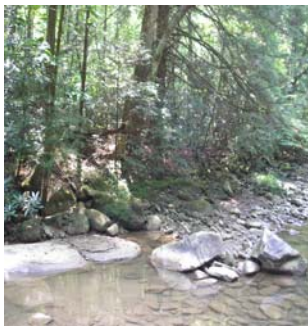
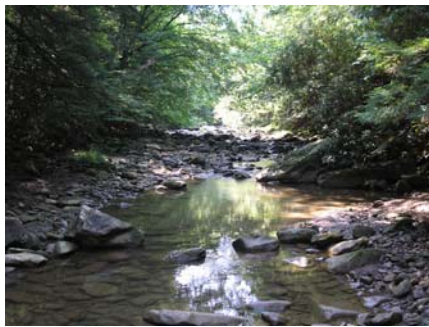
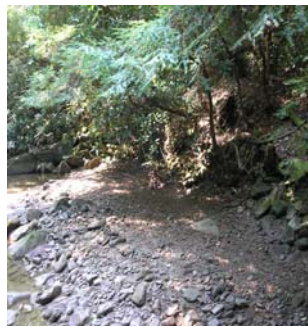
UPSTREAM PHOTO:

BRIEF DISCRIPTION OF SITE: Site is located upstream of LF-4 and off the Coal Creek ATV Trail No. 10. The site is also just upstream of the Phillips Branch junction of Ligias Fork.

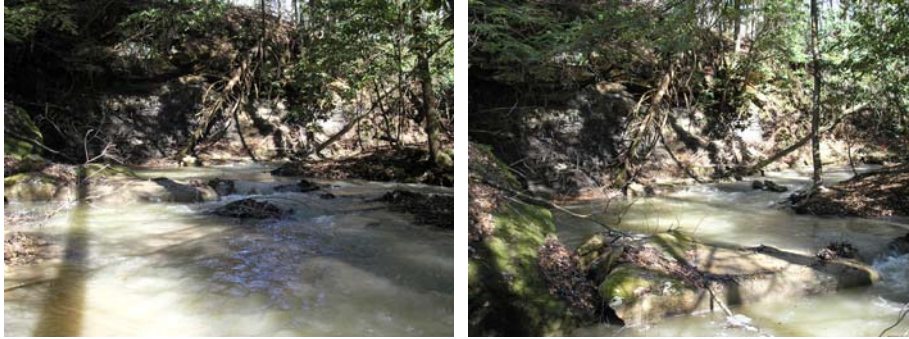
UPSTREAM PHOTOS:

BRIEF DISCRPTION OF SITE: Site is located at a sharp bend just upstream of the TWRA bridge/culvert road/trail at a riffle.

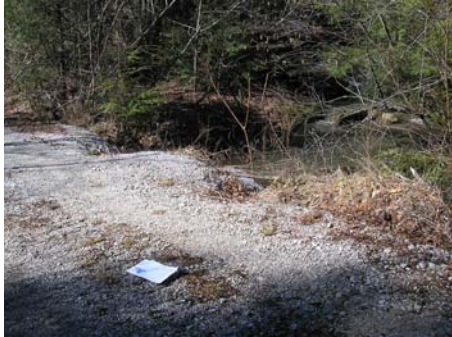
UPSTREAM PHOTO:

BRIEF DISCRPTION OF SITE: Site is located at a riffle which is just downstream of the TWRA bridge/culvert road/trail. This stream is high gradient with large boulders.

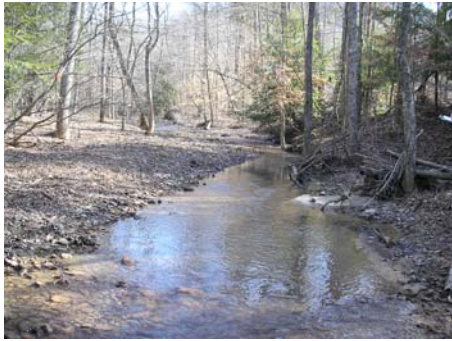
UPSTREAM PHOTO:

BRIEF DISCRPTION OF SITE: Site is a riffle located approximately 150 meters downstream of a dirt logging road that loops onto the loose gravel coal haul road.

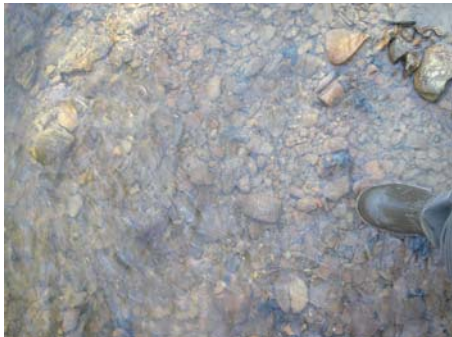
BED CHARACTER PHOTO:

There is a vast amount of fallen trees into the stream. May be caused from roads and activity above the stream.

AMOUNT OF COAL FOUND (0 None - 4 Robust): 4.0

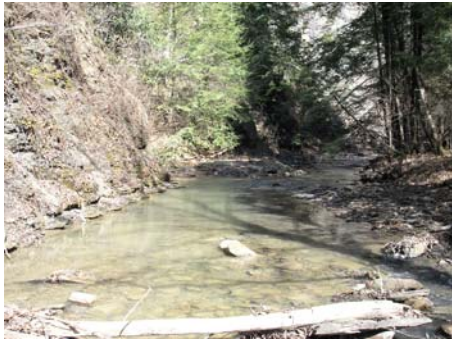
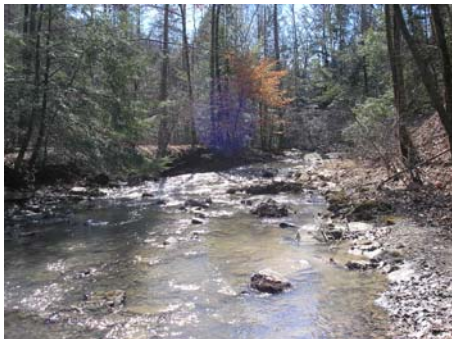
UPSTREAM PHOTO:

BRIEF DISCRPTION OF SITE: Site is a riffle located approximately 200 meters upstream from the coal haul road bridge and approximately 50 meters adjacent from a dirt logging road that is off the main coal haul road.

AMOUNT OF COAL FOUND (0 None - 4 Robust): 4.0

STRUCTURES / ACTIVITIES ADJACENT TO THE STREAM (0 None - 4 Major): 1.0
Dirt road found parallel to stream at sample site.

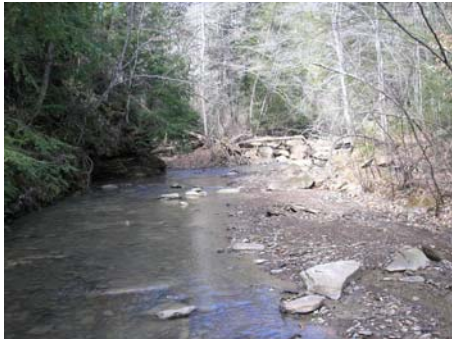
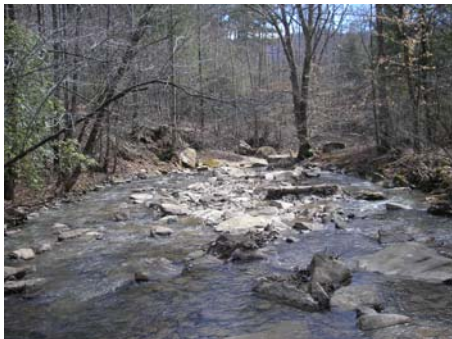
UPSTREAM PHOTO:

BRIEF DISCRIPTION OF SITE: Site is a riffle located approximately 150 meters upstream of the Roach Creek and Montgomery Fork junction.

AMOUNT OF COAL FOUND (0 None - 4 Robust): 4.0

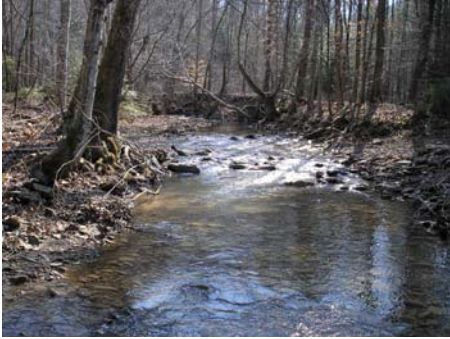
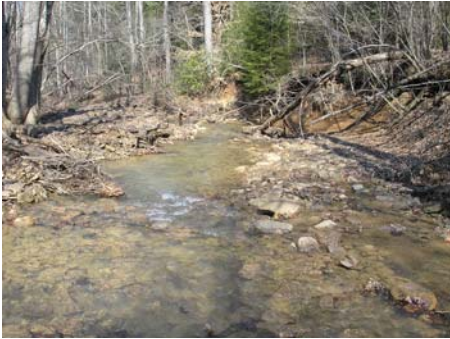
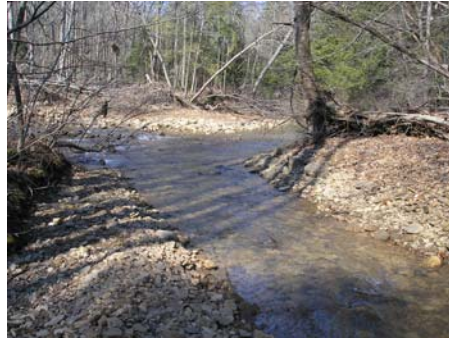
UPSTREAM PHOTO:

BRIEF DISCRIPTION OF SITE: Site is a riffle located below a dirt TWRA trail and above the Puncheon Camp Creek and Montgomery Fork junction.

AMOUNT OF COAL FOUND (0 None - 4 Robust): 0.5

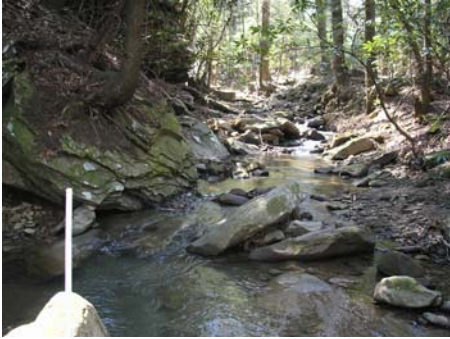
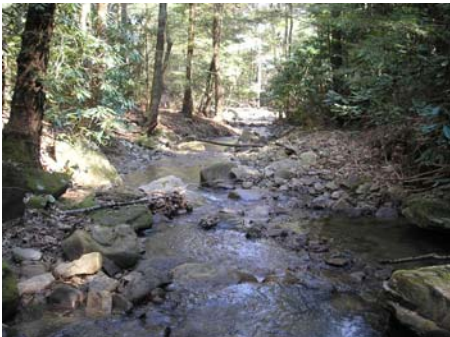
UPSTREAM PHOTO:

BRIEF DISRIPTION OF SITE: Site is a riffle located approximately 100 meters above the Montgomery Fork and Greens Branch junction.

AMOUNT OF COAL FOUND (0 None - 4 Robust): 0.0

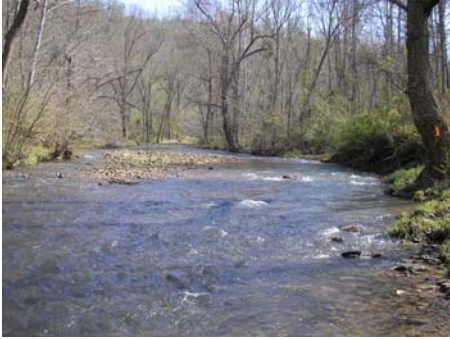
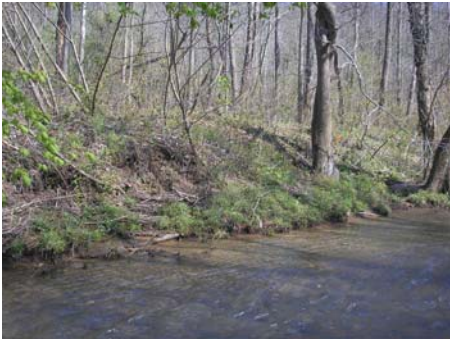
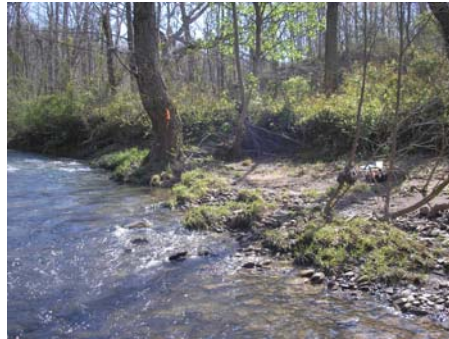
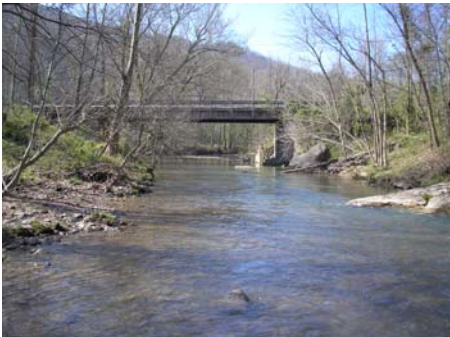
UPSTREAM PHOTO:

BRIEF DISCRIPTION OF SITE: Site is a riffle located approximately 56 meters upstream of the Norma Road Bridge.

AMOUNT OF COAL FOUND (0 None - 4 Robust): 2.5

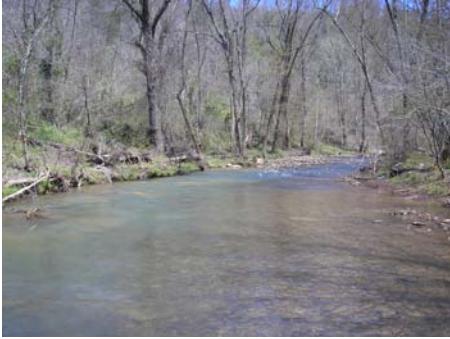
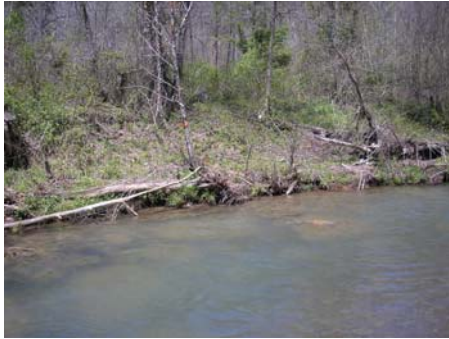
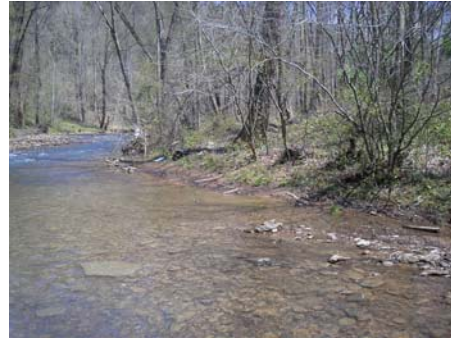
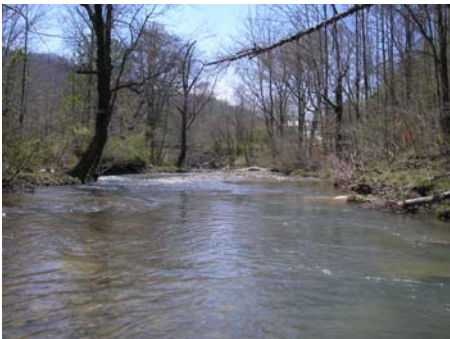
UPSTREAM PHOTO:

BRIEF DISCRIPTION OF SITE: Site is a pool located approximately 63 meters upstream of the MFCS-1.

AMOUNT OF COAL FOUND (0 None - 4 Robust): 1.0

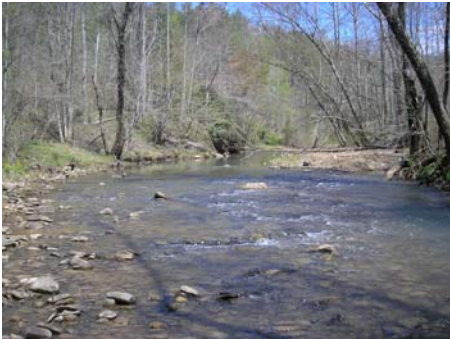
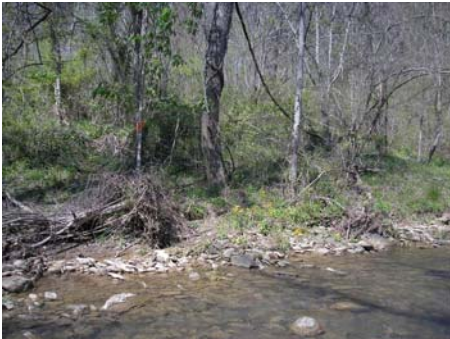
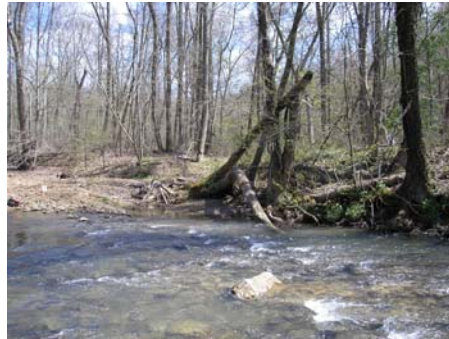
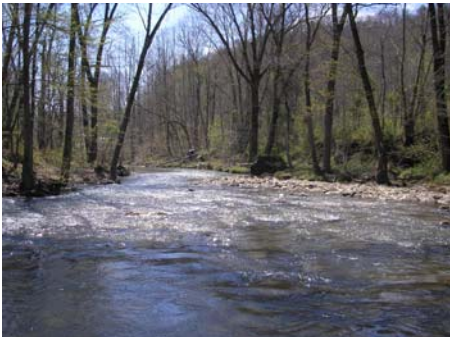
UPSTREAM PHOTO:

BRIEF DISCRIPTION OF SITE: Site is a riffle located approximately 47 meters upstream of the MFCS-2. A vast amount of coal found around site. Coal found is also very large in size.

AMOUNT OF COAL FOUND (0 None - 4 Robust): 4.0

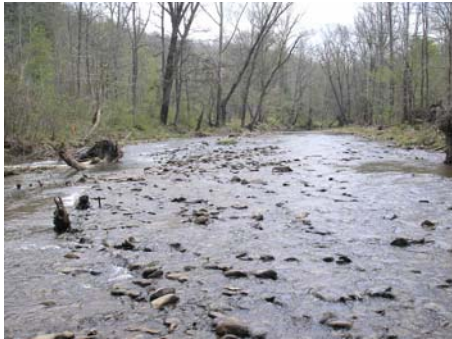
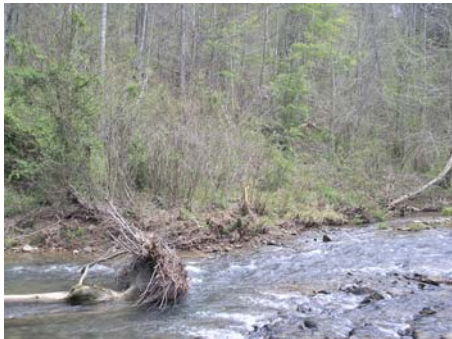
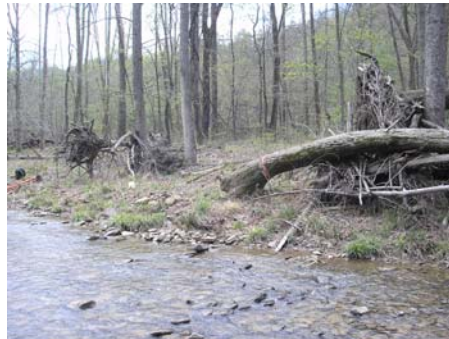
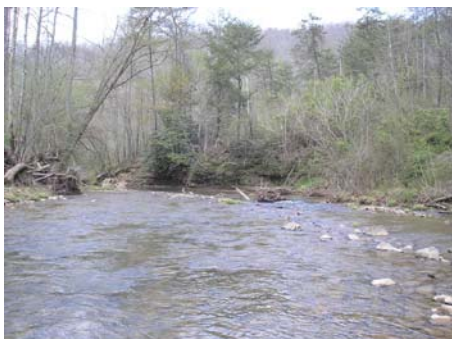
UPSTREAM PHOTO:

BRIEF DISCRIPTION OF SITE: Site is a riffle located approximately 80 meters upstream of the MFCS-3.

AMOUNT OF COAL FOUND (0 None - 4 Robust): 2.5

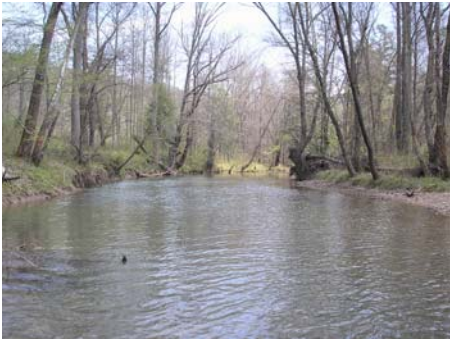
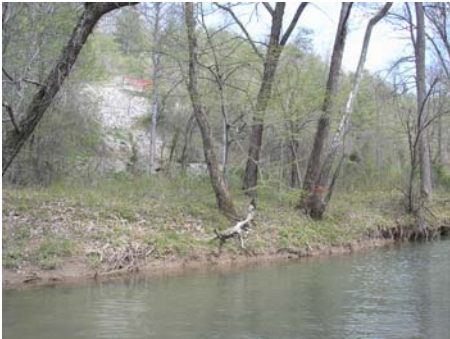
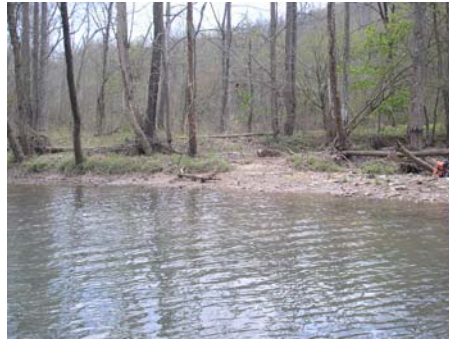
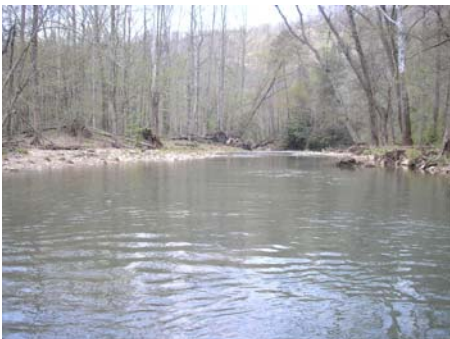
UPSTREAM PHOTO:

BRIEF DISCRIPTION OF SITE: Site is a pool located approximately 70 meters upstream of the MFCS-4. A vast amount of decomposing leaves and sediment found in this pool.

AMOUNT OF COAL FOUND (0 None - 4 Robust): 1.0

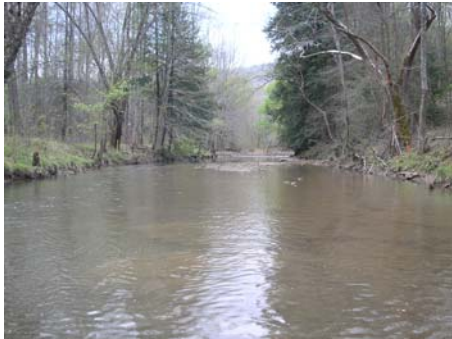
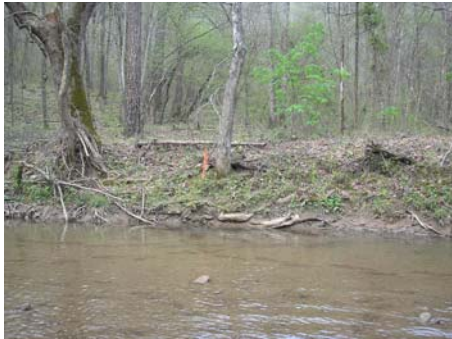
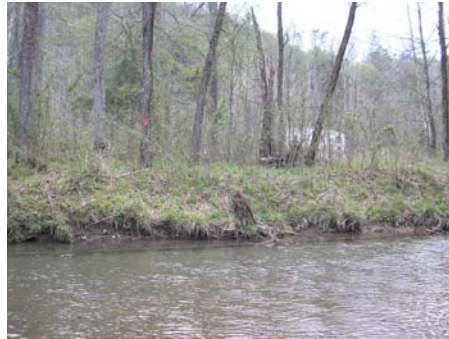
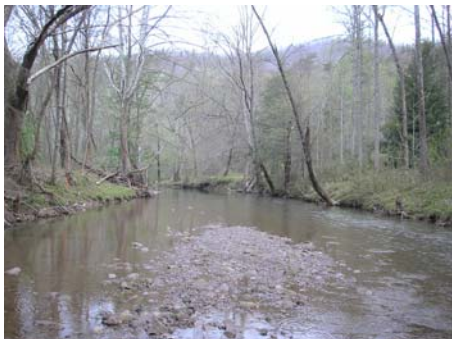
UPSTREAM PHOTO:

BRIEF DISCRPTION OF SITE: Site is a pool located approximately 83 meters upstream of the MFCS-5. Shallow pool with a uniform distribution of approximately 25mm pebbles. Site is located in front of house.

AMOUNT OF COAL FOUND (0 None - 4 Robust): 0.5

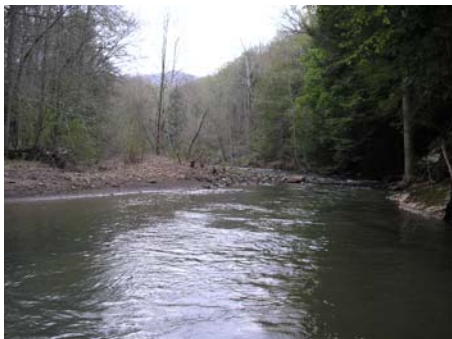
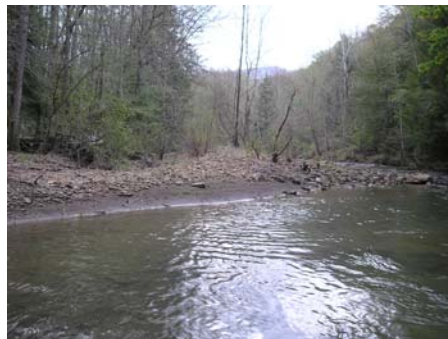
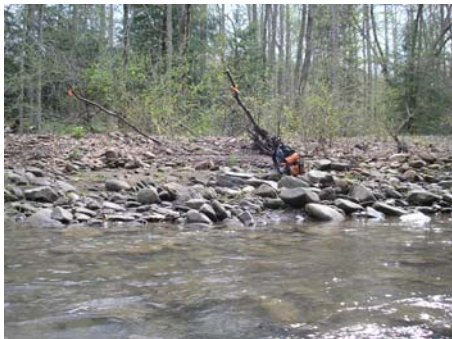
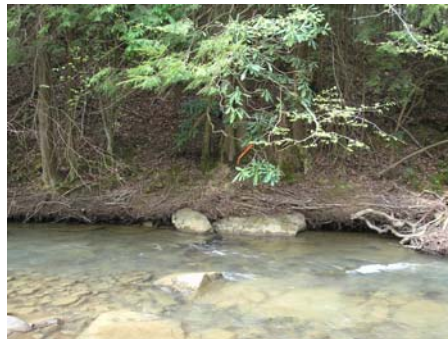
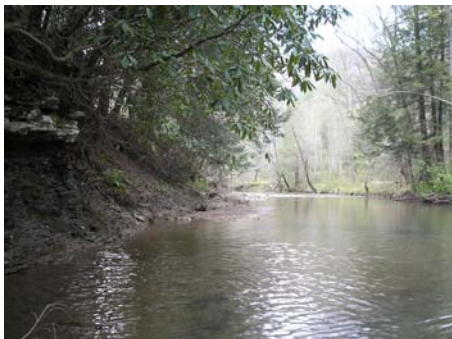
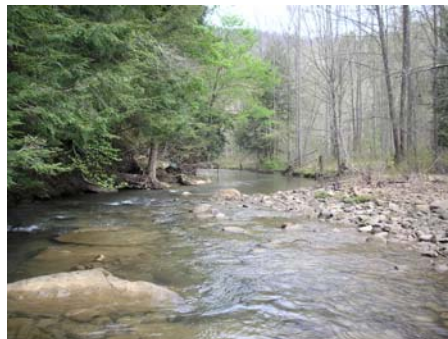
UPSTREAM PHOTO:

BRIEF DISCRPTION OF SITE: Site is a riffle located approximately 97 meters upstream of the MFCS-6. This riffle is very constricted with a rock wall on the right bank and a bedrock bed.

AMOUNT OF COAL FOUND (0 None - 4 Robust): 3.0

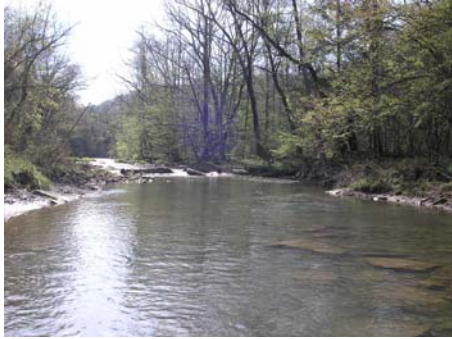
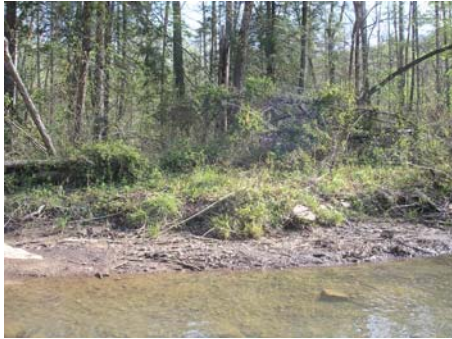
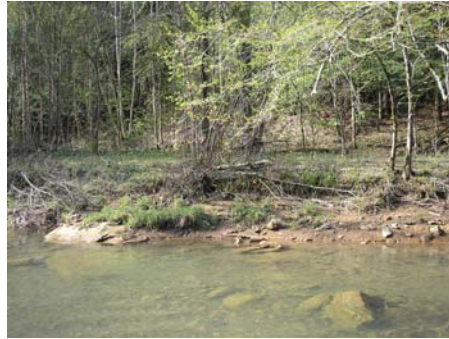
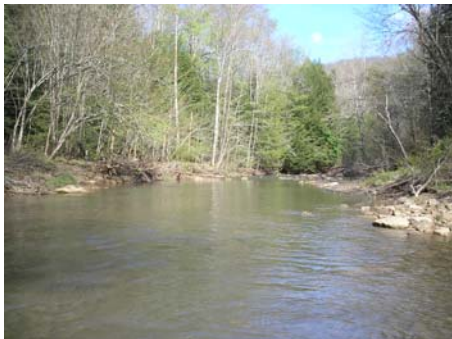
** CONTINUED -- STREAM SAMPLE SITE NO.: MFCS-8

BRIEF DISCRIPTION OF SITE: Site is a pool located approximately 92 meters upstream of the MFCS-7.

ESTIMATED RIGHT BANK SLOPE (DEGREES): 45
ESTIMATED LEFT BANK SLOPE (DEGREES): 35
ESTIMATED RIGHT BANK HEIGHT (METERS): 1.5
ESTIMATED LEFT BANK HEIGHT (METERS): 1.3
BANKFULL HEIGHT (METERS): 1.3
ESTIMATED RIGHT BANK ROOT DEPTH (METERS): 0.5
ESTIMATED LEFT BANK ROOT DEPTH (METERS): 0.5
ESTIMATED RIGHT BANK ROOT DENSITY (%): 100
ESTIMATED LEFT BANK ROOT DENSITY (%): 50
ESTIMATED RIGHT BANK SURFACE PROTECTION (%): 100
ESTIMATED LEFT BANK SURFACE PROTECTION (%): 100

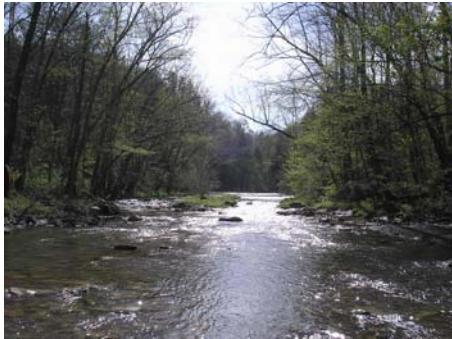
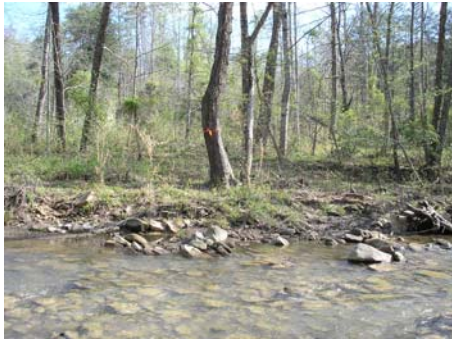
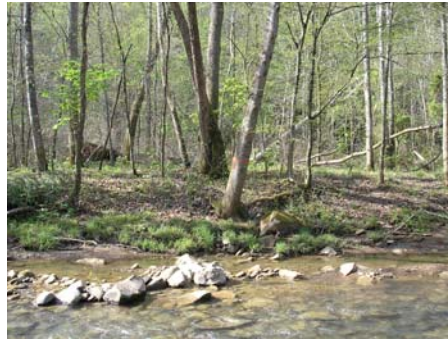
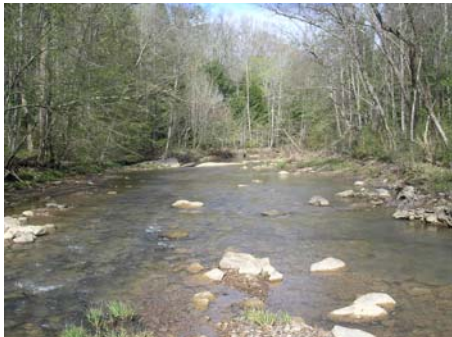
** CONTINUED -- STREAM SAMPLE SITE NO.: MFCS-9

BRIEF DISCRIPTION OF SITE: Site is a riffle located approximately 62 meters upstream of the MFCS-8. This cross-section looks to have some old structures created several years ago on the left bank.

ESTIMATED RIGHT BANK SLOPE (DEGREES): 40
ESTIMATED LEFT BANK SLOPE (DEGREES): 20
ESTIMATED RIGHT BANK HEIGHT (METERS): 1.7
ESTIMATED LEFT BANK HEIGHT (METERS): 1.7
BANKFULL HEIGHT (METERS): 1.7
ESTIMATED RIGHT BANK ROOT DEPTH (METERS): 0.8
ESTIMATED LEFT BANK ROOT DEPTH (METERS): 0.8
ESTIMATED RIGHT BANK ROOT DENSITY (%): 75
ESTIMATED LEFT BANK ROOT DENSITY (%): 100
ESTIMATED RIGHT BANK SURFACE PROTECTION (%): 100
ESTIMATED LEFT BANK SURFACE PROTECTION (%): 100

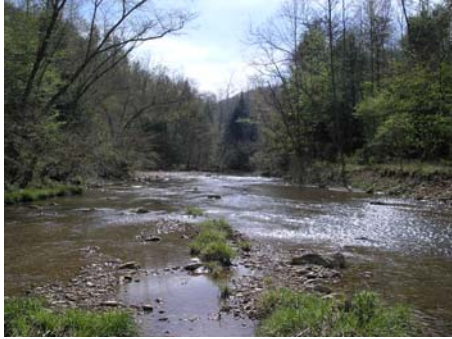
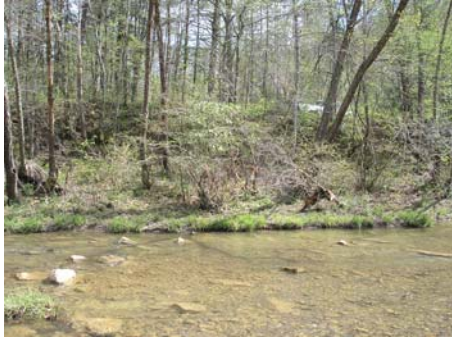
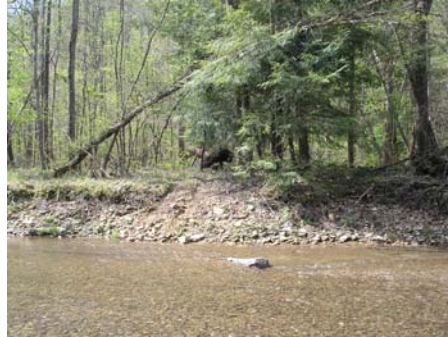
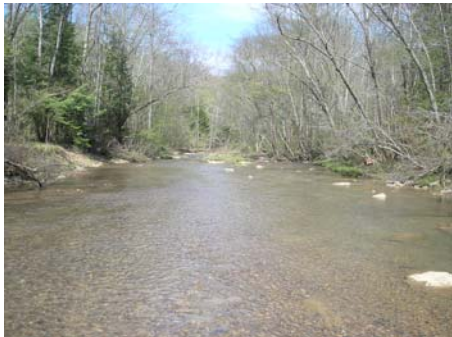
** CONTINUED -- STREAM SAMPLE SITE NO.: MFCS-10

BRIEF DISCRIPTION OF SITE: Site is a riffle located approximately 53 meters upstream of the MFCS-9. This site is also located just downstream of the Roach Creek and Montgomery Fork Junction.

ESTIMATED RIGHT BANK SLOPE (DEGREES): 80
ESTIMATED LEFT BANK SLOPE (DEGREES): 60
ESTIMATED RIGHT BANK HEIGHT (METERS): 1.6
ESTIMATED LEFT BANK HEIGHT (METERS): 5.0
BANKFULL HEIGHT (METERS): 1.6
ESTIMATED RIGHT BANK ROOT DEPTH (METERS): 1.0
ESTIMATED LEFT BANK ROOT DEPTH (METERS): 3.0
ESTIMATED RIGHT BANK ROOT DENSITY (%): 100
ESTIMATED LEFT BANK ROOT DENSITY (%): 100
ESTIMATED RIGHT BANK SURFACE PROTECTION (%): 100
ESTIMATED LEFT BANK SURFACE PROTECTION (%): 100

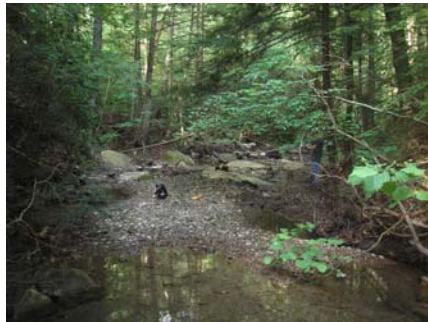
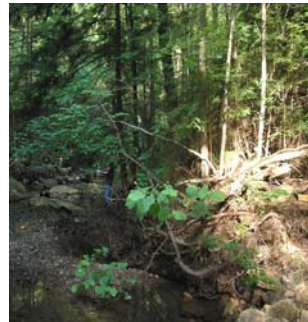
** CONTINUED -- STREAM SAMPLE SITE NO.: WC-1

ESTIMATED RIGHT BANK SLOPE (DEGREES): 60
ESTIMATED LEFT BANK SLOPE (DEGREES): 75
ESTIMATED RIGHT BANK HEIGHT (METERS): 3.0
ESTIMATED LEFT BANK HEIGHT (METERS): 5.0
BANKFULL HEIGHT (METERS): 3.0
ESTIMATED RIGHT BANK ROOT DEPTH (METERS): 2.5
ESTIMATED LEFT BANK ROOT DEPTH (METERS): 4.5
ESTIMATED RIGHT BANK ROOT DENSITY (%): 100
ESTIMATED LEFT BANK ROOT DENSITY (%): 100
ESTIMATED RIGHT BANK SURFACE PROTECTION (%): 100
ESTIMATED LEFT BANK SURFACE PROTECTION (%): 100

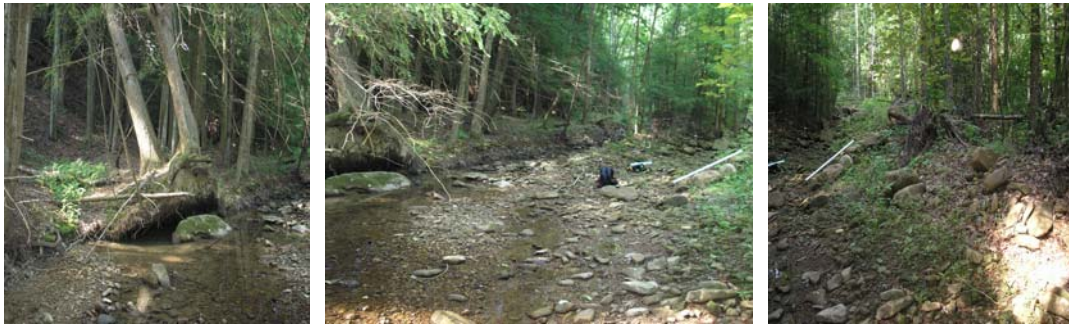
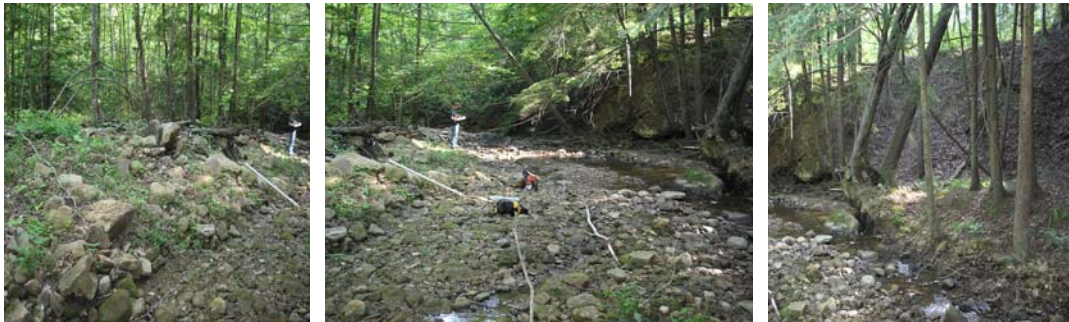
** CONTINUED -- STREAM SAMPLE SITE NO.: SB-1

BRIEF DISCRPTION OF SITE: Site is located off of a TWRA trail toward the outer portion of the watershed. This stream is one of two streams that form the Montgomery Fork.

ESTIMATED RIGHT BANK SLOPE (DEGREES): 30
ESTIMATED LEFT BANK SLOPE (DEGREES): 30
ESTIMATED RIGHT BANK HEIGHT (METERS): 2.5
ESTIMATED LEFT BANK HEIGHT (METERS): 2.5
BANKFULL HEIGHT (METERS): 2.5
ESTIMATED RIGHT BANK ROOT DEPTH (METERS): 1.0
ESTIMATED LEFT BANK ROOT DEPTH (METERS): 1.0
ESTIMATED RIGHT BANK ROOT DENSITY (%): 50
ESTIMATED LEFT BANK ROOT DENSITY (%): 100
ESTIMATED RIGHT BANK SURFACE PROTECTION (%): 100
ESTIMATED LEFT BANK SURFACE PROTECTION (%): 100

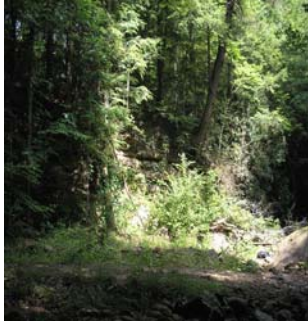
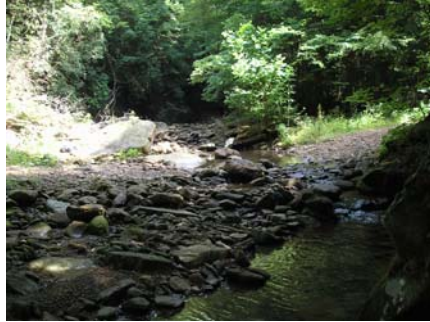
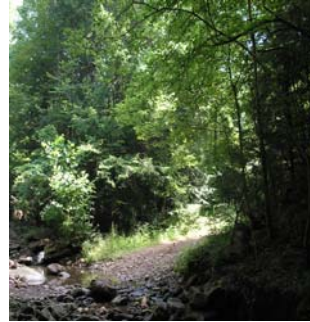
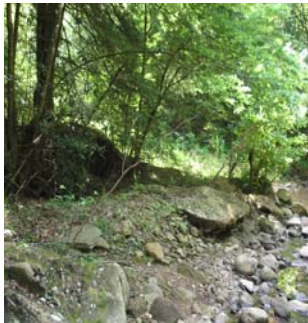
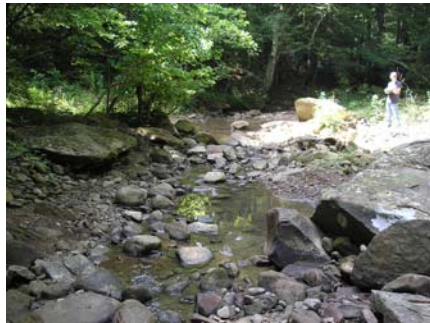
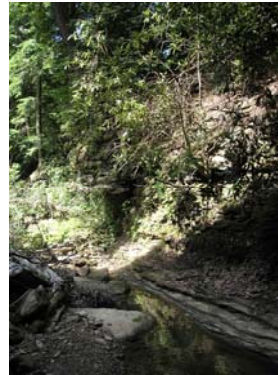
** CONTINUED -- STREAM SAMPLE SITE NO.: MKC-1

BRIEF DISCRIPTION OF SITE: Site is located off of a TWRA Trail nearing the outer portion of the Montgomery Fork Watershed. This stream is a tributary that enters into the Montgomery Fork Stream.

ESTIMATED RIGHT BANK SLOPE (DEGREES): 20
ESTIMATED LEFT BANK SLOPE (DEGREES): 90
ESTIMATED RIGHT BANK HEIGHT (METERS): 1.5
ESTIMATED LEFT BANK HEIGHT (METERS): 5.0
BANKFULL HEIGHT (METERS): 1.5
ESTIMATED RIGHT BANK ROOT DEPTH (METERS): 1.0
ESTIMATED LEFT BANK ROOT DEPTH (METERS): 1.0
ESTIMATED RIGHT BANK ROOT DENSITY (%): 100
ESTIMATED LEFT BANK ROOT DENSITY (%): 25
ESTIMATED RIGHT BANK SURFACE PROTECTION (%): 100
ESTIMATED LEFT BANK SURFACE PROTECTION (%): 100

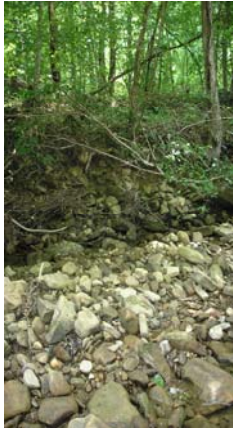
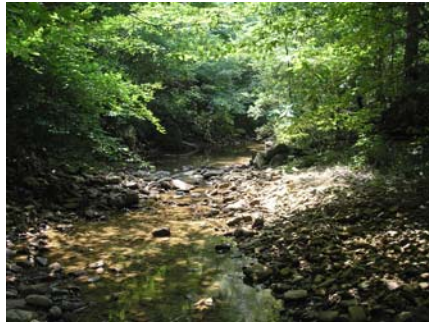
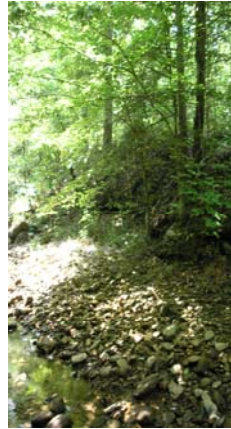
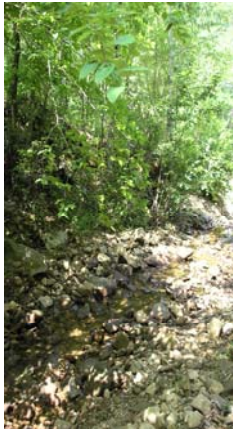
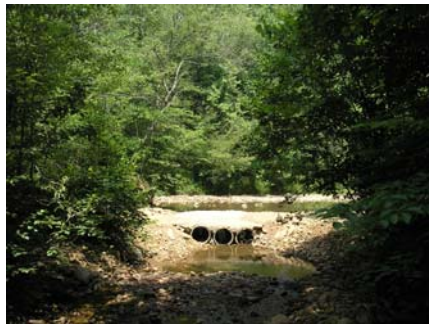
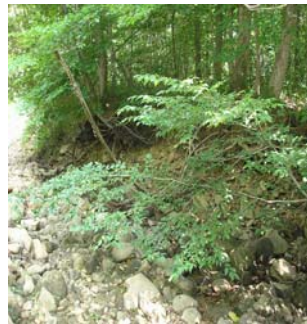
** CONTINUED -- STREAM SAMPLE SITE NO.: SF-1

BRIEF DISCRPTION OF SITE: Site is located just upstream of where Straight Fork flows into Smokey Creek. This site is located in the Sundquist Wildlife Management Area.

ESTIMATED RIGHT BANK SLOPE (DEGREES): 60
ESTIMATED LEFT BANK SLOPE (DEGREES): 60
ESTIMATED RIGHT BANK HEIGHT (METERS): 2.5
ESTIMATED LEFT BANK HEIGHT (METERS): 2.0
BANKFULL HEIGHT (METERS): 2.0
ESTIMATED RIGHT BANK ROOT DEPTH (METERS): 1.5
ESTIMATED LEFT BANK ROOT DEPTH (METERS): 1.0
ESTIMATED RIGHT BANK ROOT DENSITY (%): 100
ESTIMATED LEFT BANK ROOT DENSITY (%): 100
ESTIMATED RIGHT BANK SURFACE PROTECTION (%): 100
ESTIMATED LEFT BANK SURFACE PROTECTION (%): 100

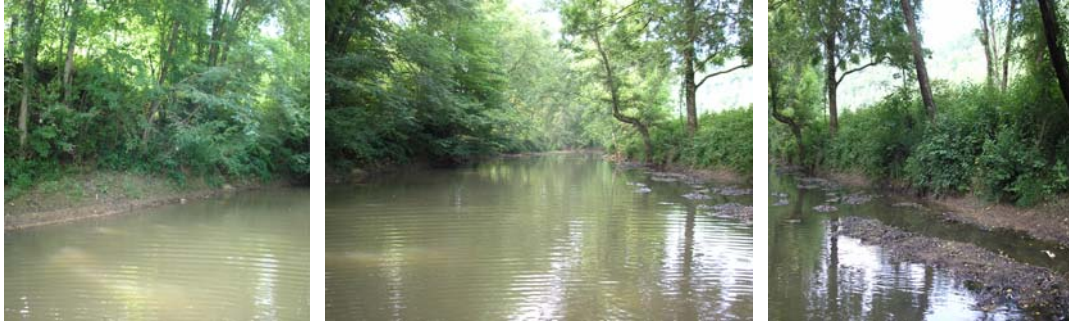
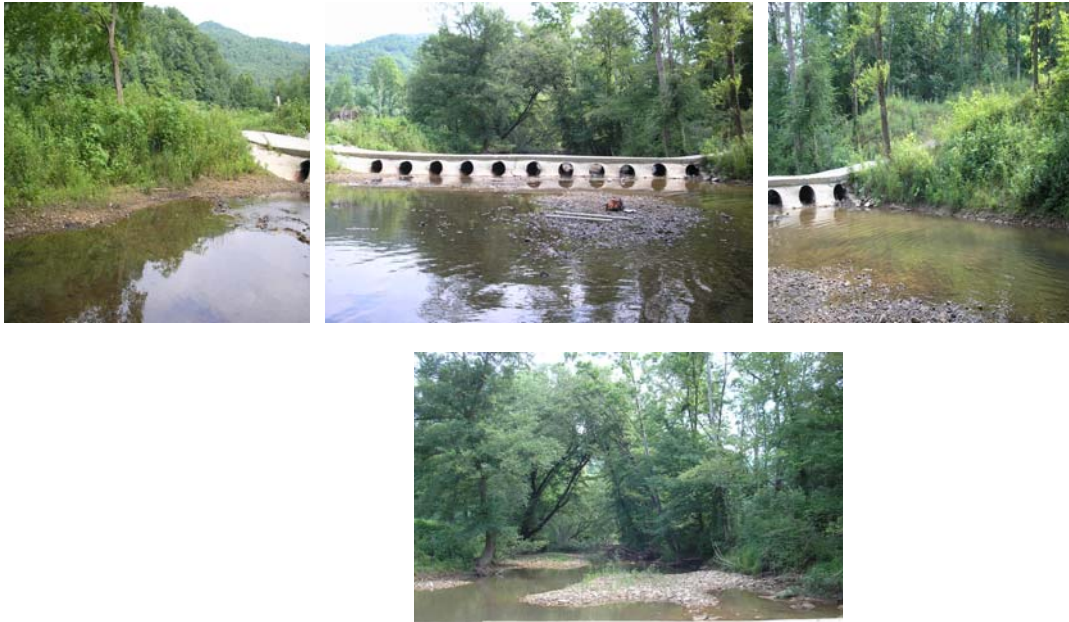
** CONTINUED -- STREAM SAMPLE SITE NO.: SC-1

BRIEF DISCRPTION OF SITE: Site is located in the Sundquist Wildlife Management Area. It is just upstream of a culvert bridge in the stream.

ESTIMATED RIGHT BANK SLOPE (DEGREES): 75
ESTIMATED LEFT BANK SLOPE (DEGREES): 75
ESTIMATED RIGHT BANK HEIGHT (METERS): 6.0
ESTIMATED LEFT BANK HEIGHT (METERS): 6.0
BANKFULL HEIGHT (METERS): 6.0
ESTIMATED RIGHT BANK ROOT DEPTH (METERS): 5.0
ESTIMATED LEFT BANK ROOT DEPTH (METERS): 5.0
ESTIMATED RIGHT BANK ROOT DENSITY (%): 100
ESTIMATED LEFT BANK ROOT DENSITY (%): 100
ESTIMATED RIGHT BANK SURFACE PROTECTION (%): 100
ESTIMATED LEFT BANK SURFACE PROTECTION (%): 100

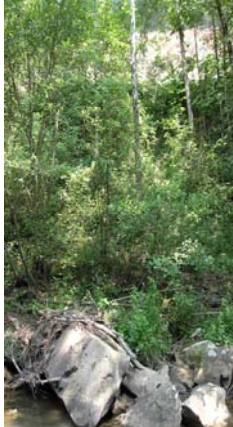
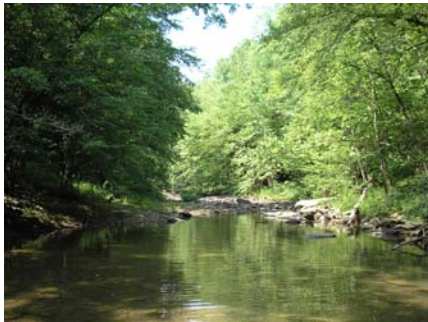
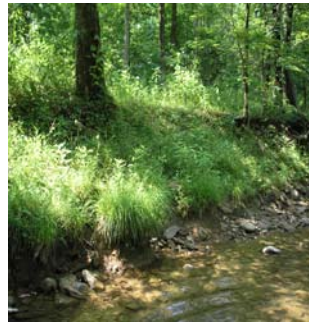
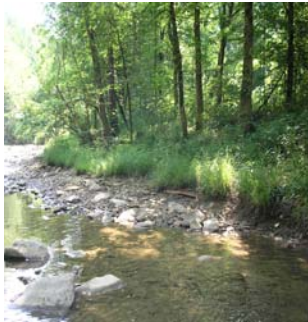
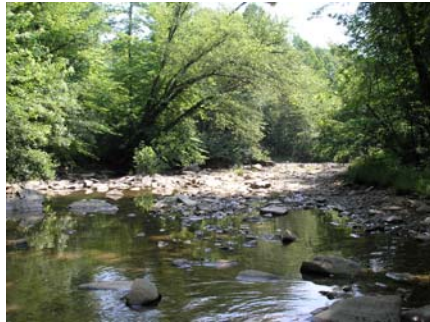
** CONTINUED -- STREAM SAMPLE SITE NO.: SC-2

BRIEF DISCRPTION OF SITE: Site is located downstream of SC-1 and is beside the Smokey Creek Road.

ESTIMATED RIGHT BANK SLOPE (DEGREES): 75
ESTIMATED LEFT BANK SLOPE (DEGREES): 60
ESTIMATED RIGHT BANK HEIGHT (METERS): 10
ESTIMATED LEFT BANK HEIGHT (METERS): 3.5
BANKFULL HEIGHT (METERS): 3.5
ESTIMATED RIGHT BANK ROOT DEPTH (METERS): 9.0
ESTIMATED LEFT BANK ROOT DEPTH (METERS): 2.5
ESTIMATED RIGHT BANK ROOT DENSITY (%): 100
ESTIMATED LEFT BANK ROOT DENSITY (%): 100
ESTIMATED RIGHT BANK SURFACE PROTECTION (%): 100
ESTIMATED LEFT BANK SURFACE PROTECTION (%): 100

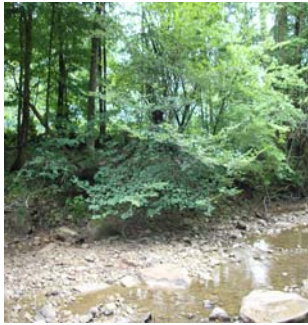
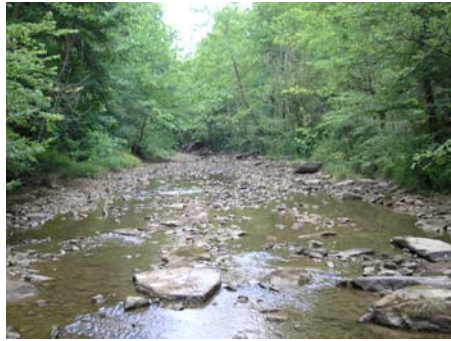
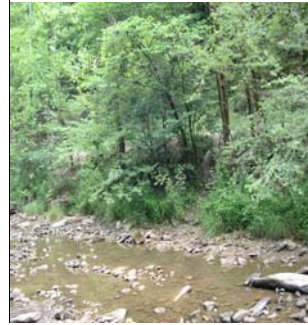
BRIEF DISCRPTION OF SITE: Site is located parallel to the Smokey Creek Road. Site is upstream of a driveway crossing and downstream of the first bridge that crosses over Smokey Creek.

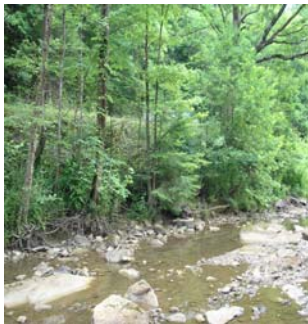
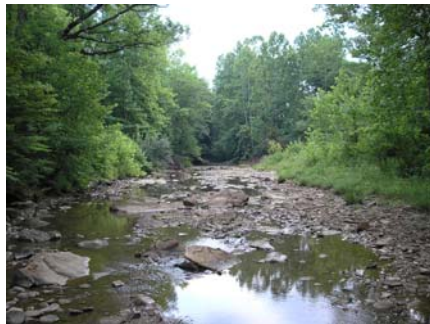
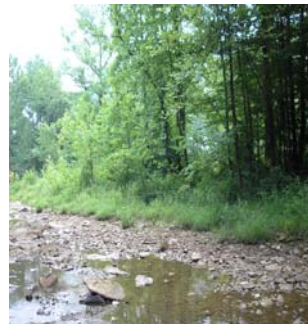
DOWNSTREAM PHOTO:

ESTIMATED RIGHT BANK SLOPE (DEGREES): 75
ESTIMATED LEFT BANK SLOPE (DEGREES): 60
ESTIMATED RIGHT BANK HEIGHT (METERS): 5.5
ESTIMATED LEFT BANK HEIGHT (METERS): 2.0
BANKFULL HEIGHT (METERS): 2.0
ESTIMATED RIGHT BANK ROOT DEPTH (METERS): 3.5
ESTIMATED LEFT BANK ROOT DEPTH (METERS): 1.5
ESTIMATED RIGHT BANK ROOT DENSITY (%): 50
ESTIMATED LEFT BANK ROOT DENSITY (%): 100
ESTIMATED RIGHT BANK SURFACE PROTECTION (%): 100
ESTIMATED LEFT BANK SURFACE PROTECTION (%): 100

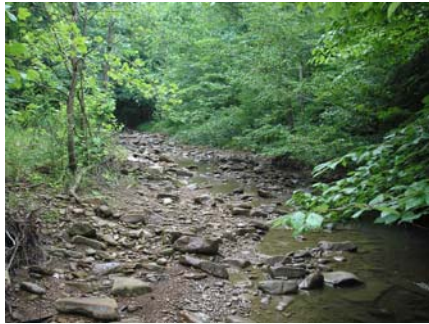
UPSTREAM PHOTO:

BRIEF DIScription OF SITE: Site is located upstream of TWRA Trail in the Sundquist Wildlife Management Area.

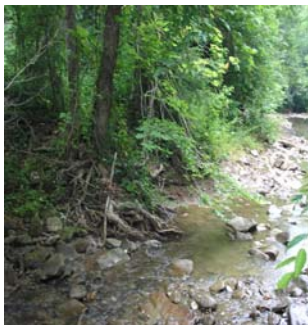
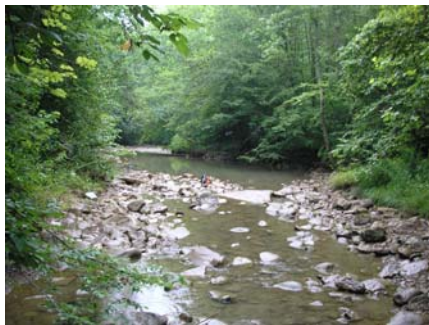
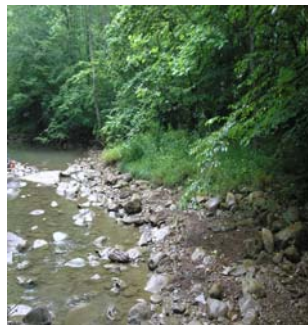
DOWNSTREAM PHOTO:

ESTIMATED RIGHT BANK SLOPE (DEGREES): 60
ESTIMATED LEFT BANK SLOPE (DEGREES): 60
ESTIMATED RIGHT BANK HEIGHT (METERS): 2.0
ESTIMATED LEFT BANK HEIGHT (METERS): 0.75
BANKFULL HEIGHT (METERS): 0.75
ESTIMATED RIGHT BANK ROOT DEPTH (METERS): 1.5
ESTIMATED LEFT BANK ROOT DEPTH (METERS): 0.5
ESTIMATED RIGHT BANK ROOT DENSITY (%): 100
ESTIMATED LEFT BANK ROOT DENSITY (%): 50
ESTIMATED RIGHT BANK SURFACE PROTECTION (%): 100
ESTIMATED LEFT BANK SURFACE PROTECTION (%): 100
