Development of a Rapid Geomorphic Assessment Technique to Support the CHIA/PHC Process: A Focus on Model Improvement for Estimating Sediment Loads

**USDoI Office of Surface Mining
Applied Science Program
Contract # CT612054**

University of Tennessee - Knoxville
Department of Civil and Environmental Engineering

May 30, 2008

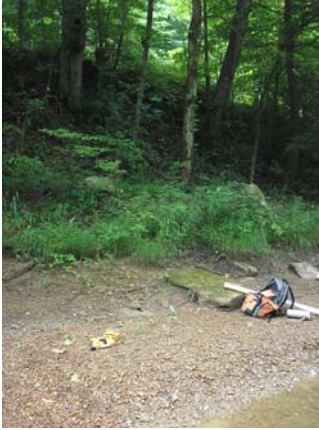
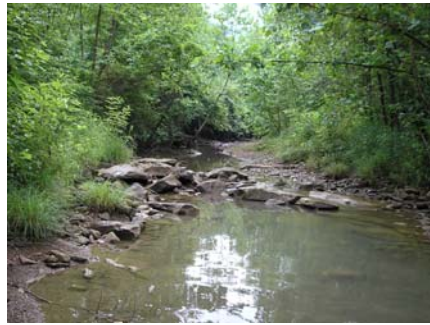
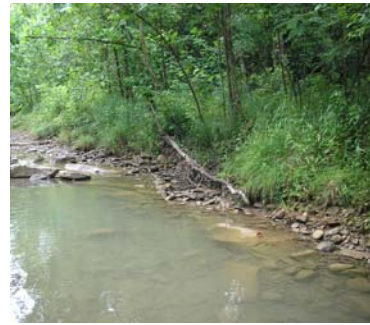
UPSTREAM PHOTO:

BRIEF DISCRPTION OF SITE: Site is located upstream of a driveway bridge and parallel to the Smokey Creek Road.

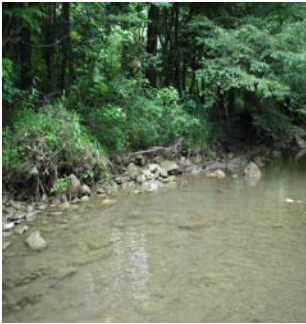
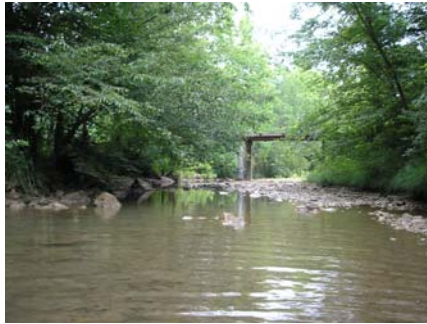
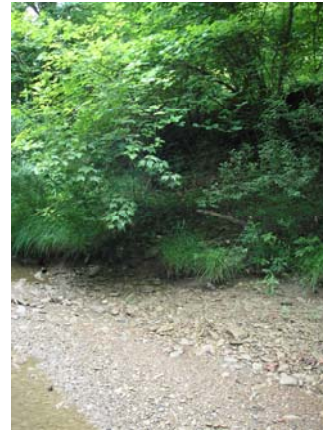
DOWNSTREAM PHOTO:

ESTIMATED RIGHT BANK SLOPE (DEGREES): 75
ESTIMATED LEFT BANK SLOPE (DEGREES): 75
ESTIMATED RIGHT BANK HEIGHT (METERS): 2.0
ESTIMATED LEFT BANK HEIGHT (METERS): 1.25
BANKFULL HEIGHT (METERS): 1.25
ESTIMATED RIGHT BANK ROOT DEPTH (METERS): 1.75
ESTIMATED LEFT BANK ROOT DEPTH (METERS): 1.00
ESTIMATED RIGHT BANK ROOT DENSITY (%): 100
ESTIMATED LEFT BANK ROOT DENSITY (%): 75
ESTIMATED RIGHT BANK SURFACE PROTECTION (%): 100
ESTIMATED LEFT BANK SURFACE PROTECTION (%): 100

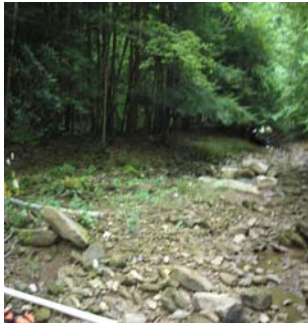
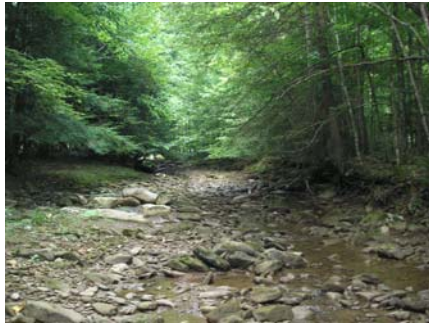
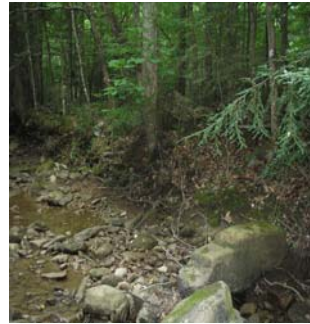
UPSTREAM PHOTO:

BRIEF DISCRIPTION OF SITE: Site is located downstream of a gravel road trail and just upstream of the Dry Creek/Shack Creek Junction.

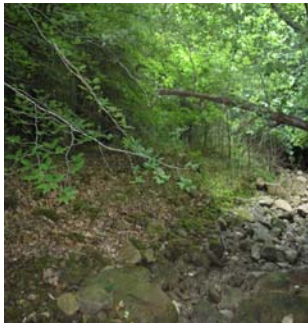
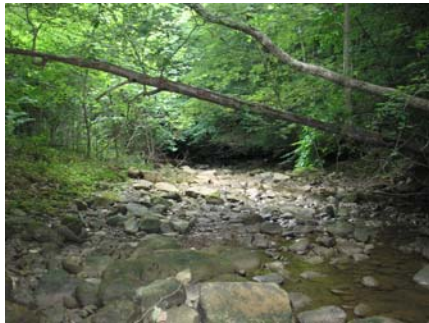
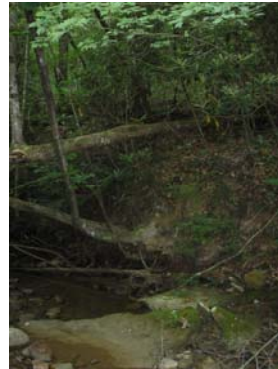
DOWNSTREAM PHOTO:

ESTIMATED RIGHT BANK SLOPE (DEGREES): 45
ESTIMATED LEFT BANK SLOPE (DEGREES): 60
ESTIMATED RIGHT BANK HEIGHT (METERS): 1.5
ESTIMATED LEFT BANK HEIGHT (METERS): 5.0
BANKFULL HEIGHT (METERS): 1.5
ESTIMATED RIGHT BANK ROOT DEPTH (METERS): 1.0
ESTIMATED LEFT BANK ROOT DEPTH (METERS): 4.0
ESTIMATED RIGHT BANK ROOT DENSITY (%): 100
ESTIMATED LEFT BANK ROOT DENSITY (%): 100
ESTIMATED RIGHT BANK SURFACE PROTECTION (%): 90
ESTIMATED LEFT BANK SURFACE PROTECTION (%): 65

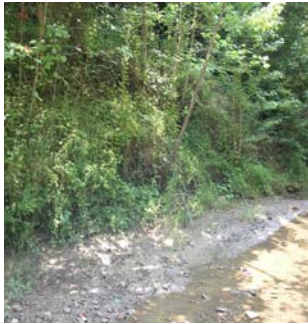
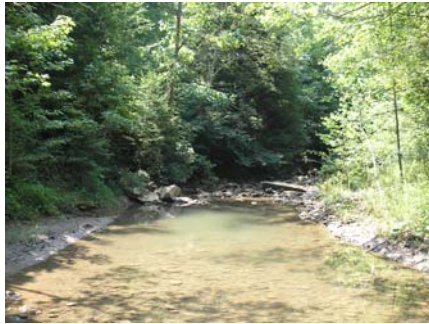
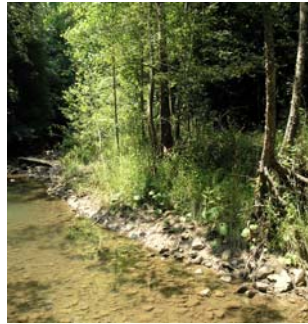
UPSTREAM PHOTO:

BRIEF DISCRIPTION OF SITE: Site is located at the very back of the Smokey Creek Watershed and at the end of the Smokey Creek Road.

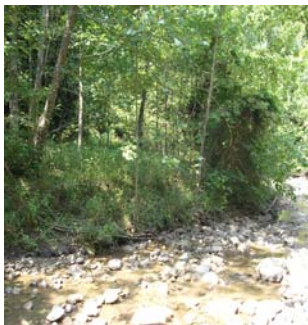
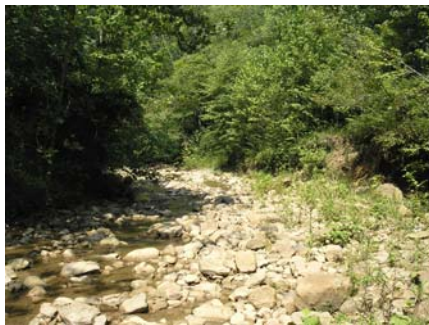
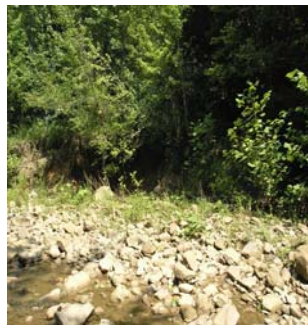
DOWNSTREAM PHOTO:

ESTIMATED RIGHT BANK SLOPE (DEGREES): 90
ESTIMATED LEFT BANK SLOPE (DEGREES): 70
ESTIMATED RIGHT BANK HEIGHT (METERS): 1.75
ESTIMATED LEFT BANK HEIGHT (METERS): 3.75
BANKFULL HEIGHT (METERS): 1.75
ESTIMATED RIGHT BANK ROOT DEPTH (METERS): 1.65
ESTIMATED LEFT BANK ROOT DEPTH (METERS): 3.50
ESTIMATED RIGHT BANK ROOT DENSITY (%): 100
ESTIMATED LEFT BANK ROOT DENSITY (%): 100
ESTIMATED RIGHT BANK SURFACE PROTECTION (%): 100
ESTIMATED LEFT BANK SURFACE PROTECTION (%): 100

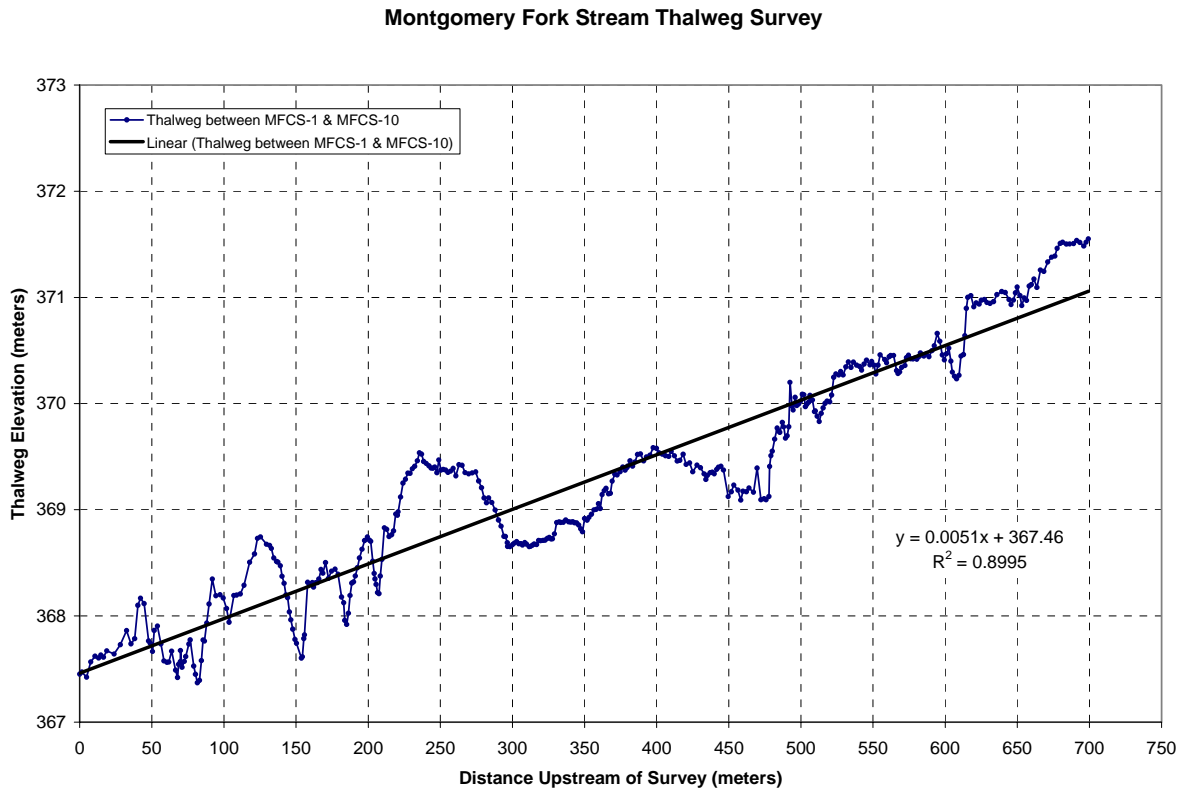
The figure found below represents the average slope of the Montgomery Fork channel simulated in the CONCEPTS model. The values plotted are the thalweg values measured from MFCS-1 (most downstream) point to MFCS-10 (the most upstream Montgomery Fork cross-section measured).
