**Field Investigation of Best Practices for Steep-Slope Mine Reclamation Employing the  
Forestry Reclamation Approach**

**Final Report**

June, 2011

University of Kentucky  
Department of Mining Engineering  
859-257-8827 (Phone)  
859-257-5727 (Fax)  
Lexington, KY 40506-0107, USA

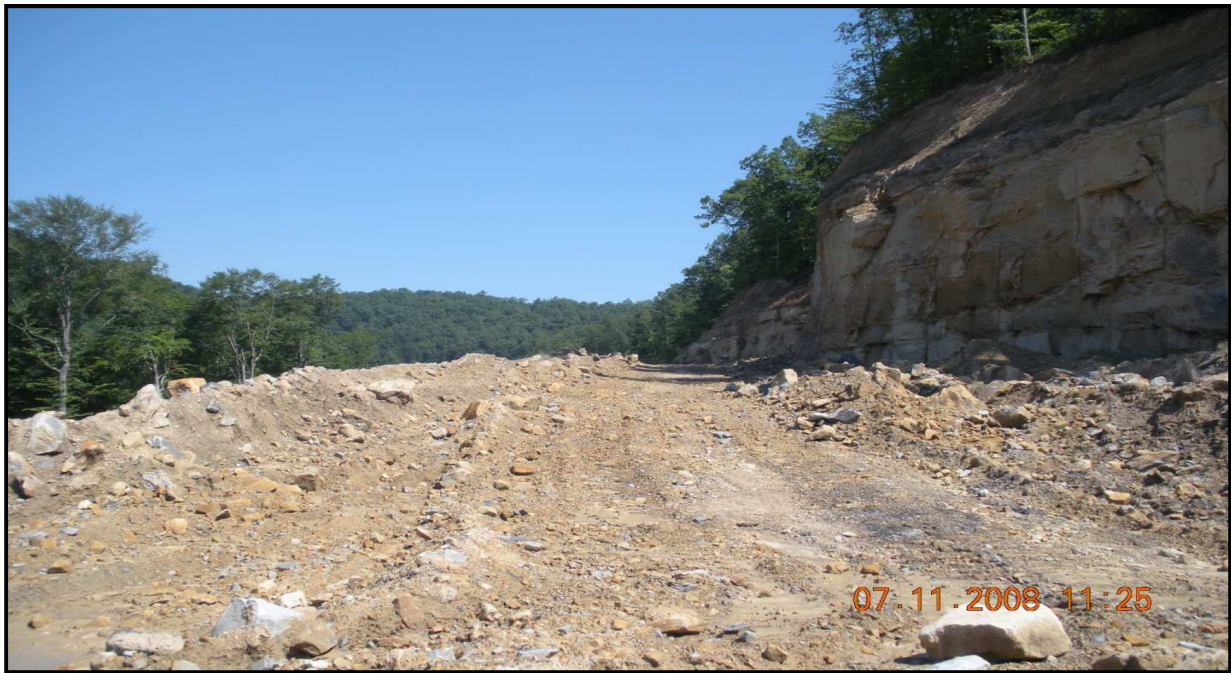
Figure 3.2: Contour haulback with horizontal lifts

prohibit downslope placement of spoil and require that the final highwall be completely eliminated. In this method, a ramp is made up to the top of the highwall and spoil material is hauled up the ramp and dumped over the edge. Then, the materials is graded with the help of dozers. In some cases, the overburden is hauled over the contour bench and then dumped into fairly horizontal lifts. In this case, each lift can be compacted, if needed as shown in Figure 3.2.

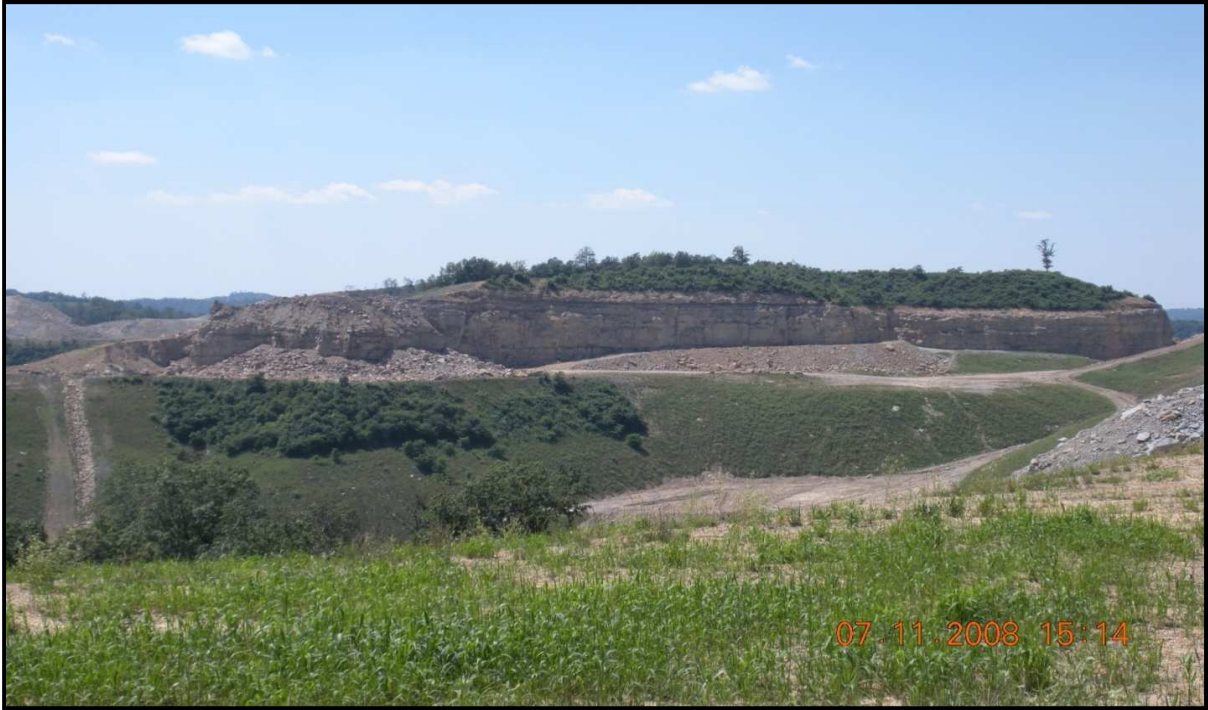
Figure 3.3: Exposed highwall (Copley Fork Surface Mine, Near Logan, WV)

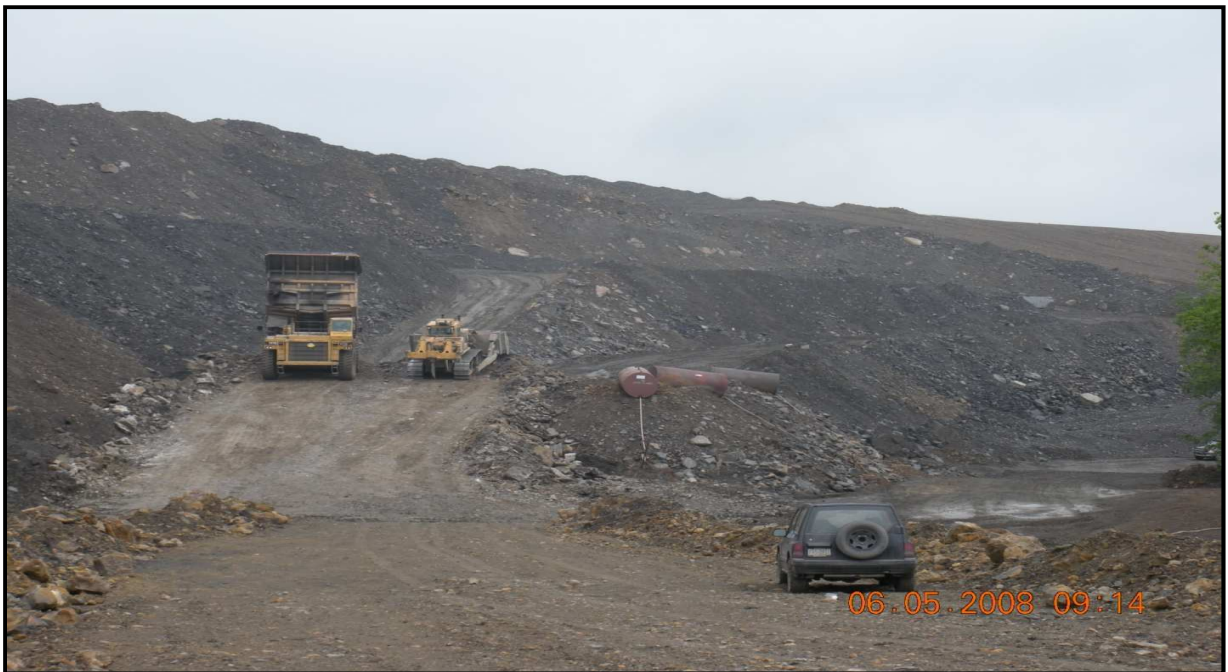
Figure 3.4: Active highwall elimination process using haulback at Brink Mine (B&M Energy), Pennsylvania

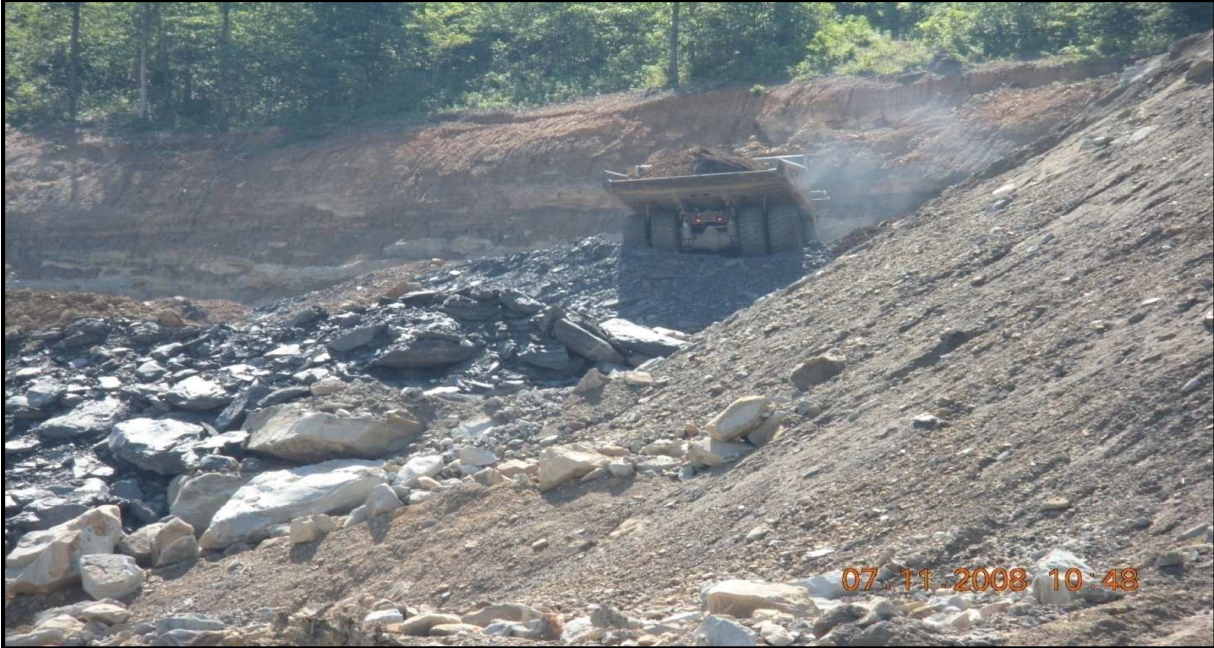
Figure 3.5: Active haulback process (North & South Surface Mine, Logan County, WV)

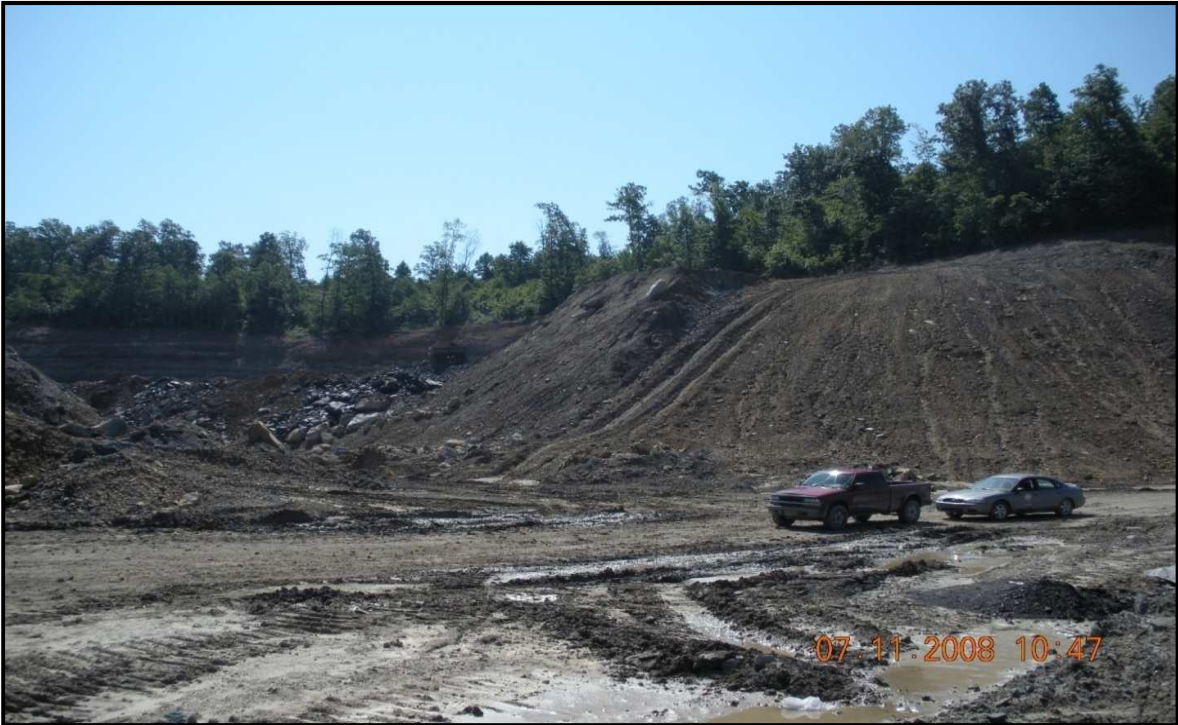
Figure 3.6: Final graded highwall (North and South Surface Mine Logan County, WV)

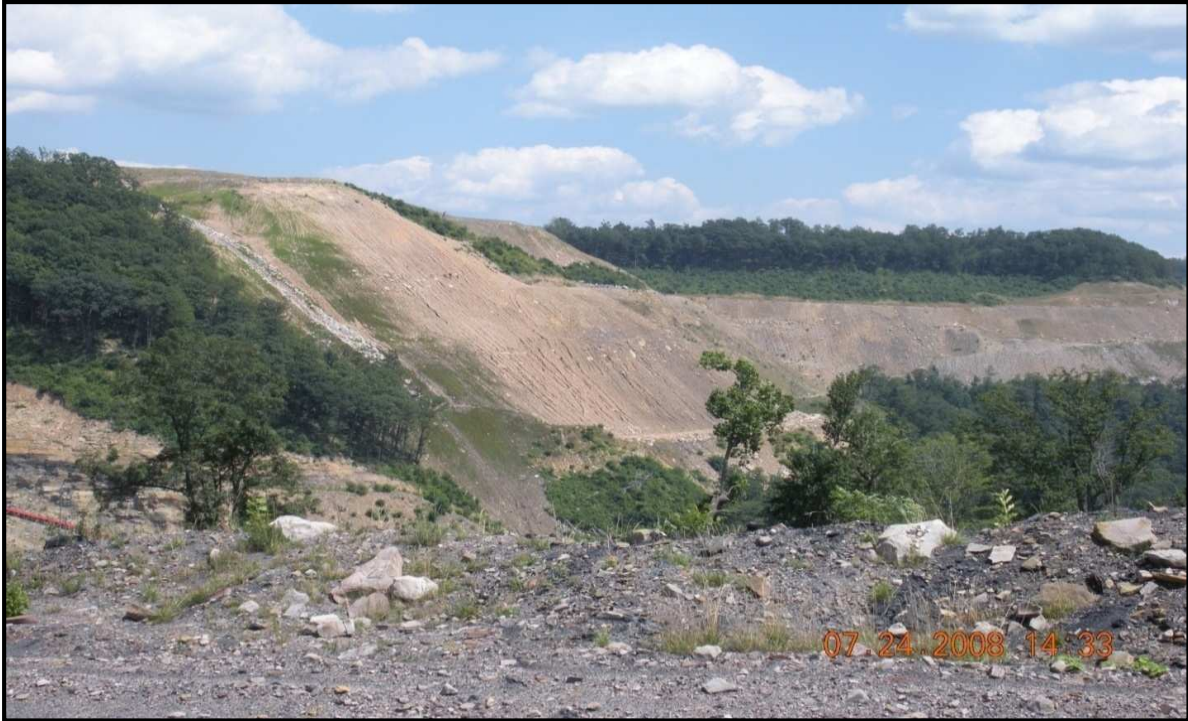
Figure 3.7: Reclaimed steep-slope highwall (Right Fork and Hardway Branch, near Drennan, WV)

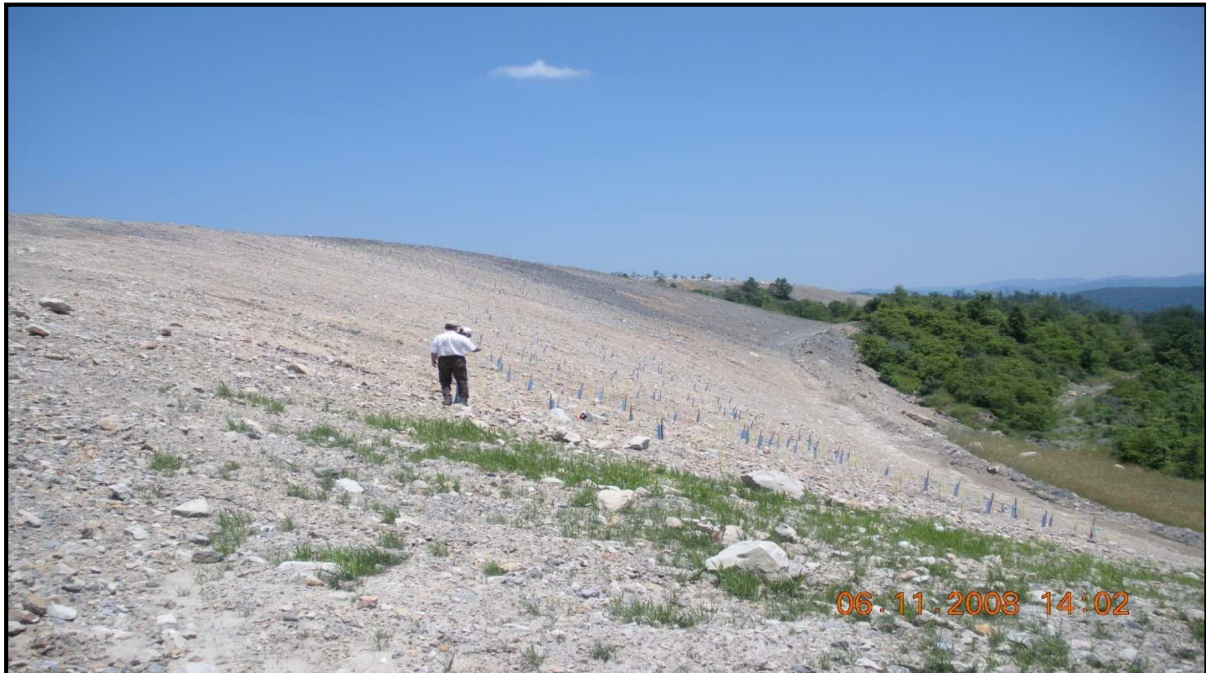
Figure 3.9: Recently planted reclaimed highwall (King Mountain Surface Mine, near Jellico, TN)

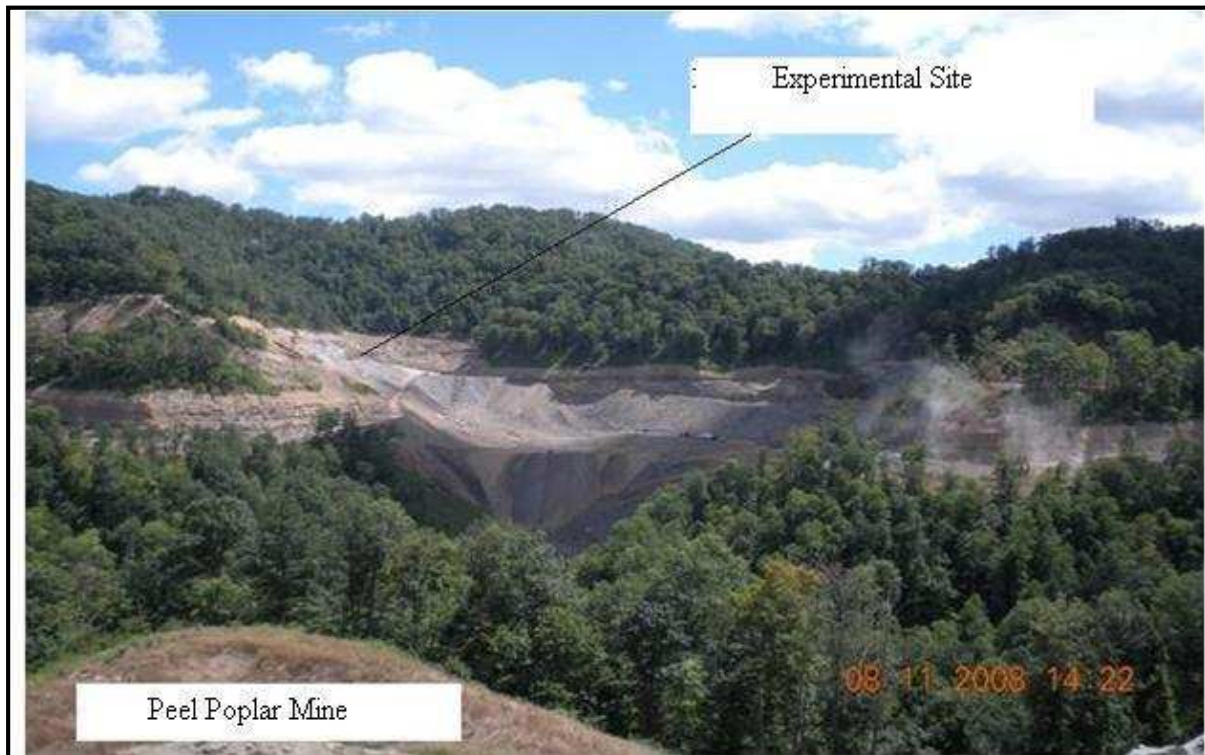
Figure 3.12: Experimental site at the Peel Poplar Mine (before highwall elimination)

The coal seams are mined using the contour haulback mining method. The mining is done using a combination of hydraulic excavators, front end loaders, trucks, and dozers. The detailed highwall elimination process is discussed in the next section. Figure 3.12 shows the experimental site, before the highwall was eliminated.

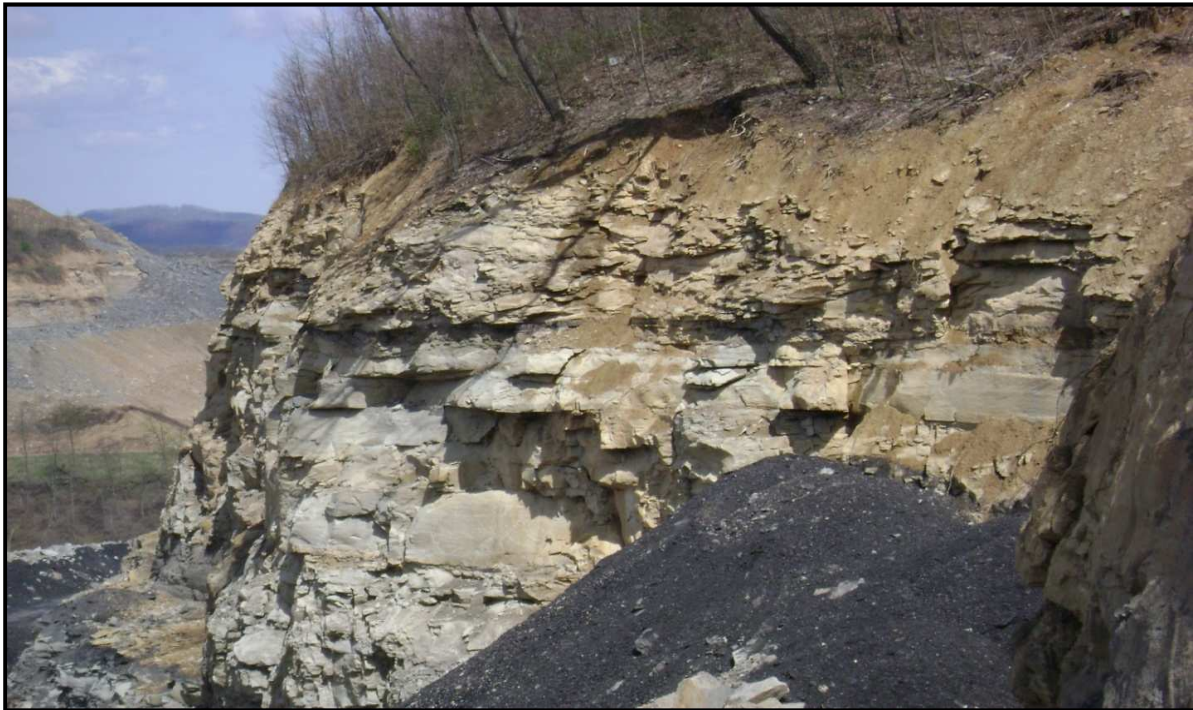
Figure 3.13: Exposed highwall at ICG Peel Poplar Mine (Pike County, Kentucky)

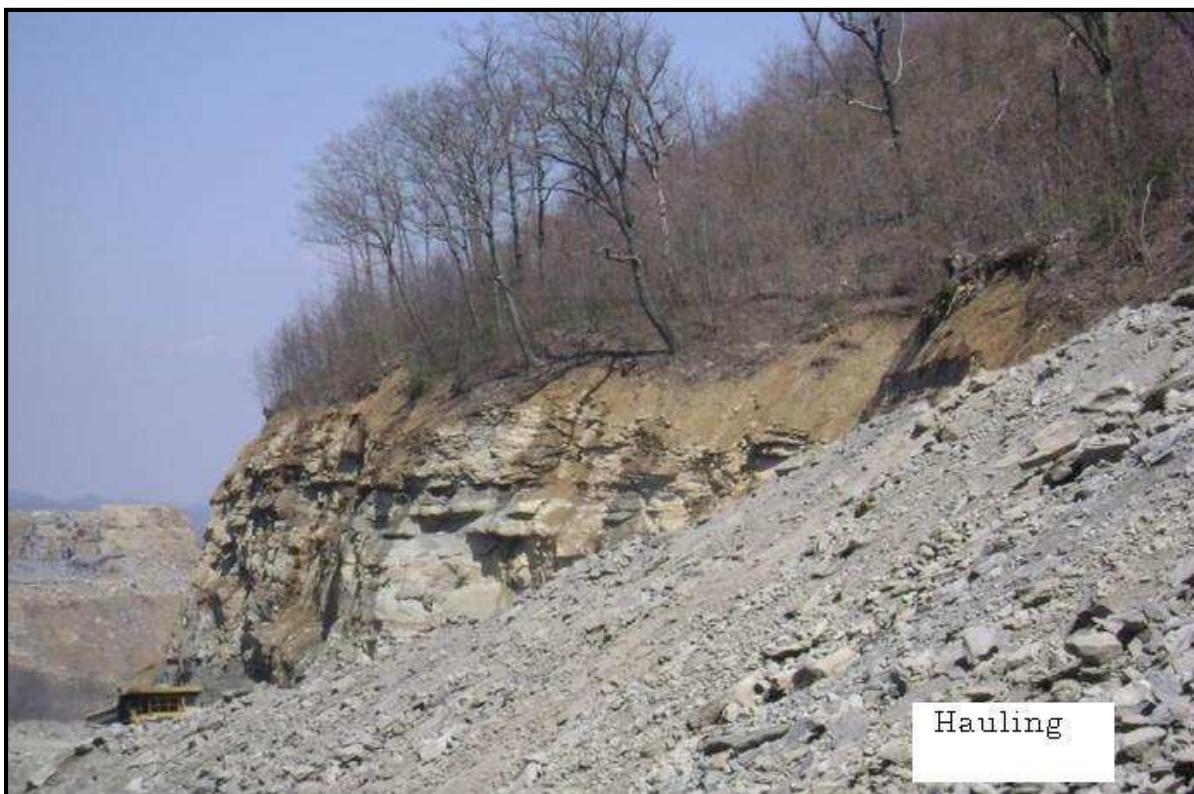
Figure 3.14: Hauling of spoil material

The first step of the process was to load the trucks using the 992D loader and then haul the spoil up the ramp along contour. Figure 3.14 and 3.15 shows the hauling and dumping activities.

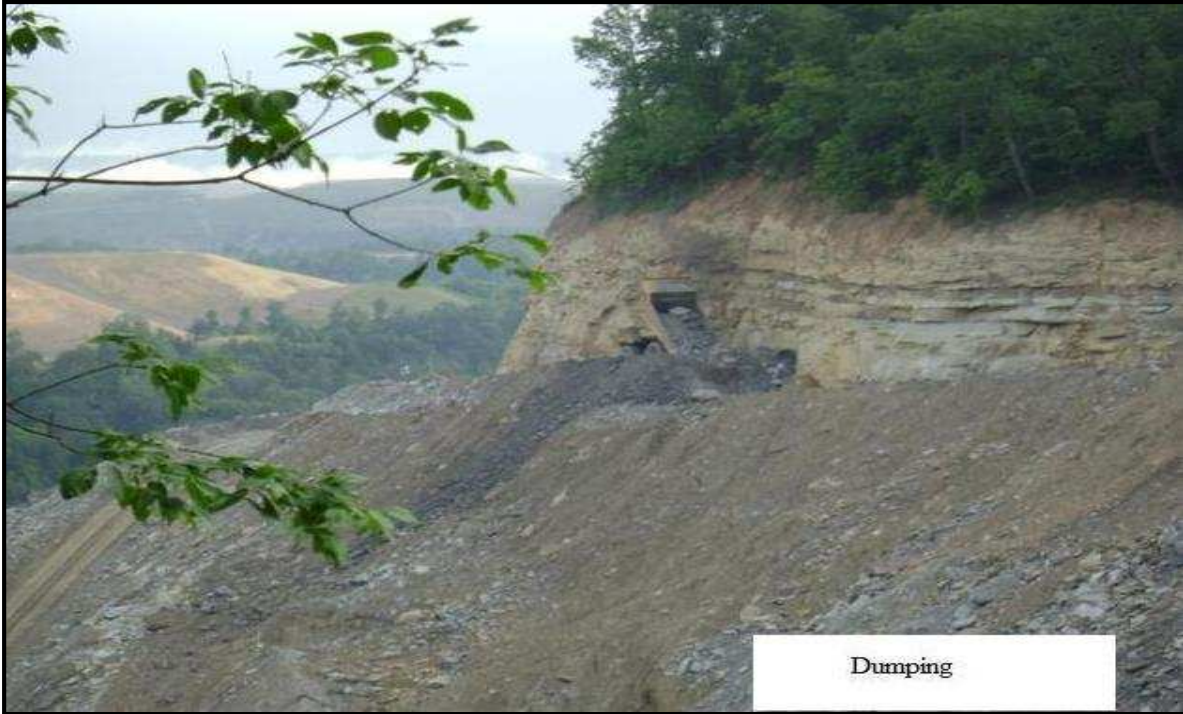
Figure 3.15: Dumping of spoil material

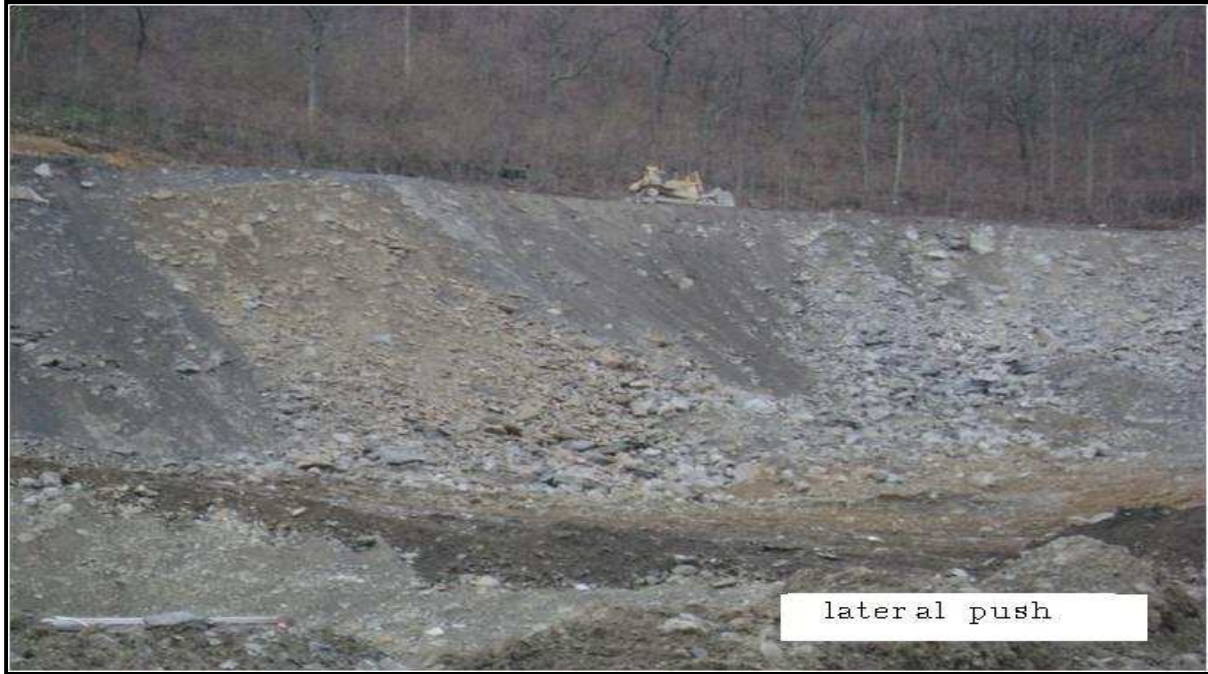
Figure 3.16: Lateral pushing of spoil material

Next, the dumped material was pushed in horizontal passes by the CAT D-11R dozer. Figure 3.16 shows the lateral pushing of spoil.

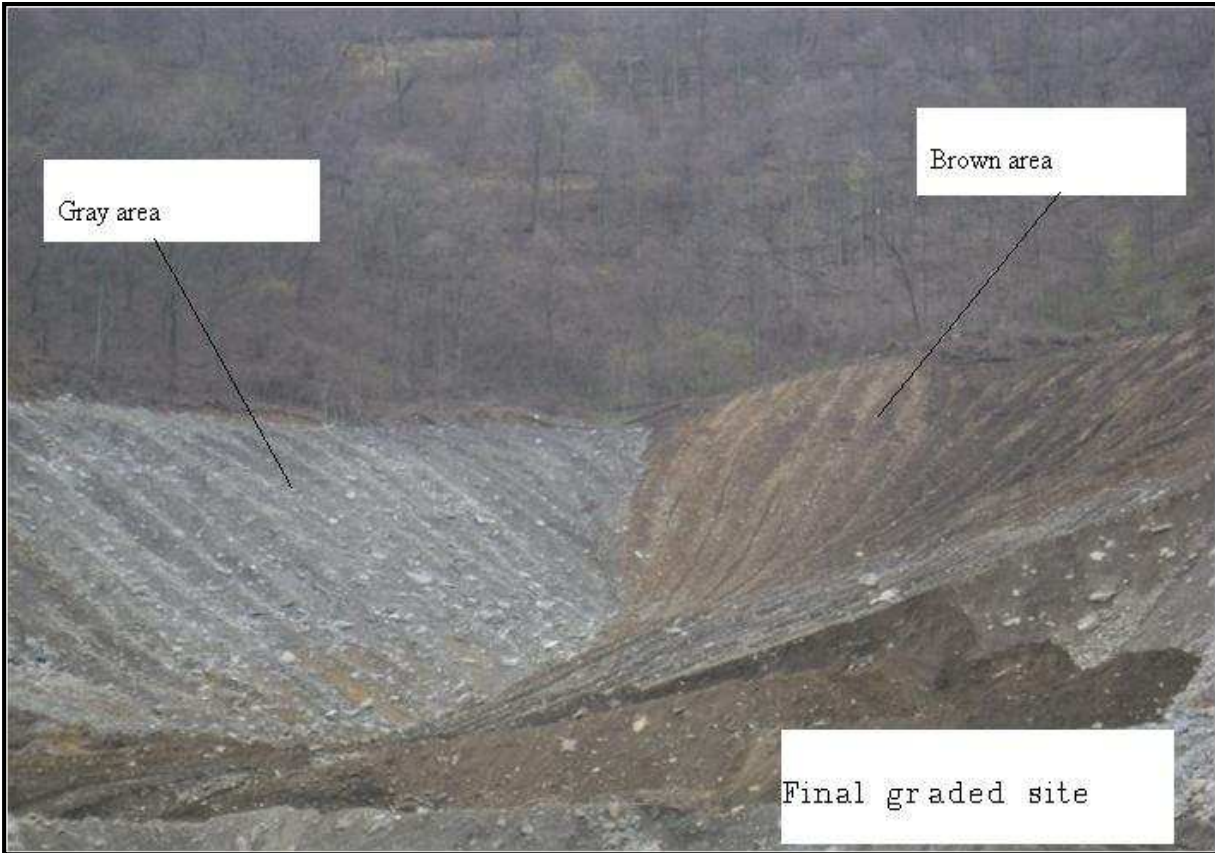
Figure 3.17: Experimental site after final grading

The last step was grading of the slope from top to bottom using the D11R dozer in a single pass following FRA recommendations (Sweigard et al., 2007). The grading was done moving downslope as suggested in Forestry Reclamation Advisory #3. It was done by leaving small ridges of rocks on the surface between passes. After final grading, the area of approximately 1.9 hectare (4.7 acres) was naturally divided into two parts (Figure 3.17) based on spoil material. One part consists almost entirely of gray sandstone mixed with some shale. The other part was a mixture of sandstone, shale, and some topsoil dozed down from above the highwall (giving the material its brown color). The gray spoil accounts for around 40% of total area and the brown spoil accounts for the remaining portion.

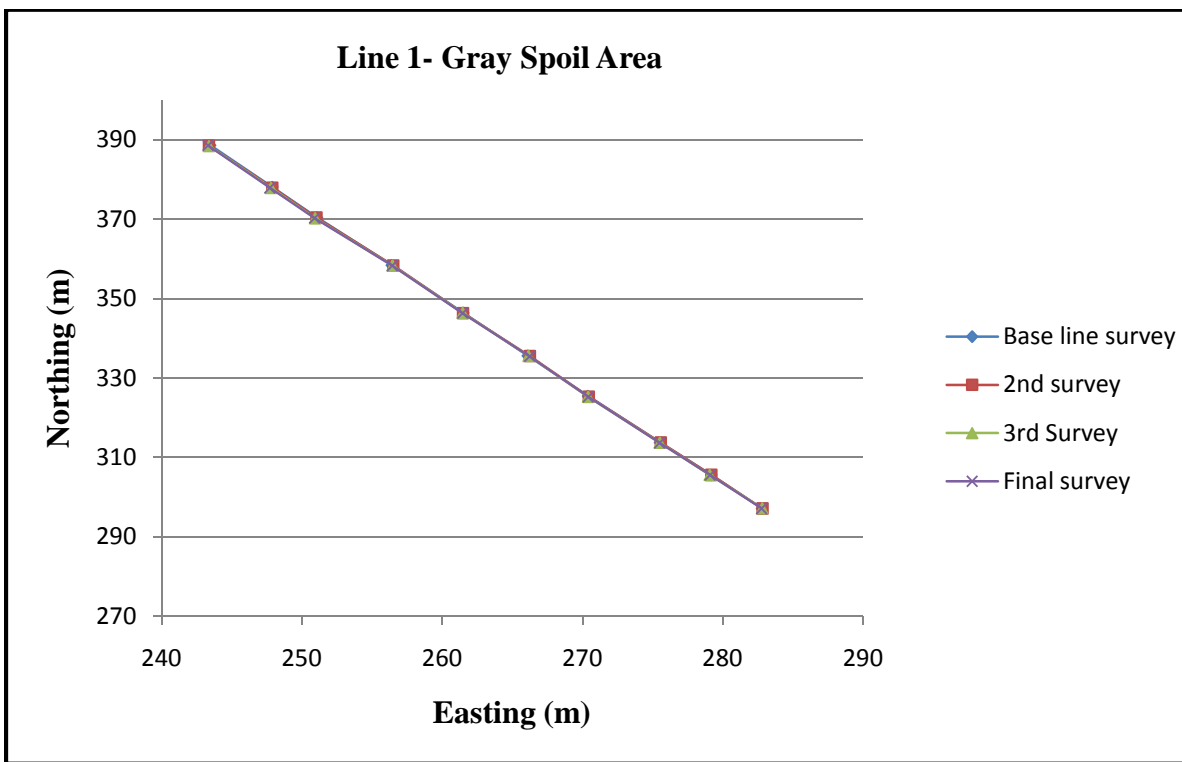
Figure 3.21: Plot to measure mass movement down the slope

survey, plots to measure horizontal and vertical movement were drawn and compared with previous survey plots. Figure 3.21 shows the plot of easting versus northing of all the monuments in line-1 and Figure 3.22 shows the plot of elevation at the top of the monuments. Plots of eastings versus northings are used to measure any horizontal movement along the slope. Plots of elevations are used to measure any type of settlement or vertical movement of the monuments.

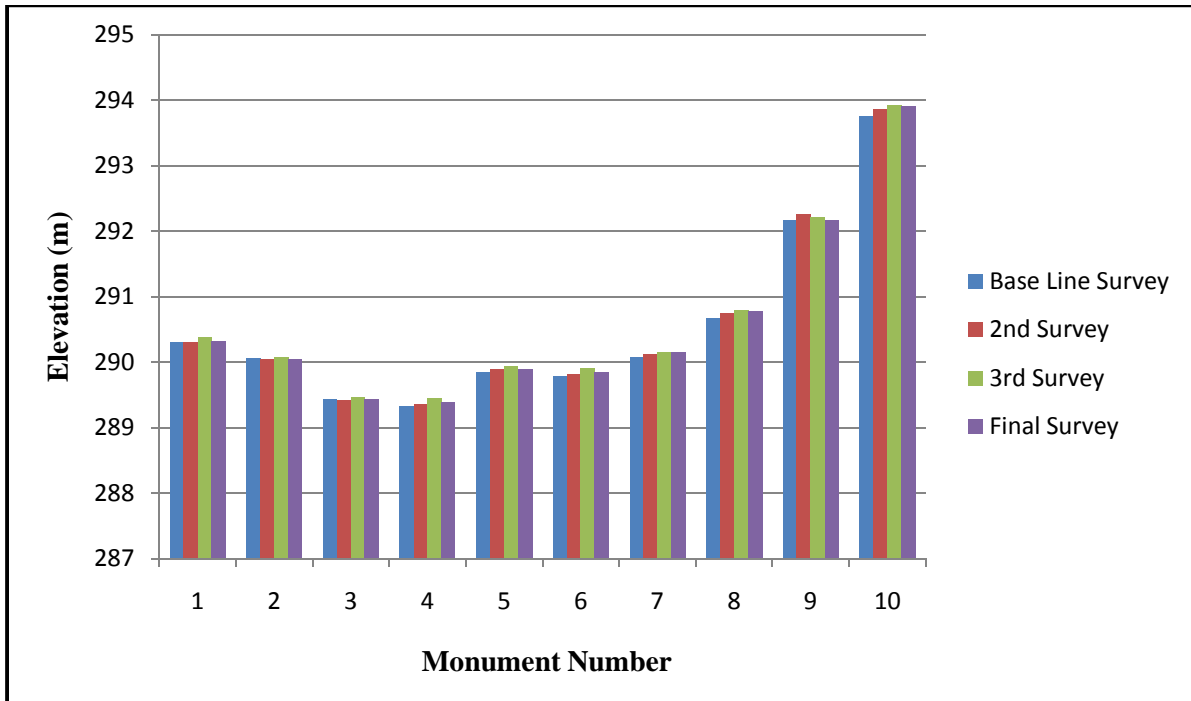
Figure 3.22: Plot to measure vertical settlement or heaving of the monuments (Line 1 –Gray spoil area)

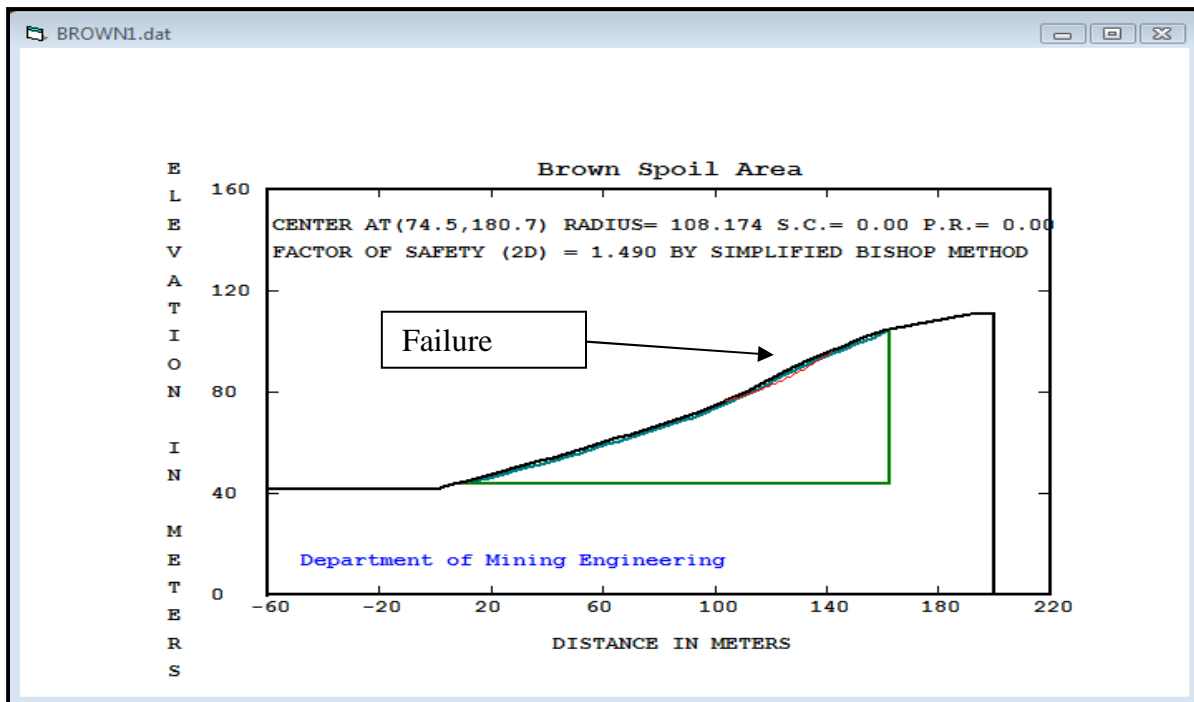
Figure 3.26: REAME model for the brown area (with loose top 1.22 m of material) and minimum depth of tallest slice

Three models were developed using the REAME program for the brown spoil area. First, without fixing the depth of the tallest circle, the top 1.22 m (4 ft.) was considered loose material. In this case a factor of safety of 1.287 was found and the very shallow failure circle is touching the upper part of the slope as shown in Figure 3.25. Secondly, the model was run by fixing the depth of the tallest slice at 3 m (9.8 ft.) and it resulted in safety factor of 1.490. The failure circle is touching the spoil materials below the top 1.22 m (4 ft.) of the loose material, as shown in Figure 3.26. Finally, the model was run without consideration for loose top material and this resulted in a safety factor of 1.507. The failure circle is passing through the upper part of the slope as shown in Figure 3.27. The contours of safety factors for the REAME models are shown in appendix C.

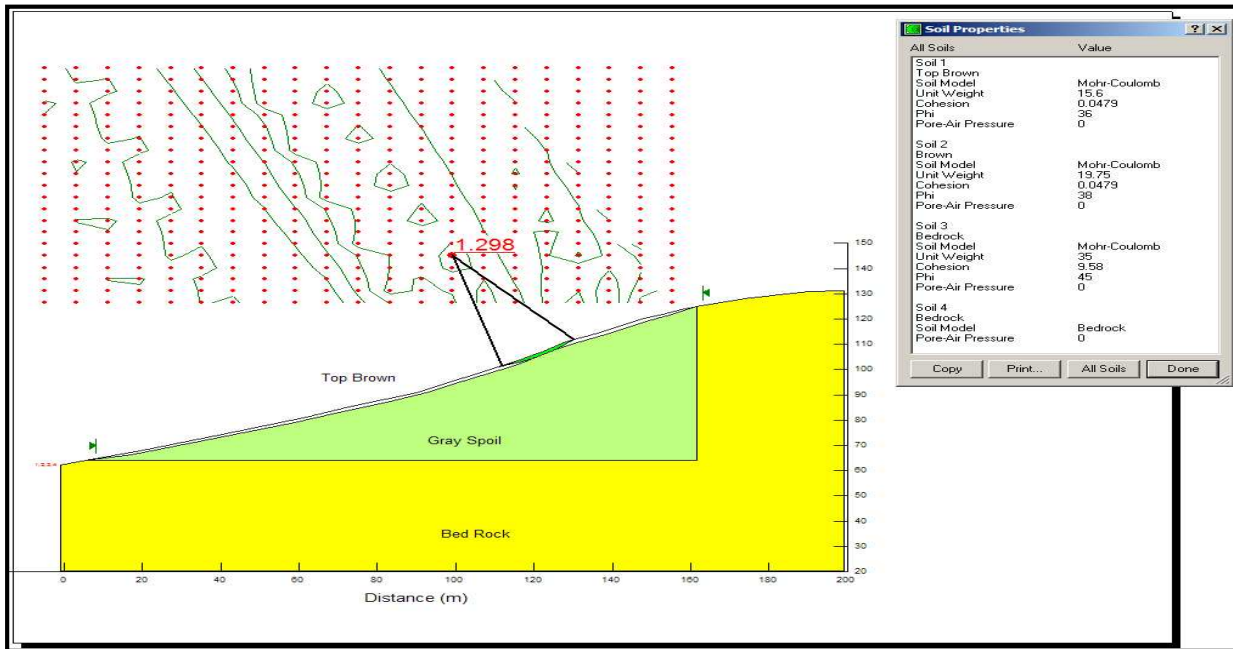
Figure 3.28: Geo-Slope model for the brown area (with loose top 1.22 m of material)

Similar to the REAME models, three models were developed using the Geo-Slope (W) program. Initially, considering the top 1.22 m (4 ft.) of loose material, a factor of safety of 1.298 was found and the failure circle is touching the upper part of the slope as shown in Figure 3.28. Secondly, considering a slightly deeper circle touching the lower part of the top 1.22 m (4 ft.) of loose material resulted in a safety factor of 1.50, as shown in Figure 3.29. Finally, the model was run without consideration of the loose material and resulted in a safety factor of 1.393. The failure circle is passing through the upper part of the slope as shown in Figure 3.30.

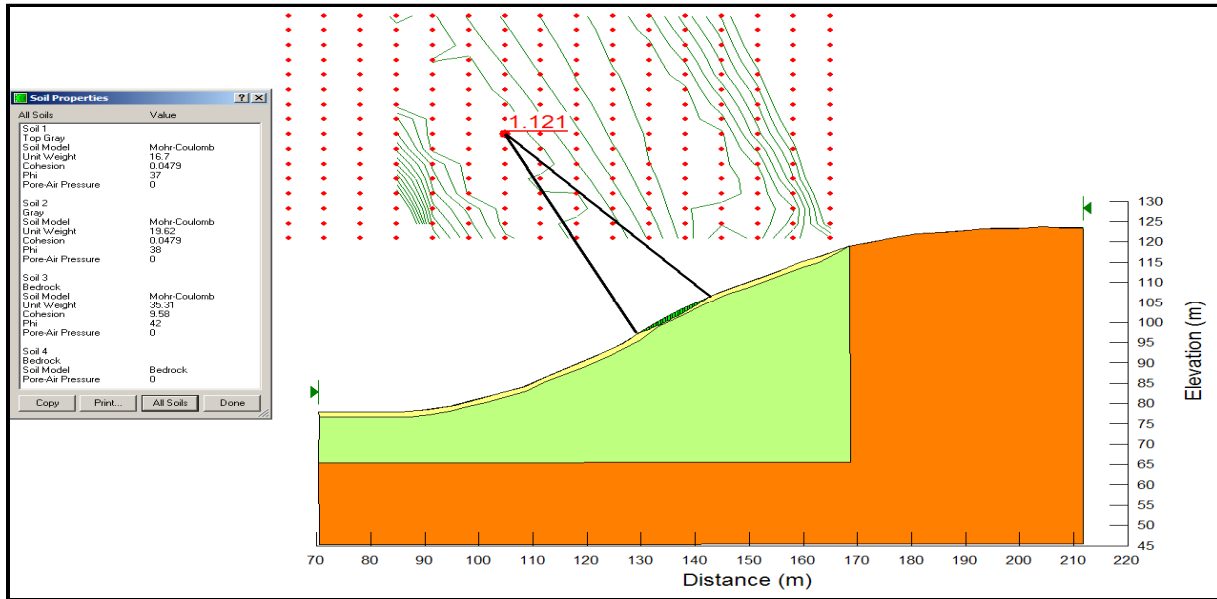
Figure 3.35: Geo-Slope model for the gray area (with loose top 1.22 m of material)

Similar to the Geo-Slope models for the brown spoil area, three models were developed for the gray spoil area. Considering the top 1.22 m (4 ft.) as loose material, the factor of safety was found to be 1.121 as shown in Figure 3.35. In the second case with a deeper circle, the factor of safety was found to be 1.154 as shown in Figure 3.36. In the last case, without the top 1.22 m (4 ft.) of loose materials, the safety factor was found to be 1.158 as shown in Figure 3.37.

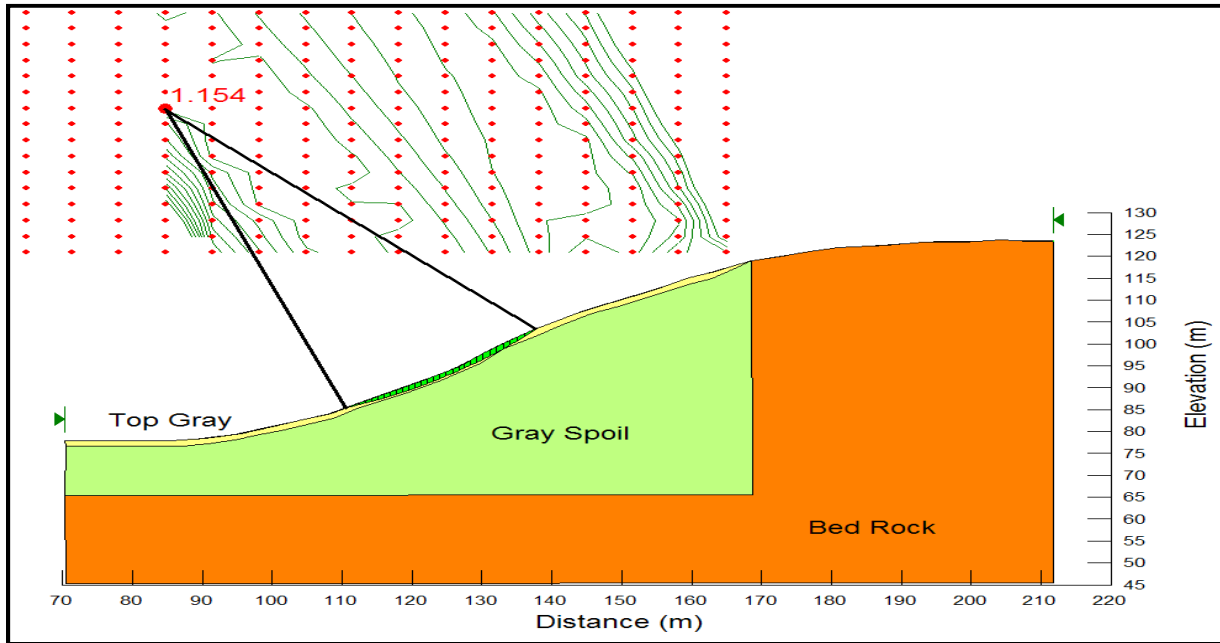
Figure 3.36: Geo-Slope model for the gray area (with loose top 1.22 m of material considering deeper circle)

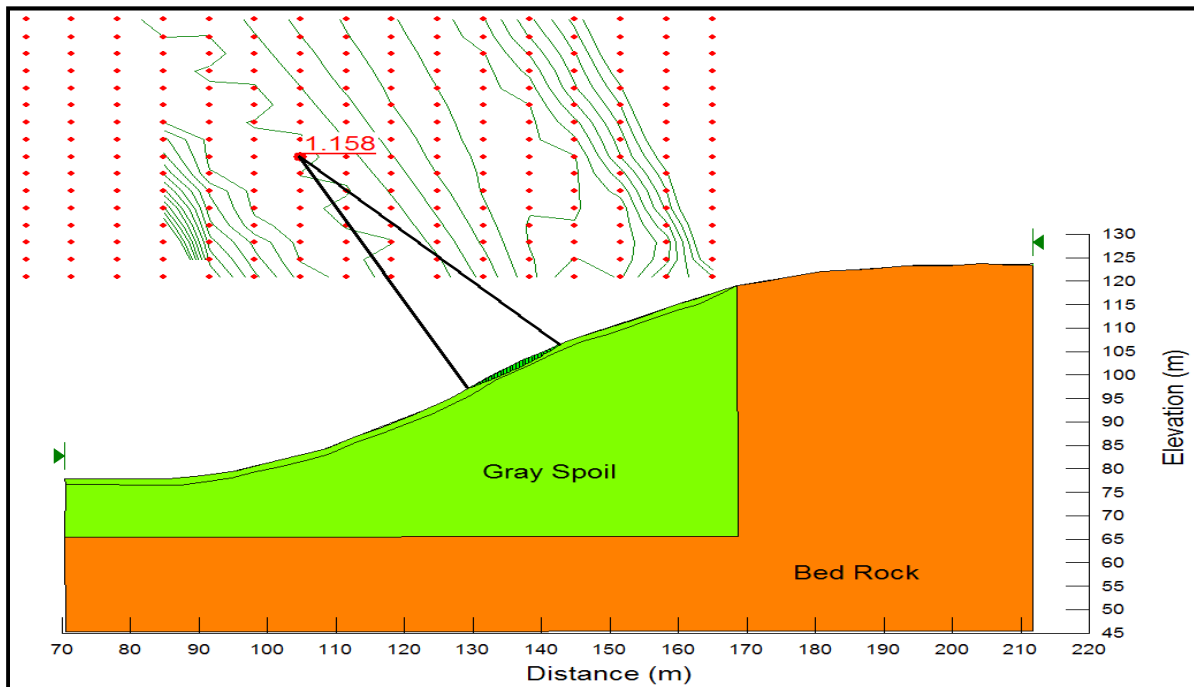
Figure 3.37: Geo-Slope model for the gray area (without loose top 1.22 m of material)

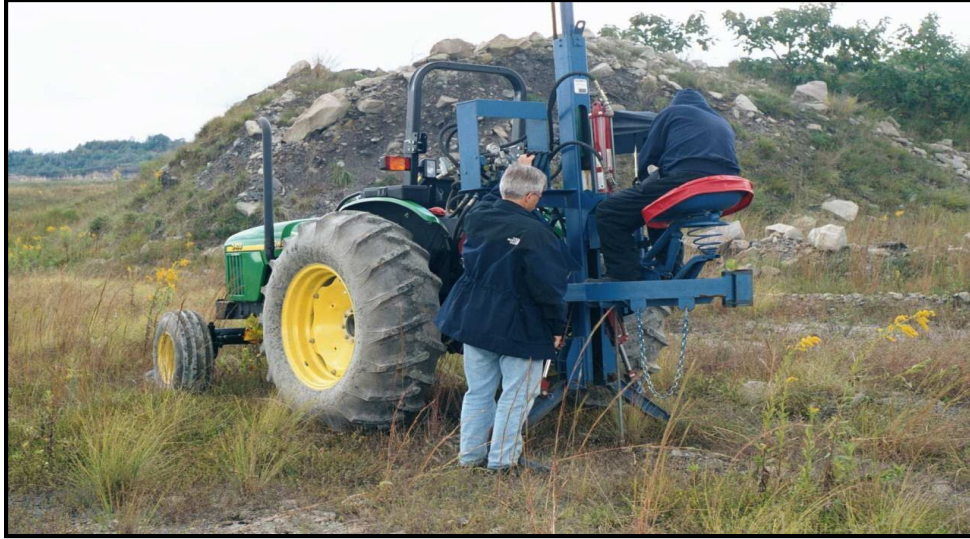
Figure 3.40: Static cone penetrometer used to collect data at the Starfire Mine (Source: Conrad, 2002)

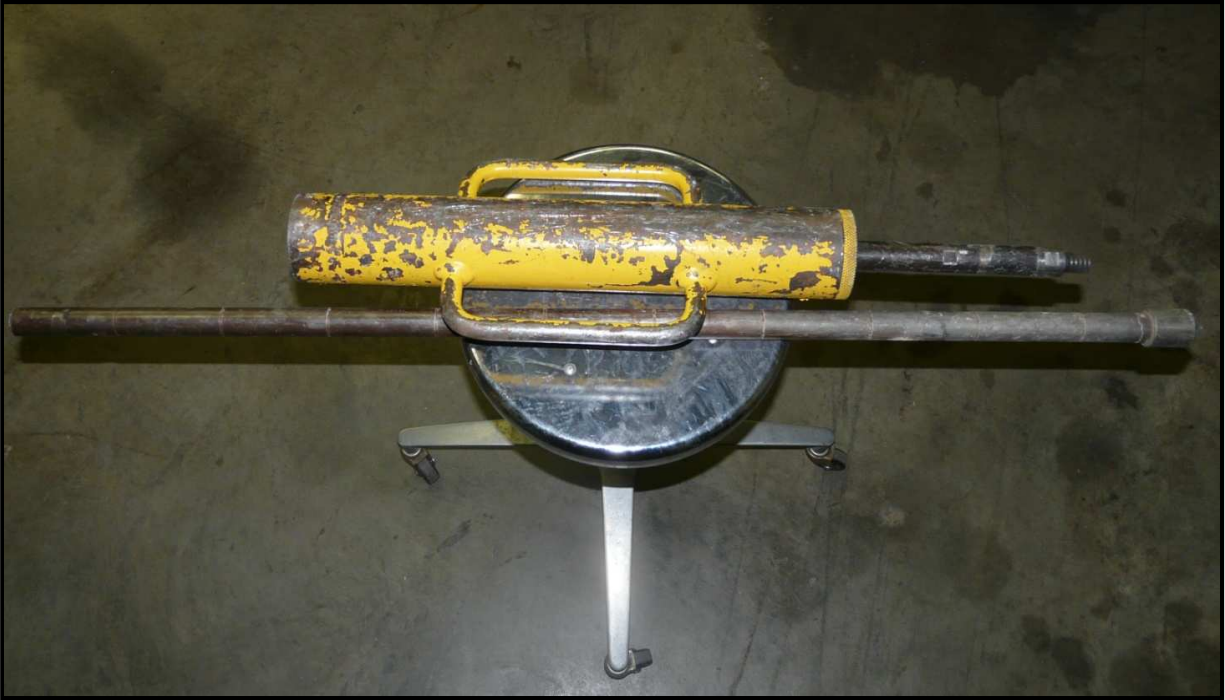
Figure 3.41: Wildcat Dynamic Cone Penetrometer

The Wildcat Dynamic Cone Penetrometer, manufactured by Trigg's Technology, is used to measure in-situ strength (penetration resistance and maximum penetration depth) of the growing media. A Wildcat Dynamic Cone Penetrometer is shown in Figure 3.41. It is lightweight and one person can handle it to test soil strength properties. This penetrometer can measure penetration resistance normally up to 5 m (16.4 ft.). Standard penetration test (SPT) method is used by this equipment to measure soil resistance. It applies a known amount of kinetic energy to the cone, which causes the penetrometer to move a distance through the soil (Herrick and Jones, 2002). Either number of blows required to penetrate a specified depth, or the depth of penetration per blow are recorded to calculate penetration resistance. The number of blows required is an indication of the density of the ground (Hunt, 2007). The weight of the hammer, slide distance, and cone angle influence the energy delivered and these can be adjusted to local conditions.

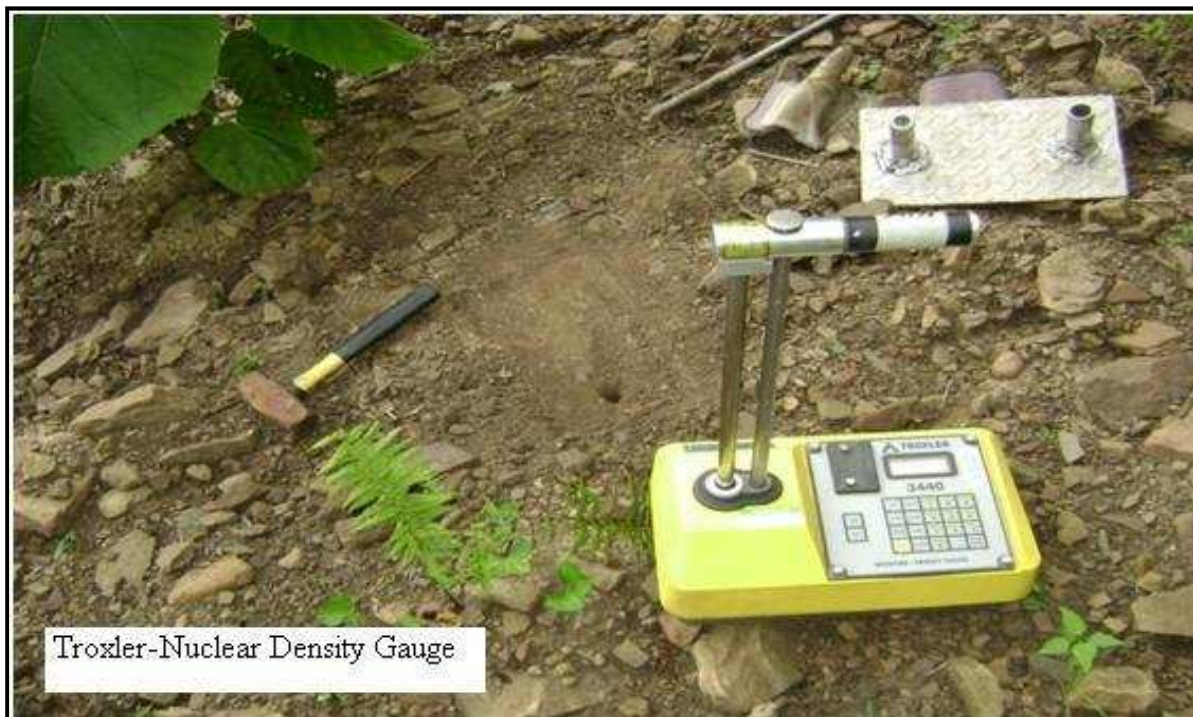
Figure 3.42: Field set up of nuclear density gauge

Surface preparation for spoil testing is important for gauge performance and test results. A hole of 30.5 cm (12 in.) depth is made using the rod provided with the gauge and the surface is smoothed using a scraper plate as shown in Figure 3.42. The purpose of smoothing the surface is to fill small voids, cracks or holes with sand or fine particles to avoid scattering of radiation. Due to operational difficulties and accuracy concerns, the bulk density at 15 cm (6 in.) depth is considered for all further analyses in this investigation. The bulk density readings for the brown and the gray spoil area recorded in June, 2009 and May, 2010 measurements are listed in appendix D.

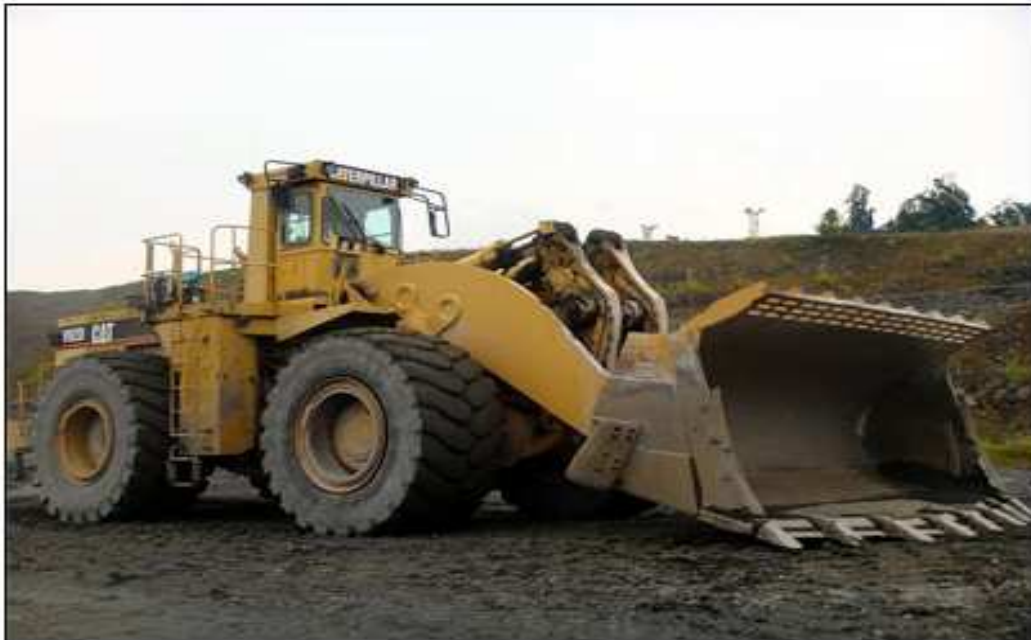
Figure 3.47: Caterpillar 992 D loader (Source: Emeco Equipment)

No.	Parameter	Detail
1	Loader model	992D
2	Make	Caterpillar
3	Bucket capacity	11.5 m <sup>3</sup> (15 yd <sup>3</sup> )
5	Rated payload	21.7 tonne (23.9 T.)
6	Bucket payload	33,100 kg (73,000 lb.)

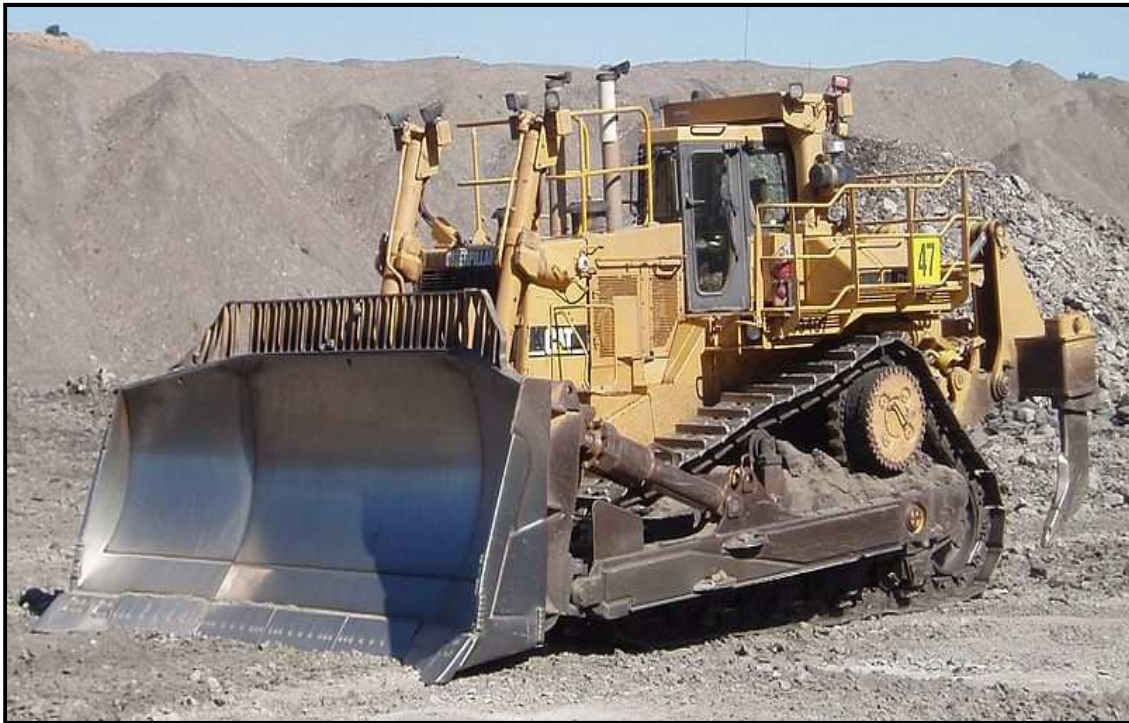
Figure 3.49: Caterpillar D11R dozer (Source: Emeco Equipment)

No.	Parameter	Detail
1	Make	Caterpillar
2	Model	D11R
3	Blade capacity	13 m <sup>3</sup> (17 yd <sup>3</sup> )
4	Gross power	698 kW (935 hp)
5	Flywheel Power	634 KW (850 hp)
6	Operating weight	104,400 kg (230100 lb)
7	Speed (Forward)	11.7 km/hr (7.3 mph)
8	Speed (Reverse)	14 km/hr (8.7 mph)
