**Field Investigation of Best Practices for Steep-Slope Mine Reclamation Employing the  
Forestry Reclamation Approach**

**Final Report**

June, 2011

University of Kentucky  
Department of Mining Engineering  
859-257-8827 (Phone)  
859-257-5727 (Fax)  
Lexington, KY 40506-0107, USA

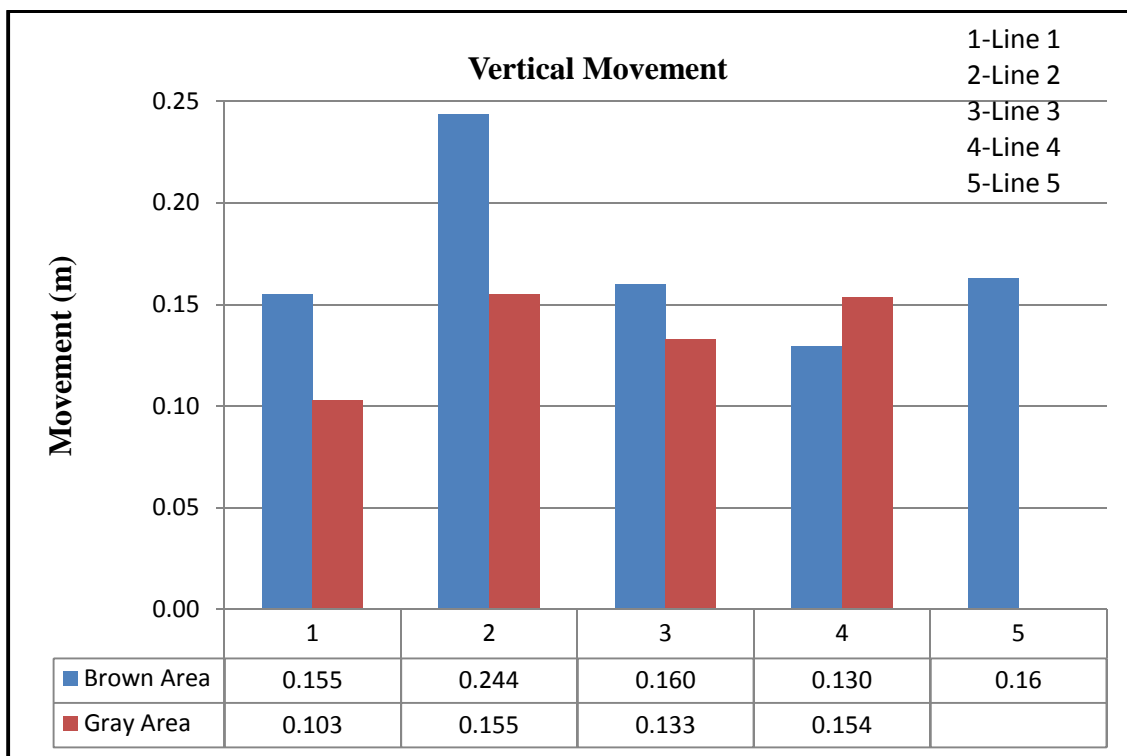
Figure 4.3: Maximum vertical movement of brown and gray area

Survey results from the baseline survey and the final survey are plotted and analyzed by monument line for movement of monuments down the slope and vertical settlement or heaving. The results of maximum downward horizontal and vertical movement for the brown and the gray spoil area are shown in Figure 4.2 and 4.3, respectively. Maximum downward horizontal and vertical slope movements are shown in Figure 4.5. By the end of the project, even after a period of very heavy rainfall (6.1 cm in a day, May, 2009 and 6.2 cm in a day, August, 2009) that resulted in serious flooding in the region, the slope did not experience any significant mass movement. At one area in the brown spoil, there has some localized slumping with a maximum vertical displacement of 37.5 cm (15 in.) to 45 cm (18 in.) as shown in Figure 4.4. In some parts of the slope, heaving of the monuments was recorded possibly due to consolidation of loose spoil and the freezing and thawing cycle. Maximum horizontal slope movements of 0.227 m (0.74 ft.) in the brown area (Line 1) and 0.294 m (0.96 ft.) in the gray area (Line 1) were recorded. Maximum vertical displacements of monument of 0.244 m (0.84 ft.) in the brown area (Line 2) and 0.155 m (0.51 ft.) in the gray area (Line 2) were recorded. These small slope movements are consistent with the computer model analyses in the slope stability section, which did not predict any massive slope failure.

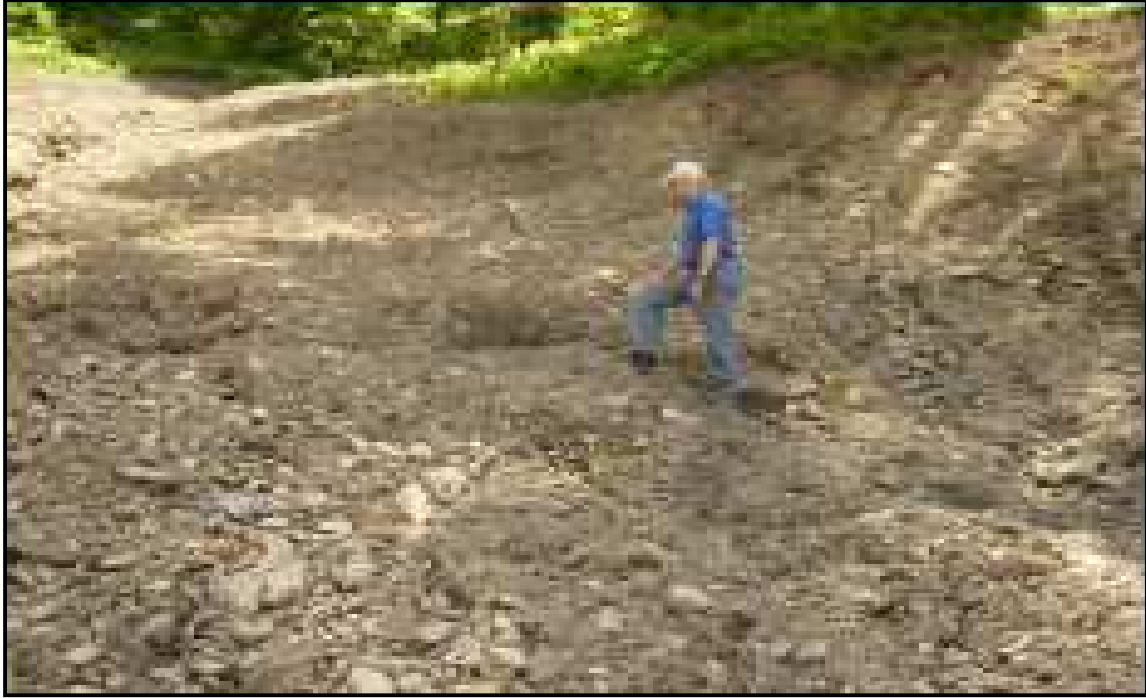
Figure 4.4: Small slumping in the brown spoil area after two heavy rains

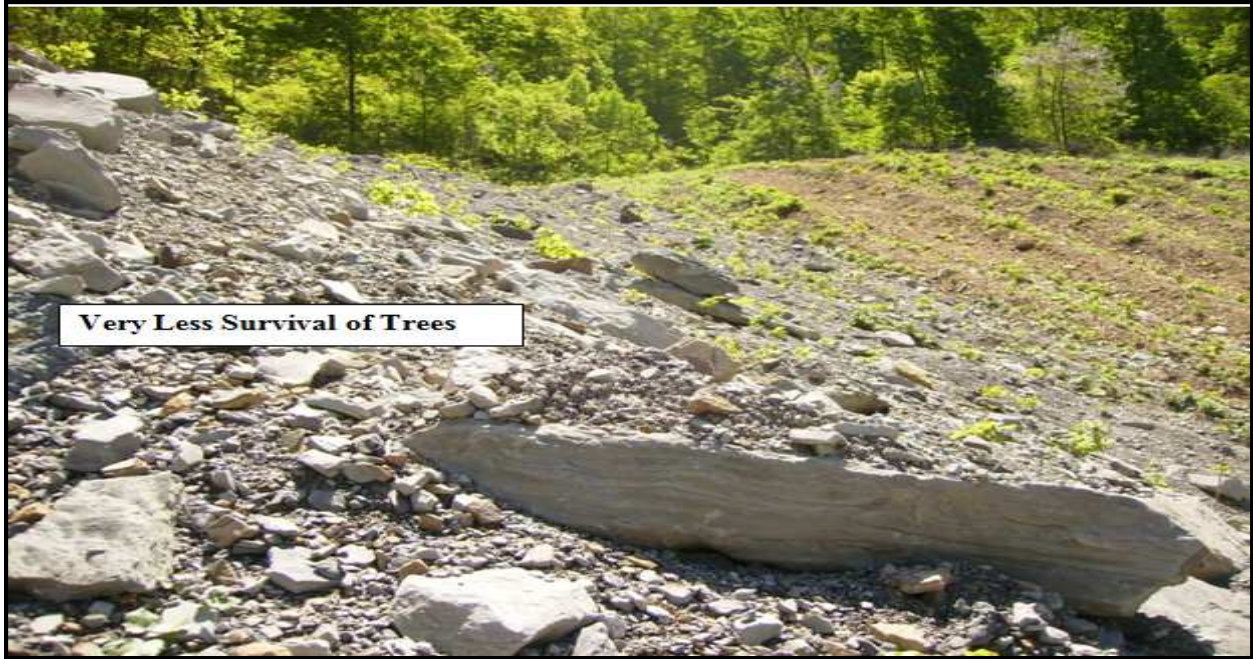
Figure 4.13: Lower survival rate area of the gray spoil area

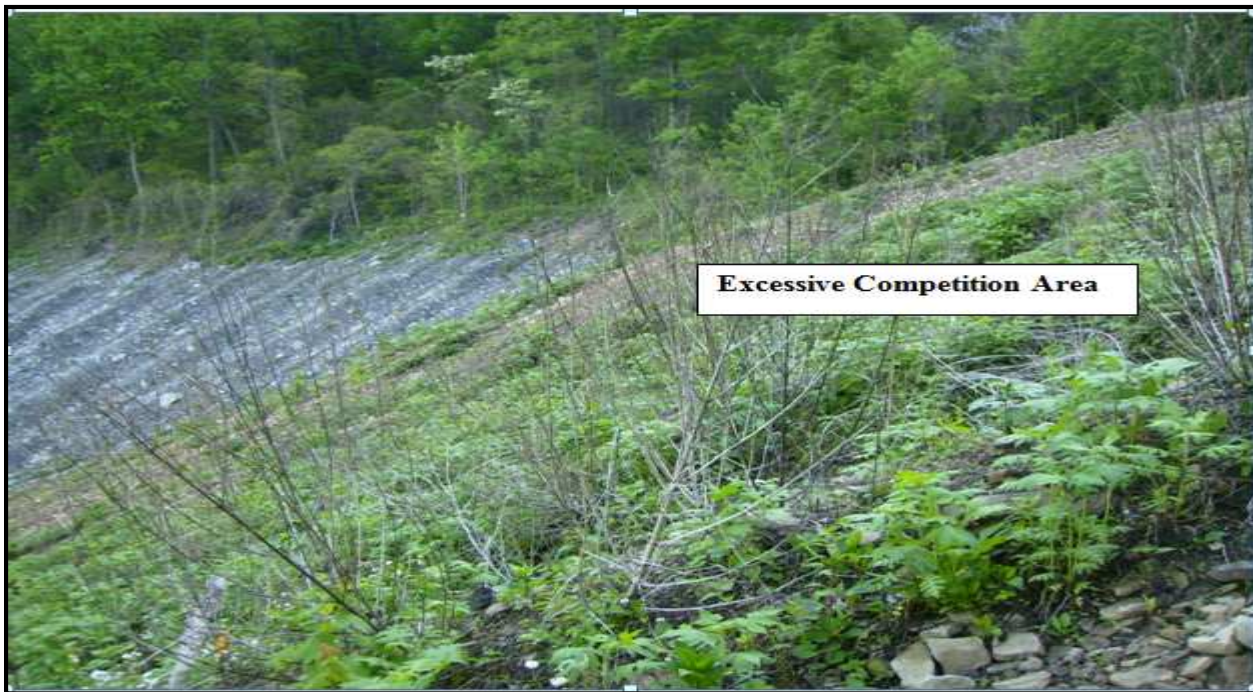
Figure 4.14: Lower survival rate area of the brown spoil area
