# **Assessing Geomorphic Reclamation in Valley Fill Design for West Virginia**

OSM Cooperative Agreement Number: S12AC20020

Final Report  
Reporting Period: 09/01/2012-12/31/2014

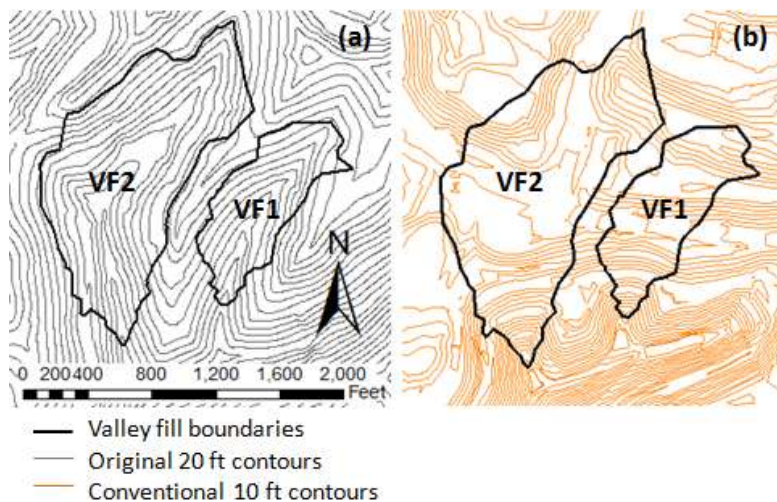
**Figure 5.** VF1 and VF2 locations on (a) original contours; (b) conventional reclamation contours.

The field site for the generation of geomorphic reclamation designs was a surface mine in Boone Co., WV, in the same ecoregion as the reference landform sites (Fig. 4). Two valley fills (VF1 and VF2) with an existing conventional reclamation plan were used within the permit boundary for geomorphic designs (Fig. 5). Small-scale fills were investigated in this study with the intention of designing a geomorphic landform that shows the practicality of a pilot construction project incorporating geomorphic design principles in southern WV. A third valley fill was evaluated but later excluded because applying geomorphic design principles would have resulted in a valley fill that impacted multiple drainage basins. This work evaluated designs draining to a single outlet.

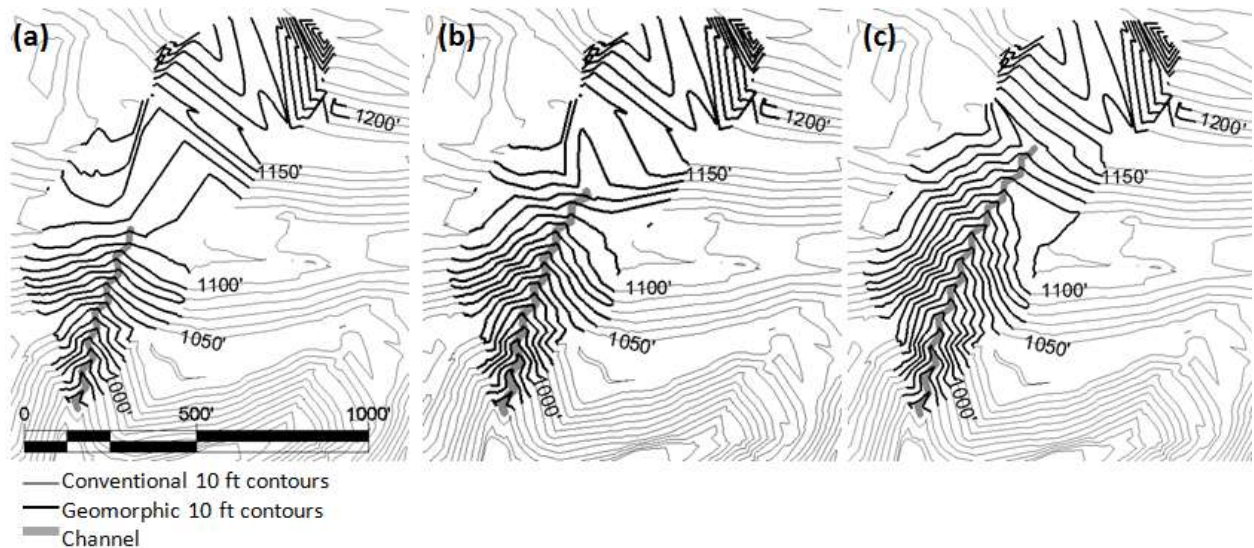
**Figure 12. Geomorphic designs for VF1 with varying drainage density: (a) low drainage density (Design 1); (b) target drainage density (Design 2); (c) high drainage density (Design 3).**

<b>Design</b>	<b>Valley fill</b>	<b>DD (ft/ac)</b>	<b><math>V_{GLD}/V_{CV}</math> (%)</b>
1	1	48.2	83
2	1	60.8	73
3	1	74.8	66
4	2	48.3	77
5	2	60.7	63
6	2	72.4	49

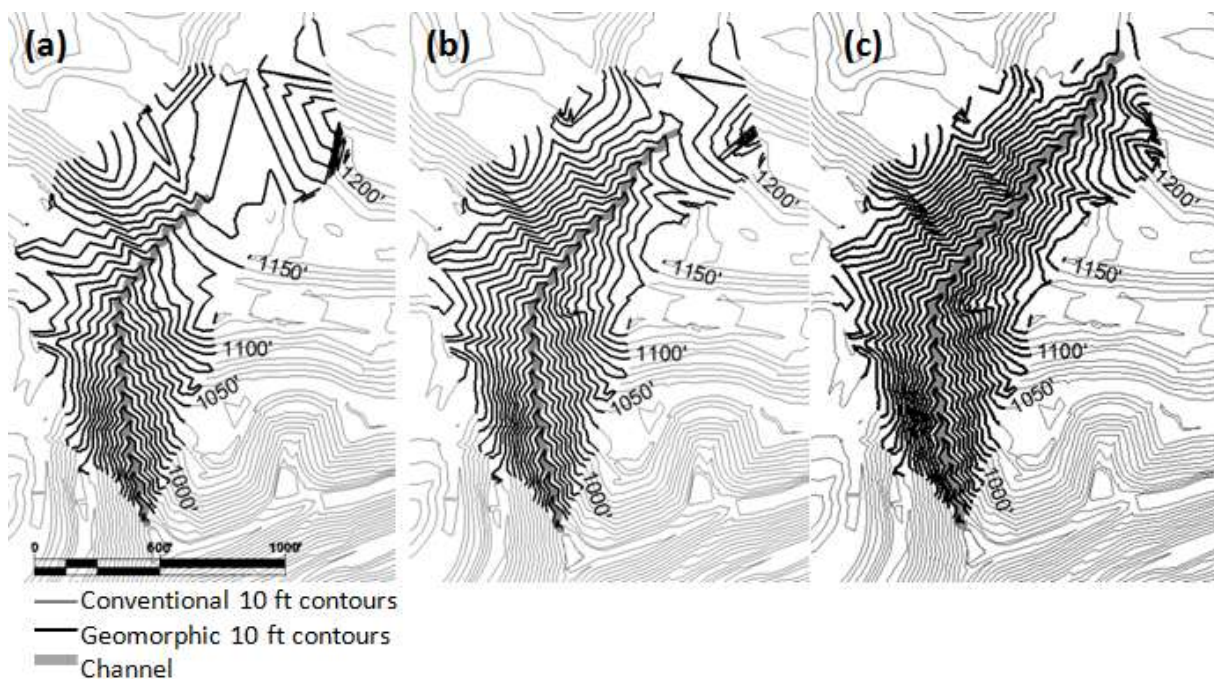
**Figure 13. Geomorphic designs for VF2 with varying drainage density: (a) low drainage density (Design 4); (b) target drainage density (Design 5); (c) high drainage density (Design 6).**

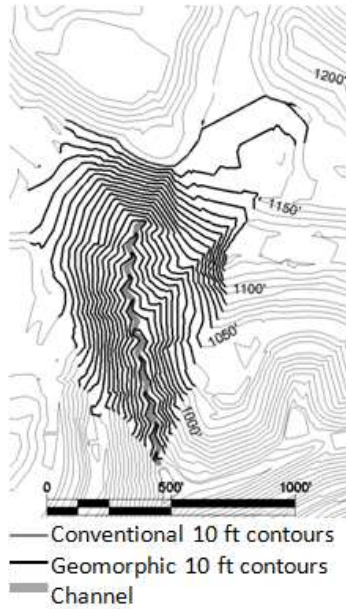
**Figure 15. Geomorphic design for VF2 in permitted area with maximum channel stability (Design 8).**

Design	Valley fill	$S_c$ (%)	$\tau_{max}$ (psf)	$P_{HS}$ (%)	$V_{GLD}/V_{CV}$ (%)
7	1	6.7-12	2.84; 3.67	33	65
8	2	6.7-12	4.09; 5.28	26	53

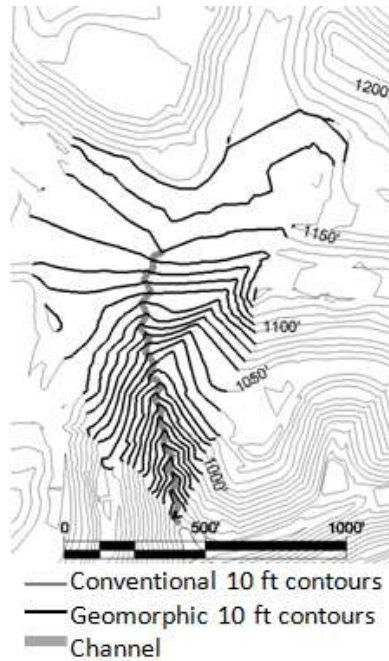
**Figure 17. Geomorphic design for VF2 in permitted area with maximum fill volume (Design 10).**

Design	Valley fill	$S_c$ (%)	$\tau_{max}$ (psf)	$P_{HS}$ (%)	$V_{GLD}/V_{CV}$ (%)
9	1	9.7-35	8.24; 10.64	6.1	99
10	2	8.5-24	8.09; 10.45	4.4	85

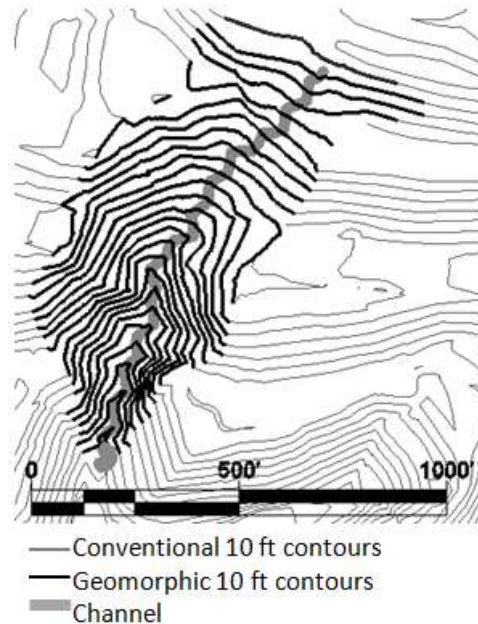
**Figure 25. Geomorphic design for VF1 using software's default input values (Design 17).**

Design	$S_c$ (%)	$\tau_b$ (psf)	$P_{HS}$ (%)	$V_{GLD}/V_{CV}$ (%)
17	2.1-25	6.02; 7.77	22	60

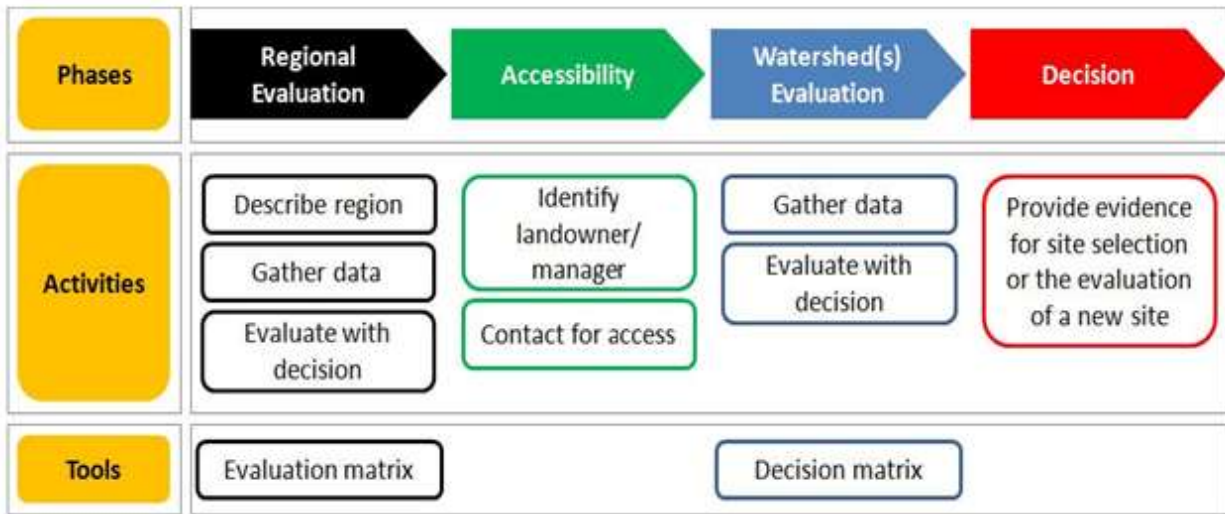
**Figure 28. Evaluation procedure guiding field site selection.**

A decision procedure was developed to select reference landforms comprised of four phases (Figure 28). The two major landform categories, mature landforms and long-term valley fill reclaimed sites, were under consideration. While the decision procedure was the same for both types of sites, the evaluation tools varied to match the needs of the specific landform. First the region was evaluated at a landscape scale. Then, the region was evaluated at the single watershed scale (1 km<sup>2</sup>) to make a final decision on which watersheds from which field data would be collected.

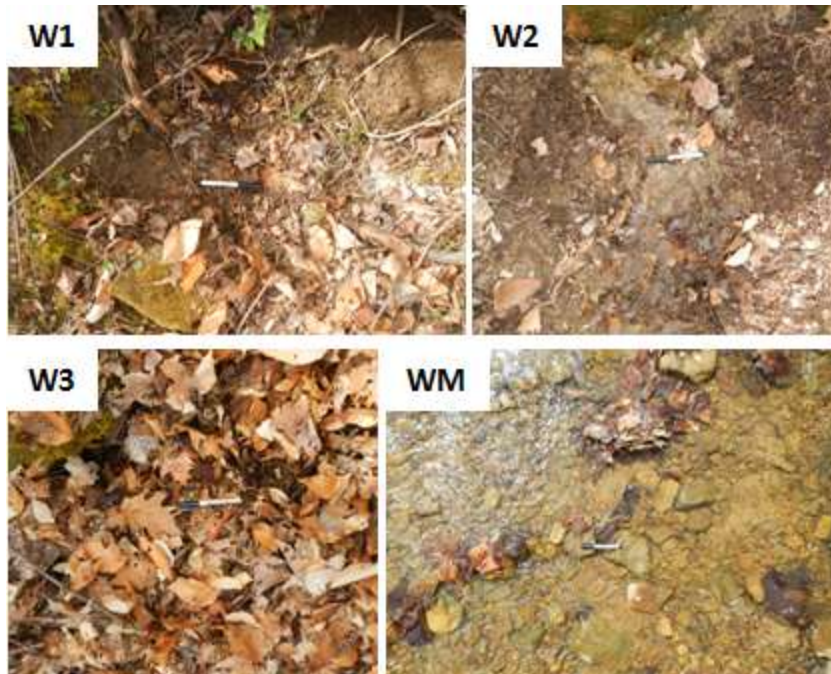
**Figure 31. Channel beds at channel heads and mouth of Wiley watershed**

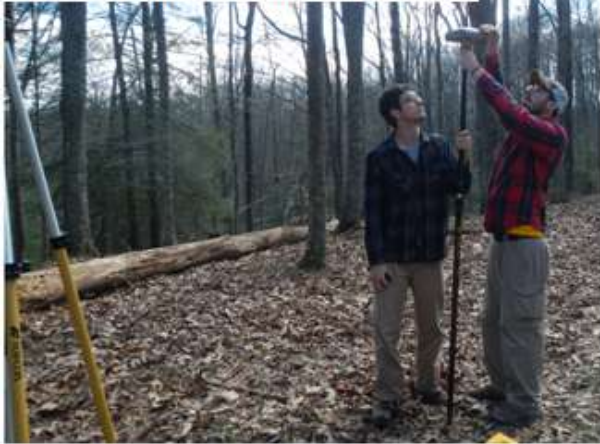
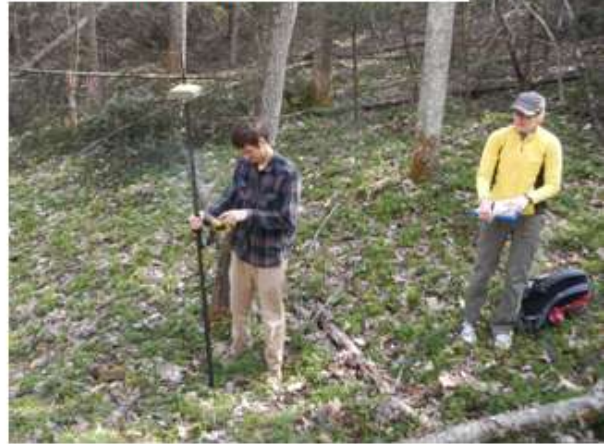
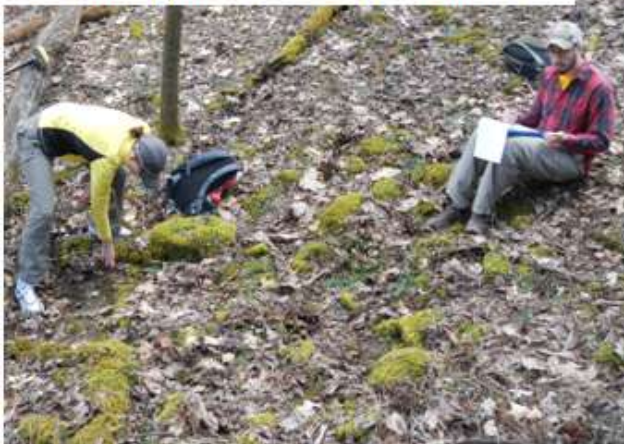
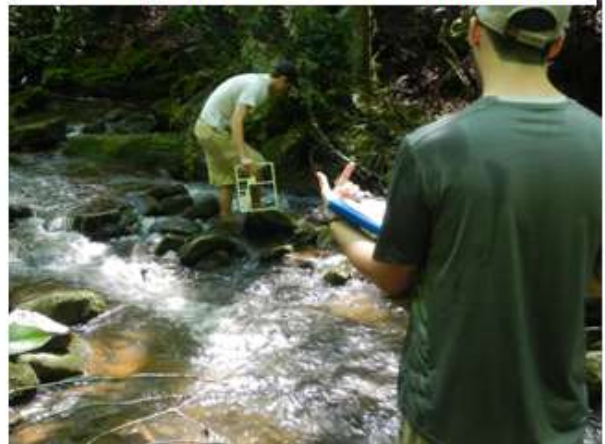
**Figure 34. Photos of field data collection**

**Setting up surveying equipment**

**Surveying channel head location**

**Performing pebble count at channel head**

**Performing pebble count at watershed mouth**
